4.0 Function and Physical Fabric

4.1 Current Conservation Status

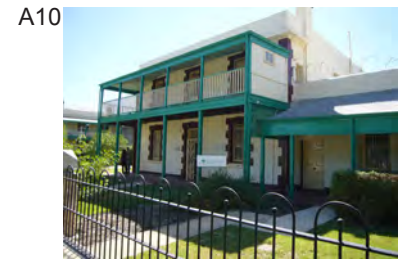
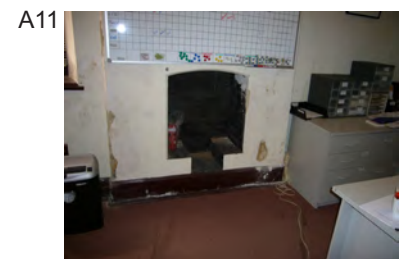
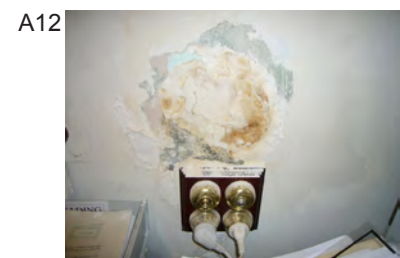
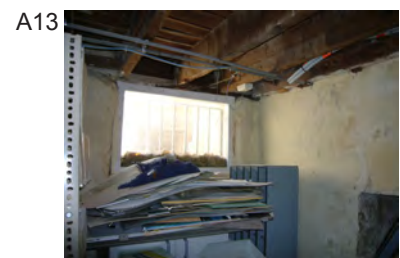
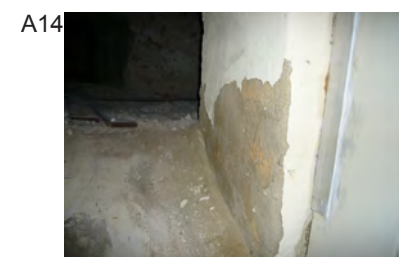
- Extensive damp internally, particularly at the ground floor and basement levels (currently being rectified)
- Some isolated external Localised failure of the render
- Applied paint externally retarding vapour passage in walls
- Concrete verandah at ground floor
- Built up ground levels
- Intrusive electrical and plumbing services
- Reticulation over spray onto building
- Weathered timber floorboards to upper floor verandah

A10	View looking north-east towards No. 10 The Terrace
A11	Detail of damage caused by damp to internal wall
A12	Detail of damage caused by damp to internal wall
A13	Detail of damage caused by damp in basement
A14	Detail of damage caused by damp in basement

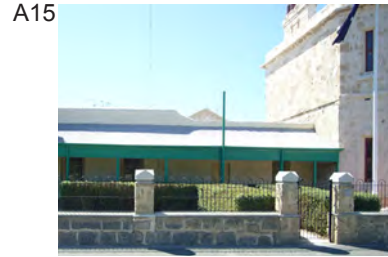
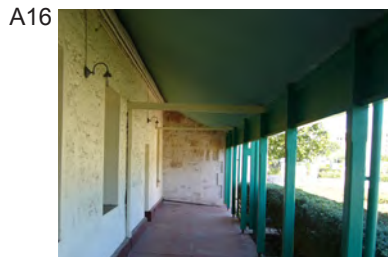
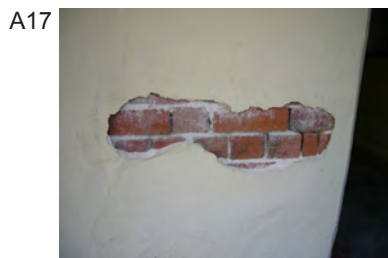
- A15 View looking east towards No. 12 The Terrace
- A16 View looking south along front verandah
- A17 Detail of render failure on courtyard wall
- A18 View of south courtyard showing applied render above shoulder height
- A19 View looking south-west across south courtyard showing deterioration of joinery

- Applied paint externally retarding vapour passage in walls
- Concrete verandah
- Built up ground levels
- Intrusive and damaged electrical services
- Some render failure
- Damage to the west wall of the northern office
- Damage to the floor of the northern office
- Extensive damage caused by damp to the kitchen ceiling
- Some drumminess to the walls of the conference room
- Damage caused by damp to the external toilet and storage space, including lifting of wall tiles in the storage space
- Localised failure of external limestone walls
- Inappropriate concrete render applied to external limestone walls
- Previous repairs to external walls

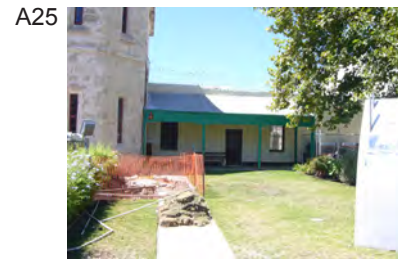
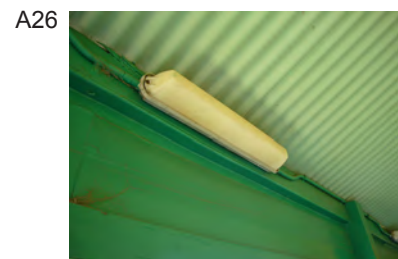
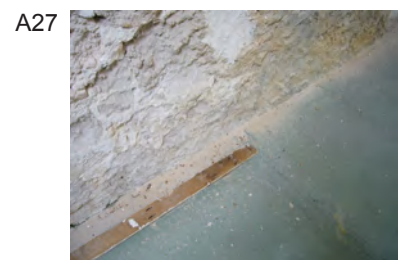
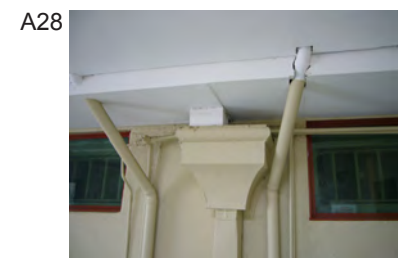
- Damp internally
- Intrusive services and rain water goods
- Concrete verandah and floors
- Built up ground levels
- Applied paint externally retards vapour passage in walls
- Damaged external render

A25 View looking east towards No. 14 the Terrace

A27 Detail of failed internal limestone wall

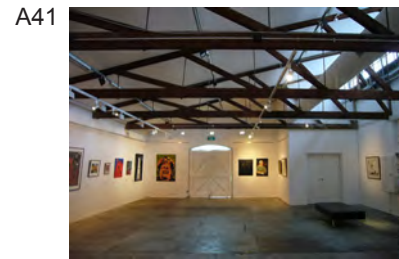
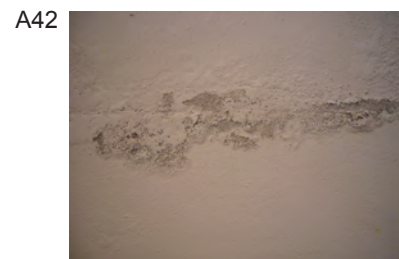
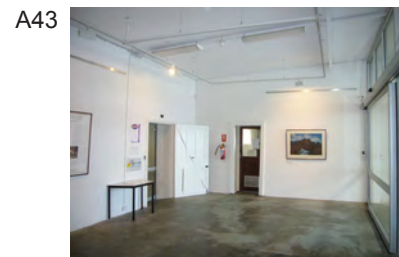
- A41 *View looking east across Exhibition Space*
- A42 *Detail of render failure on west wall*
- A43 *View looking south across foyer*

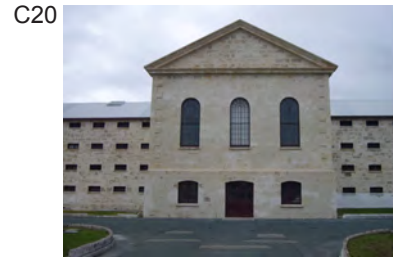
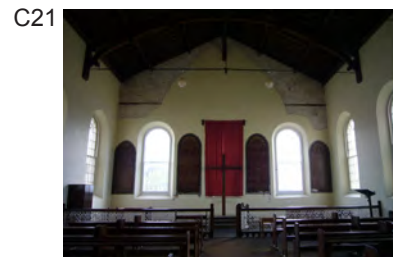
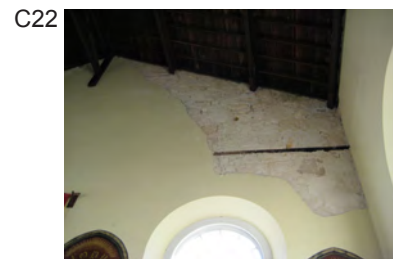
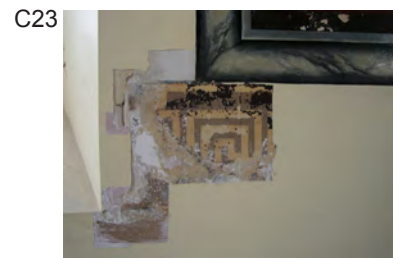
- Previous failure of the western limestone wall at high level
- Water leaks at high level on the eastern wall in the choir loft

C20 View of front (west) facade of the Chapel

C22 Detail showing high level failure of internal render

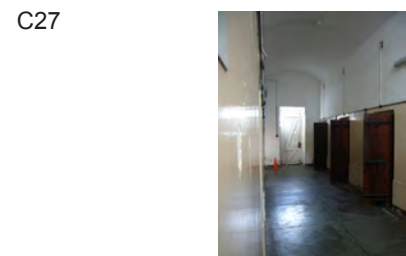
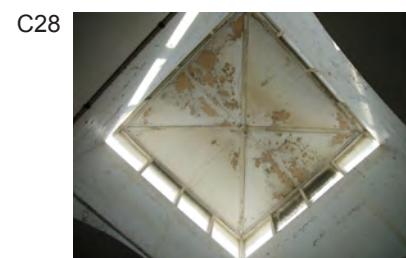
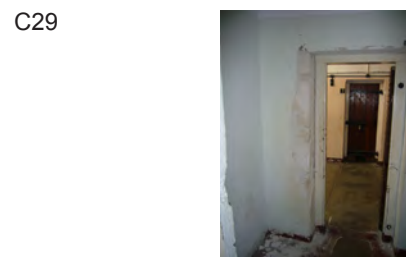
- Failure of the limestone
- Failure of the applied render and paint finishes
- Deterioration of the external joinery
- Deterioration of metal canopy structures
- Asbestos cement products are hazardous
- Intrusive earlier repairs
- Failure of internal walls
- Deterioration of floor surfaces

- C24 View of north-west corner of Refractory Cell Block
- C25 Detail of wall showing failure of dado and previous repairs
- C26 Detail of previous repairs to walls
- C27 View looking along corridor of Refractory Cell Block
- C28 Detail of skylight in Refractory Cell Block
- C29 Detail showing failure of plaster surface

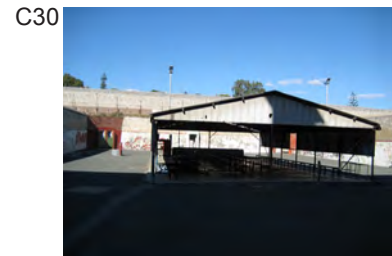
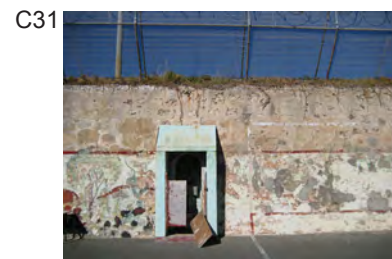
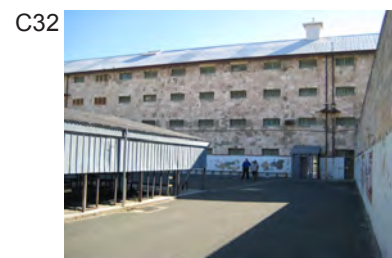
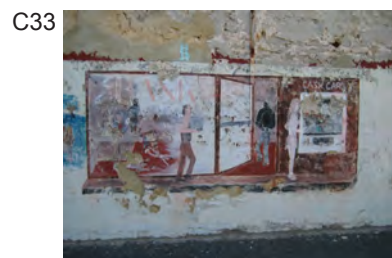
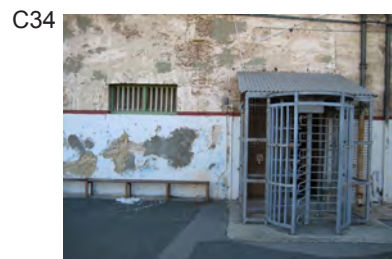
- Failure of the limestone walls and dado
- Previous repairs to the walls, including cement patches
- Deterioration of the metal shelters
- Deterioration of murals on the walls
- External toilets and other water services have been capped with concrete. Doors and screens have not been maintained

- C30 View looking east across 3 Division Yard
C31 Detail showing deterioration of wall
C32 View looking west across 3 Division Yard
C33 Detail of art work by prisoners
C34 Detail of previous repairs to walls

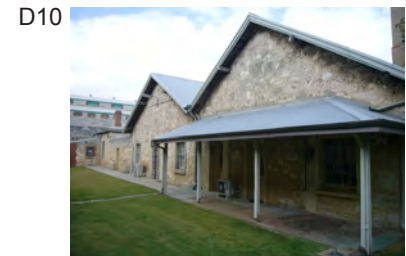
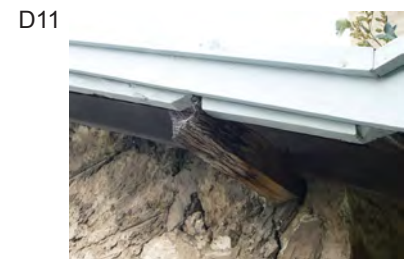
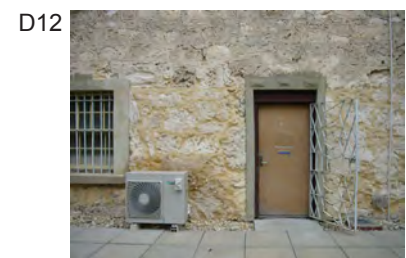
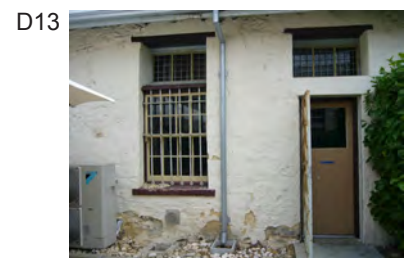
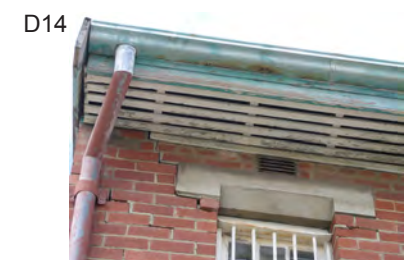
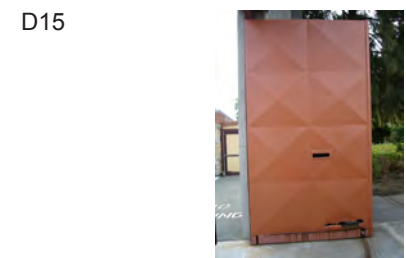
- Extensive deterioration of the exterior stonework
- Previous poor repairs of the stonework
- Fretting brickwork, and tuckpointed brickwork now rendered over (to office)
- Damage to brickwork caused by rusting metal window bars and other metal fixtures
- Deterioration of external joinery
- Some failure of the paint and plaster applied to internal walls
- The metal entry gates to the Terrace are in poor condition

D10	View of north-west corner of Female Division
D11	Detail of joinery deterioration
D12	Detail of north facade showing previous repairs, intrusive services
D13	Detail of east facade showing failure of wall
D14	Detail showing cracking caused by fixtures embedded in brick work
D15	View of entry gates showing deterioration

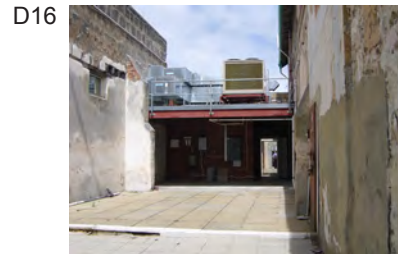
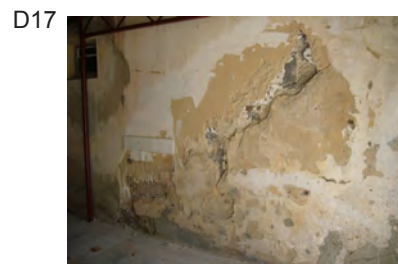
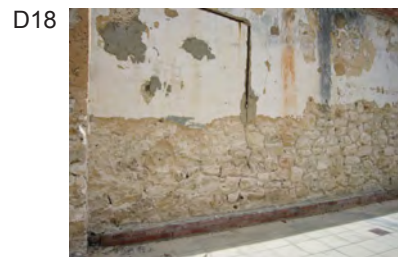
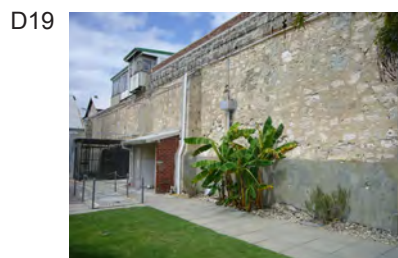
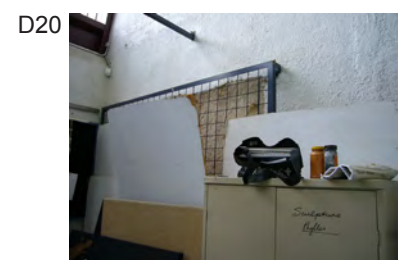
- Extensive damage caused to perimeter and exterior limestone walls
- Drumminess of renders/plasters to perimeter and exterior walls
- Render applied to exterior walls
- Previous poor repairs to the exterior walls
- Some isolated damage caused by damp to interior walls
- Intrusive air-conditioning plant in the space between the exterior and perimeter walls.

- D16 *Detail of intrusive air conditioning units to West Workshops*
- D17 *Detail of western wall showing deterioration*
- D18 *Detail of perimeter wall adjacent to West Workshops showing failure and previous repairs*
- D19 *Detail of north facade showing concrete dado*
- D20 *Detail of exposed limestone to internal south-west corner*

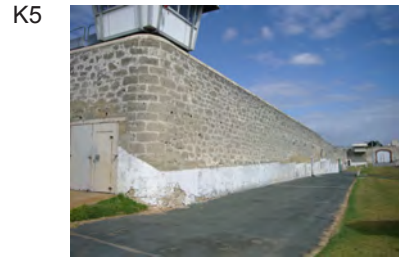
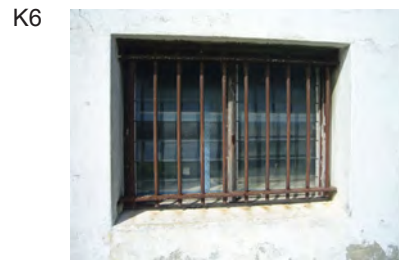
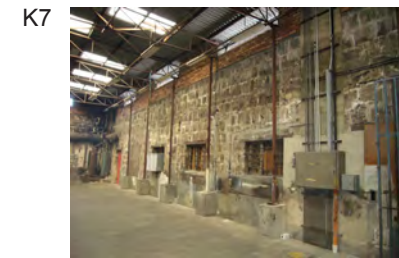
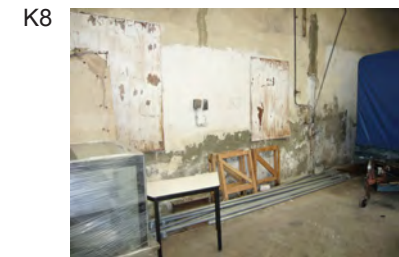
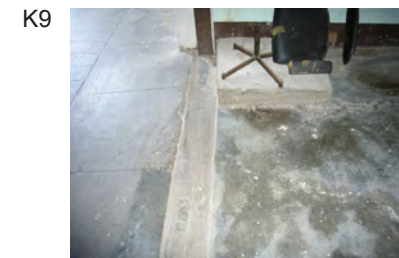
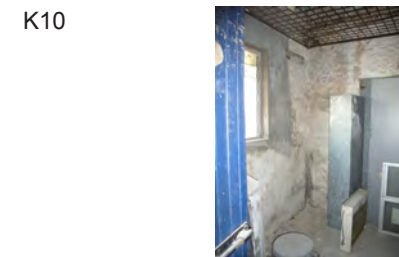
- Failure of the limestone walls
- Previous poor repairs
- Deterioration of external joinery
- Deterioration of exposed metalwork

- K5 View of the southwestern corner of the south perimeter wall forming the external wall of the East Workshops
- K6 Detail of window showing deterioration of joinery and metal bars
- K7 View of interior of west wall of East Workshops
- K8 View showing damage to internal wall
- K9 Detail showing deterioration of floor
- K10 View showing damage to internal wall

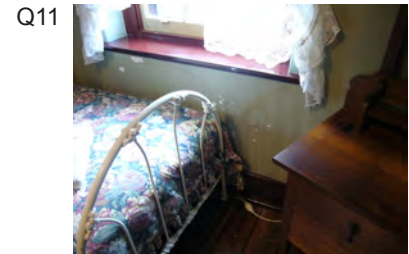
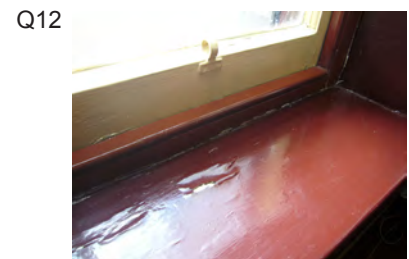
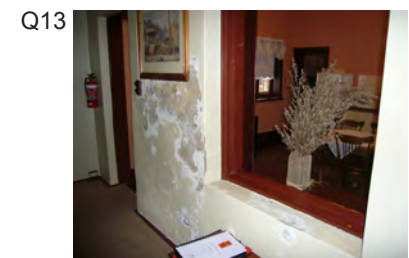
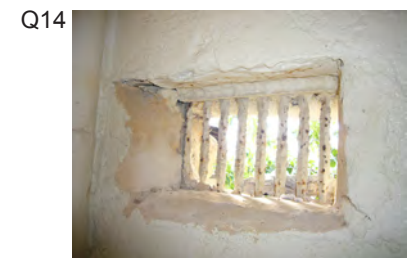
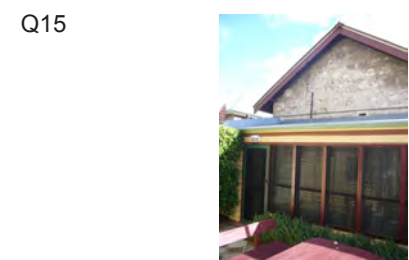
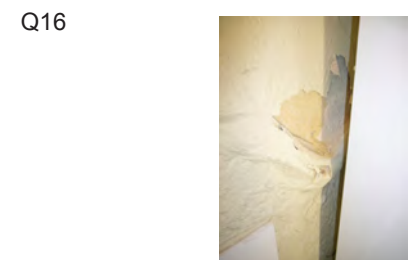
- Some failure of the painted render
- Low level failure of the northern limestone wall extending the length of the wall
- Damaged light fitting above front entry door
- Weathering of exposed timber floorboards on verandah
- Failure of roof sheeting
- Some cracking of the lath on plaster ceilings
- Some cracking of internal walls
- Extensive damage caused by damp to the western and southern walls of the rear room
- Damage caused by damp to the western wall of the bathroom
- Deterioration of painted timber surfaces, particularly the windows and frames
- Damage to some timber window frames
- Damage caused by damp to the interior and exterior of the laundry walls
- Damage caused by damp to the interior and exterior of the toilet walls
- Corrosion of an embedded metal wall vent in the northern wall of the toilet

- Q11 Detail of damage to wall in front room
 Q12 Detail of deterioration of window cill in kitchen
 Q13 Detail of damage to western wall in rear room
 Q14 Detail of corrosion of embedded metal vent in toilet
 Q15 View looking south-west towards rear of No. 2 The Terrace
 Q16 Detail of damage caused by damp to laundry

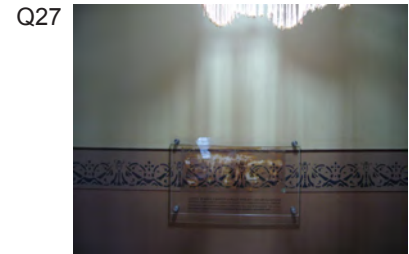
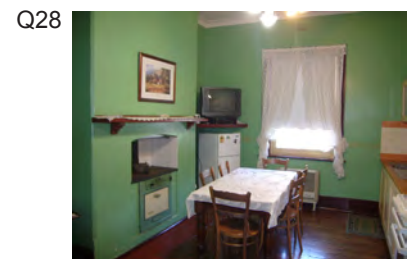
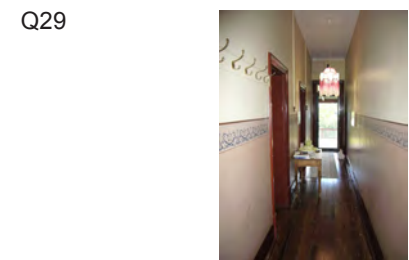
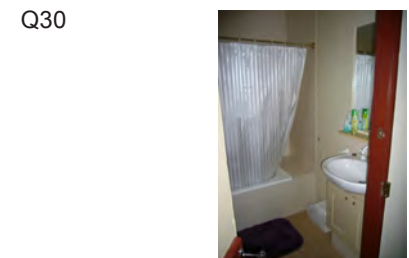
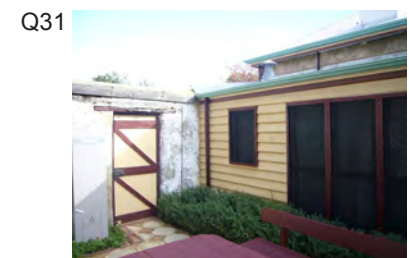
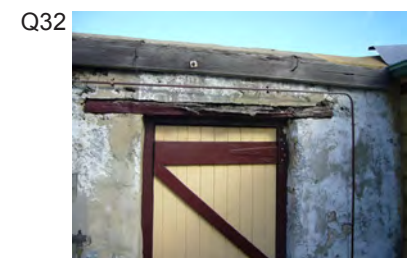
- Some failure of the painted render
- Weathering of exposed timber floorboards on verandah
- Some cracking of the plaster on lath ceilings
- Water damage to the ceiling of the second bedroom
- Deterioration of painted timber surfaces, particularly the windows and frames
- Damage to some window frames
- Cracking of some internal walls
- Damage caused by damp to the internal western wall of the bathroom
- Damage caused by damp to the exterior and interior of the toilet walls, particularly the south wall
- Damage caused by damp to the exterior and interior of the laundry walls
- Deterioration of the timber lintel over the gate in the south fence

- Q27 Detail of paint scrape in hallway
 Q28 View looking south-east across kitchen
 Q29 View looking west along hallway towards entry
 Q30 Detail damage to bathroom wall
 Q31 View looking south-west across rear courtyard
 Q32 Detail of deterioration of timber lintel above courtyard gate

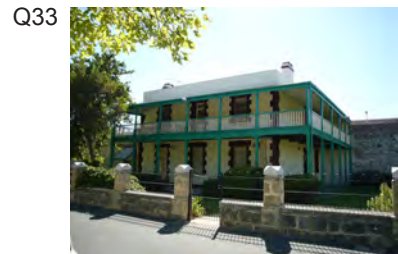
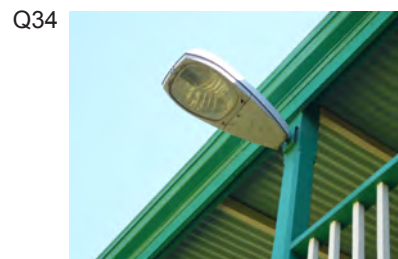
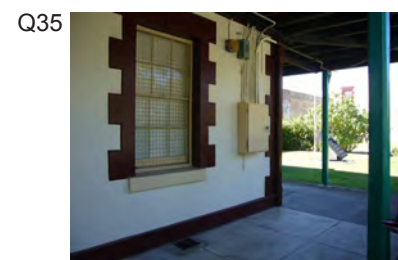
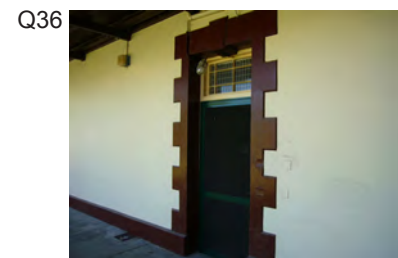
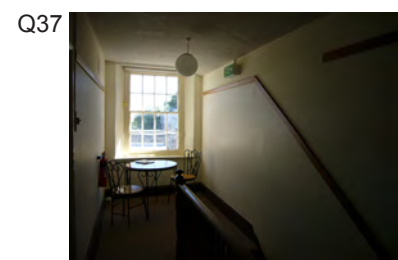
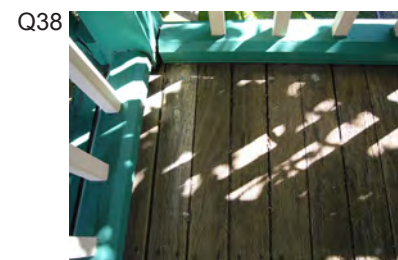
- Drumminess of the exterior render
- Deterioration of render in some areas
- Wear to timber floorboards in north-west corner of first floor verandah
- Intrusive electrical services, especially on west facing verandah

- Q33 View looking north-east towards No. 8 The Terrace
- Q34 Detail of intrusive light fitting on first floor verandah
- Q35 Detail of intrusive services on front verandah
- Q36 Detail of render failure by front entry door
- Q37 View looking north-east across stairwell
- Q38 Detail of verandah floorboards in north-west corner
