**ARCHAEOLOGICAL ASSESSMENT  
OF TIMBER FEATURE  
FREMANTLE PRISON NO. 12 THE TERRACE**

Philip Griffiths Architects and  
Department of Housing and Works

February 2009

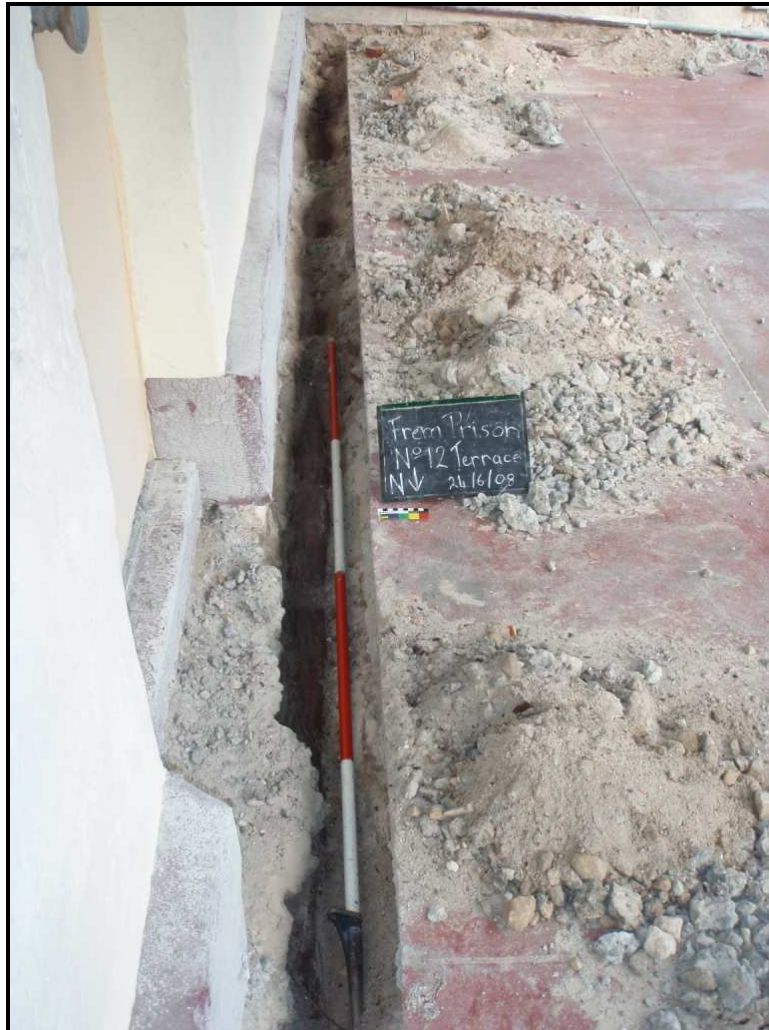
The timber was observed lining the bottom of the drainage trench in an approximate north south direction (Figure 2). Along the western wall, sections of timber were also visible suggesting that at some time in the past wooden joists had extended outwards from the main building, most likely as part of a wooden veranda. This has now been covered over by the existing concrete veranda.

Figure 2. Timber feature No. 12 The Terrace Fremantle Prison prior to full exposure

Consultation between Historical Archaeologist Dr Alistair Paterson (UWA) and Don Smith (CPD group), determined that the timber lining the bottom of the trench was a sacrificial plank and was not part of the actual structure of the veranda. However, the timbers exposed in the western face of the trench (Figures 3 & 4) were determined to be *in situ* joists of the former timber veranda.

It was recommended that the timber at the bottom of the trench (the sacrificial plank) could be recorded and removed as it was in an extremely fragile state. It was further recommended that the timber joists along the western face should also be recorded and left *in situ*, as they were protected by the existing concrete veranda. If any further development or removal of the veranda takes place the feature should be reassessed.

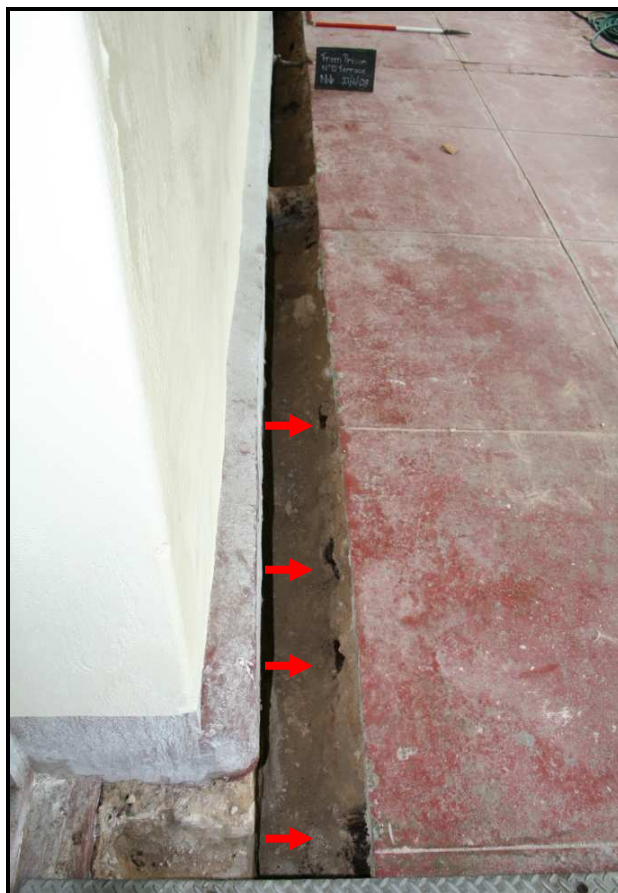
Figure 3. Timber joists in west wall underlying concrete veranda No. 12 The Terrace, looking south

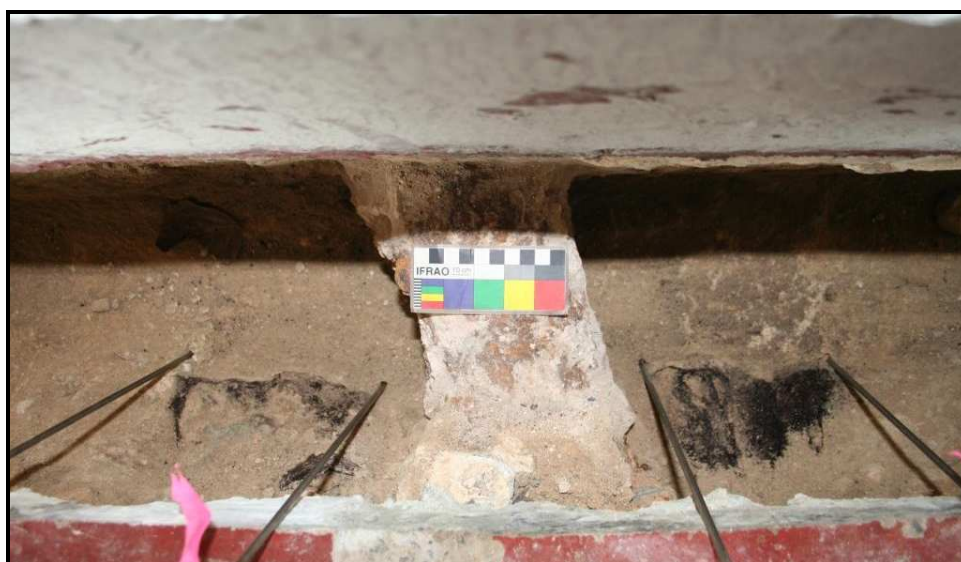
Figure 4. Timber joists in west wall underlying concrete veranda No. 12 The Terrace from above

The timber veranda joists underlying the existing concrete veranda are currently protected by this surface. However, the portions exposed were found to be in a fragile and deteriorated state. If any further development works are planned (i.e. the removal of the present concrete veranda) appropriate methods should be used to protect the timber features and professional conservation advice sought.

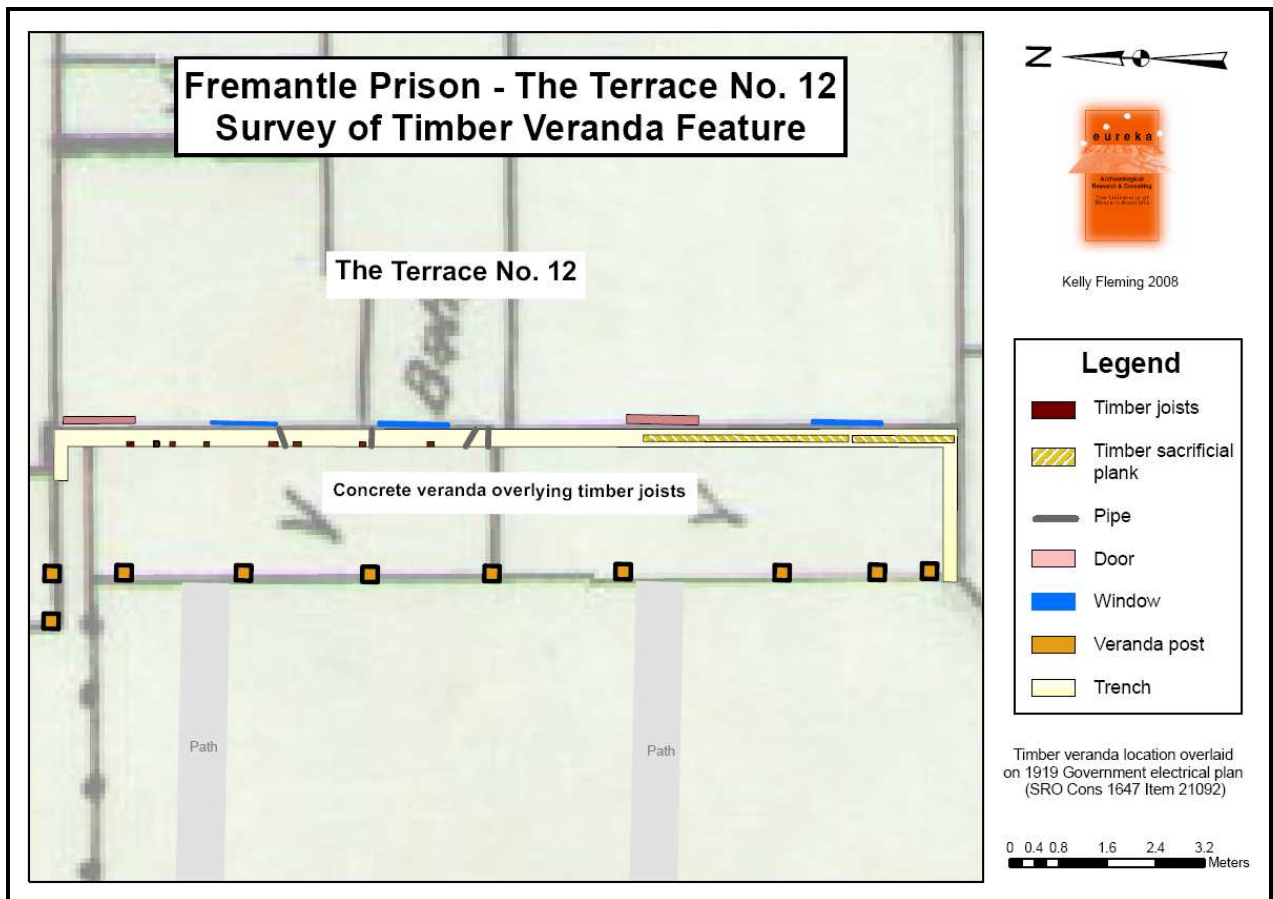
Figure 5. Plan showing location of timber features No. 12 The Terrace veranda

Eight joists were visible underlying the northern portion of the veranda and appeared to be relatively intact however the timber is soft and deteriorated. The joists differ in dimensions with two larger joists of approximately 15 x 6 cm and six small approximately 8 x 4 cm. The joists are spaced between 20 cm and 100 cm from one another (Figure 5).

The sacrificial plank was only visible at the southern end of the trench, however a number of fragments of timber were removed from the northern end of the trench prior to Eureka being called, suggesting the plank may have originally existed along the majority of the trench. The surviving portion was in two pieces, the northernmost measuring 3.4 m in length and 10 cm (width) x 4 cm (depth). The second portion measured 1.7m x 10 cm x 4 cm. A hand forged bolt was embedded in the southern end however this was not attached to any other timbers. No joists were visible in the northern wall at the southern end of the veranda adjacent to the sacrificial plate.

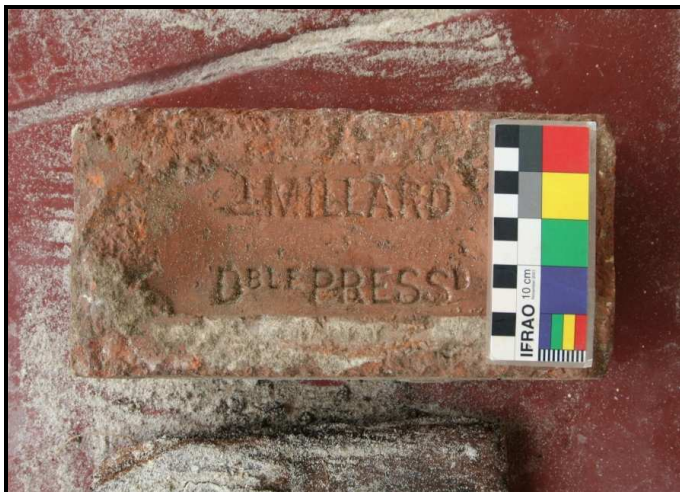
The drainage trench had already been excavated around the entire frontage of No. 10 and No.12 The Terrace prior to Eureka being called. No further veranda features were visible however miscellaneous building rubble, including bricks believed to date to c.1900 and limestone rubble was removed from the trench (Figures 6 & 7).

Figure 6. Millard brick c. 1900

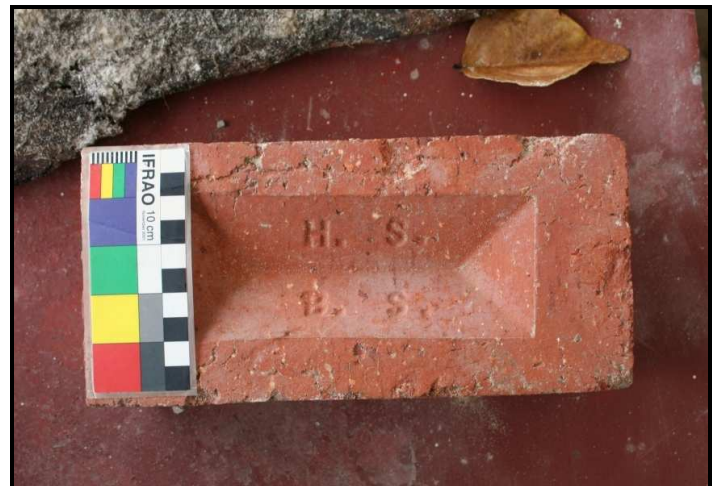
Figure 7. H.S.B.S. brick c. 1900?
