Watercraft In The old Fremantle Prison Tunnels

Maritime Heritage Site Inspection Report

**Report - Dept. of Maritime Archaeology
WA Maritime Museum, No 191.**

Date of Inspection: 20 February 2004

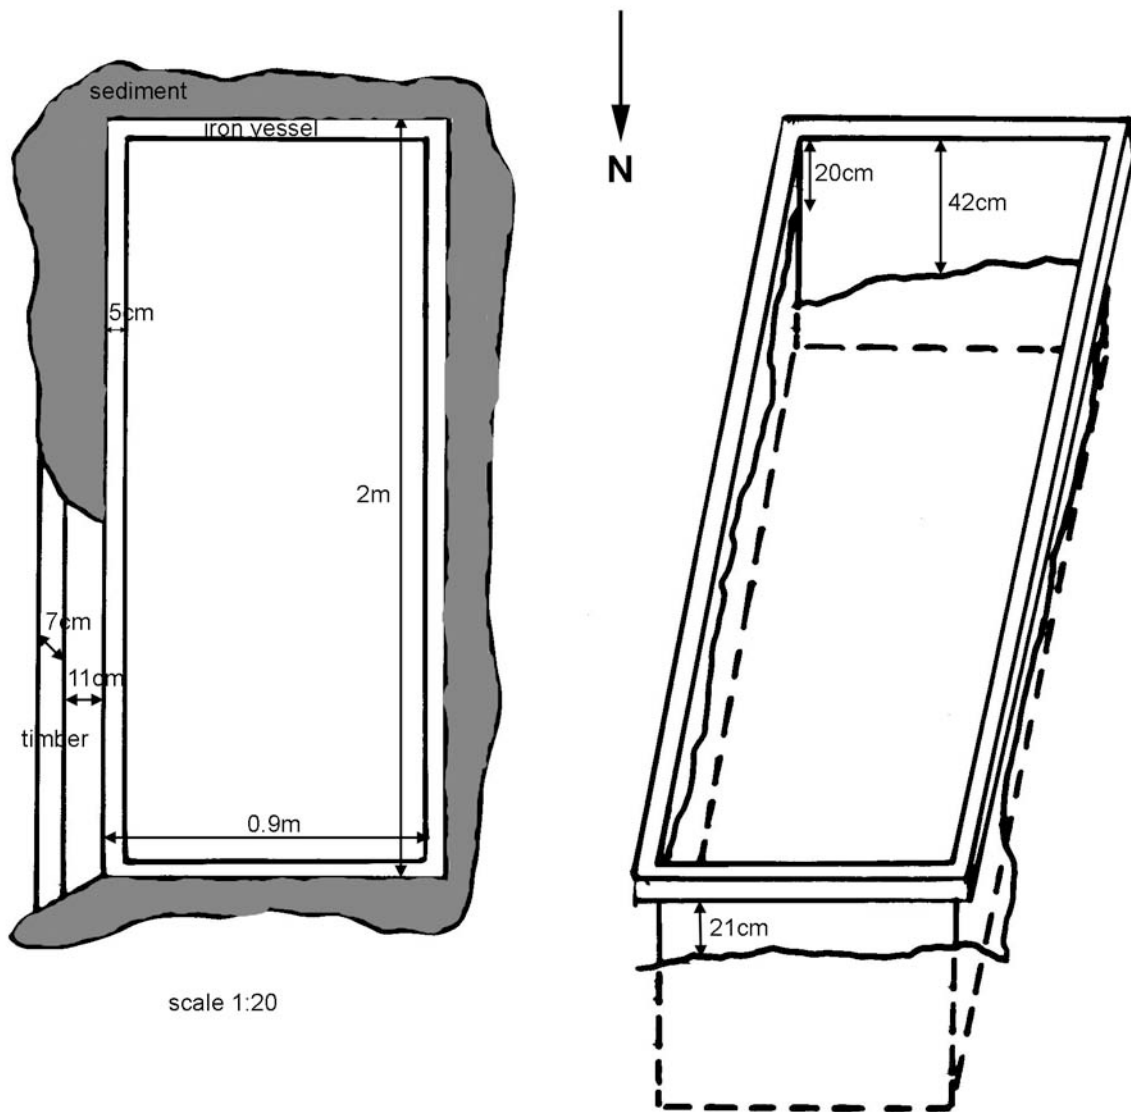
In remarkably clear underwater conditions, a number of photographs were taken from an inflatable and the remains were examined and measured manually. The 'vessel,' which lay on a soft 'muddy' deposit over a hard rough floor partially buried in the sediment, was an open rectangular metallic structure (considered to be probably iron, or its derivative steel) 2m in length and 0.9m wide with enclosed ends and 5cm x 5cm safe edges surrounding the periphery of the vessel (Figure 2). The skin was not concreted and the metal was in excellent condition, however there were some signs of active aerobic corrosion. The depth to sediment from the top of the frame on the southern side was about 42cm, on the eastern side 20cm and on the north-eastern edge 21cm. On the eastern side, a large piece of timber (11cm x 7cm) was located lying directly adjacent to the vessel some 9cm from the top of the frame, partially buried in parts. The timber was in an excellent state of preservation. It was not ascertained whether this timber was directly attached to the iron vessel. A small piece of loose timber (N1.1) was collected from the northern end of the vessel. Due to the extremely poor in-water visibility, a more extensive inspection was not performed and therefore, further structural features were not noted and recorded.

Figure3. Sketch of iron/steel vessel located in tunnel N1 [Vicki Richards].

The 'tank' or 'vessel' was surrounded by debris, some of it visible and the remainder palpable through the mud. Samples of materials from and near the vessel were taken, even though on preliminary indications (metric scantlings, corrosion-products etc., as outlined above) it was evident that it was of contemporary construction and that it could have been used to transport materials during the 1990s cleanup.

Having ascertained that this is modern and that it will not necessarily become part of the tunnel collection or interpretive facility any decision on prospective treatment of this object would await a decision on its future.

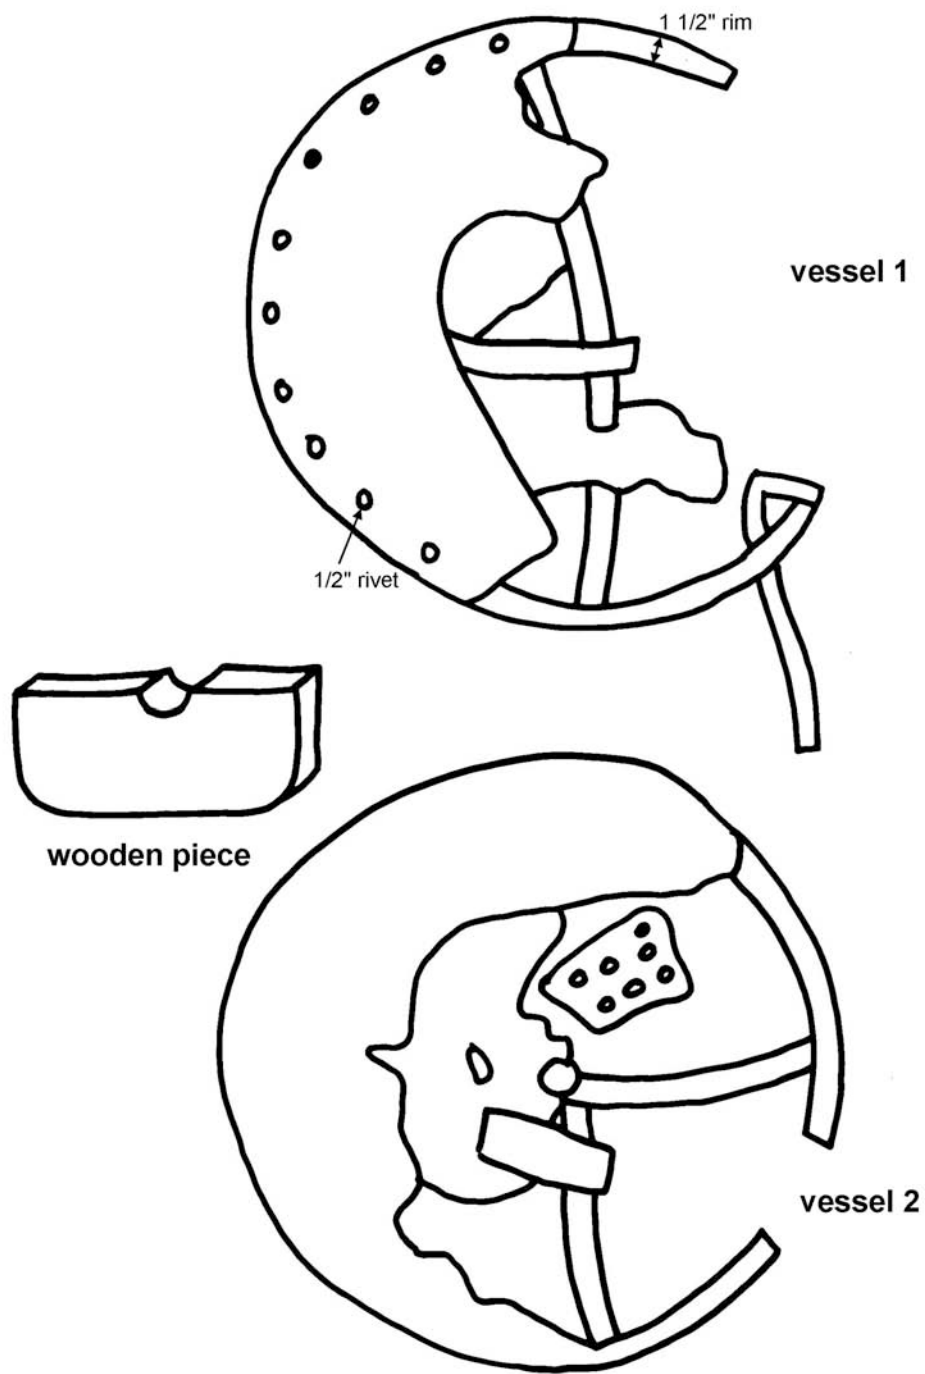
At the northern end of N3 were found two heavily-corroded and very fragile 'vessels' that resembled coracles—a form of skin or hide boat stretched over a wicker or similar frame that has been used in places like Wales and on the Tigris from time immemorial. They were normally quite small, with just enough space and freeboard for one person and were commonly found propelled by a single 'paddle' (e.g. Hornell, 1982). The 'prison coracles' had a metal 'skin' possibly of wrought iron over a part-riveted frame of iron. Photos were taken of both and they were also sketched and measured.

Both vessels were very similar, each approximately 1m in diameter. Two iron sheets had been riveted together with half inch (1.27 cm) diameter rivets to form the 'bowl', which was then riveted to a circular rim one and a half inches (3.8 cm) wide. There were two curved supporting straps 3.8cm wide running under the base of the 'bowl', connected to opposite sides of the rim providing added strength to the structure.

The conservator's analysis indicates that they are lightly concreted, as is typical of fresh water anaerobic iron concretions. Being totally exposed to the atmosphere the vessels were exhibiting extensive aerobic corrosion and there were significant quantities of aerobic iron corrosion products (rust) on the surface of each. This corrosion process was causing the exfoliation of the previously corroded surface layers and concretion. Both vessels were extensively corroded, fragile and easily damaged.

Figure 4a. Sketch of the iron vessels (1 and 2) and wooden item located in tunnel N3 [Vicki Richards].

These vessels are fragile and will need additional support when they are recovered to prevent any further damage. On recovery the vessels should be placed in water and kept wet until the commencement of the conservation treatment.

The concretion and corrosion product layers should be removed by the flame deconcretion method to minimise any further physical damage to the artefacts. This method involves gently heating the outer surfaces with an oxy-acetylene torch, which causes the scale to separate from the residual metal with minimal damage to the underlying parent metal. Assuming the iron alloy is of low quality (not spring steel) the remaining material should be cleaned in a bath of 2% citric acid solution. After the artefacts are clean, the excess citric acid should be neutralised in a bath of 2% caustic soda solution, then soaked in water to remove any excess caustic soda solution and dewatered with methylated spirits to minimise flash rusting. Finally a protective coating should be applied over the entire surface. The type of coating used will be dependent on the aesthetic finish required.

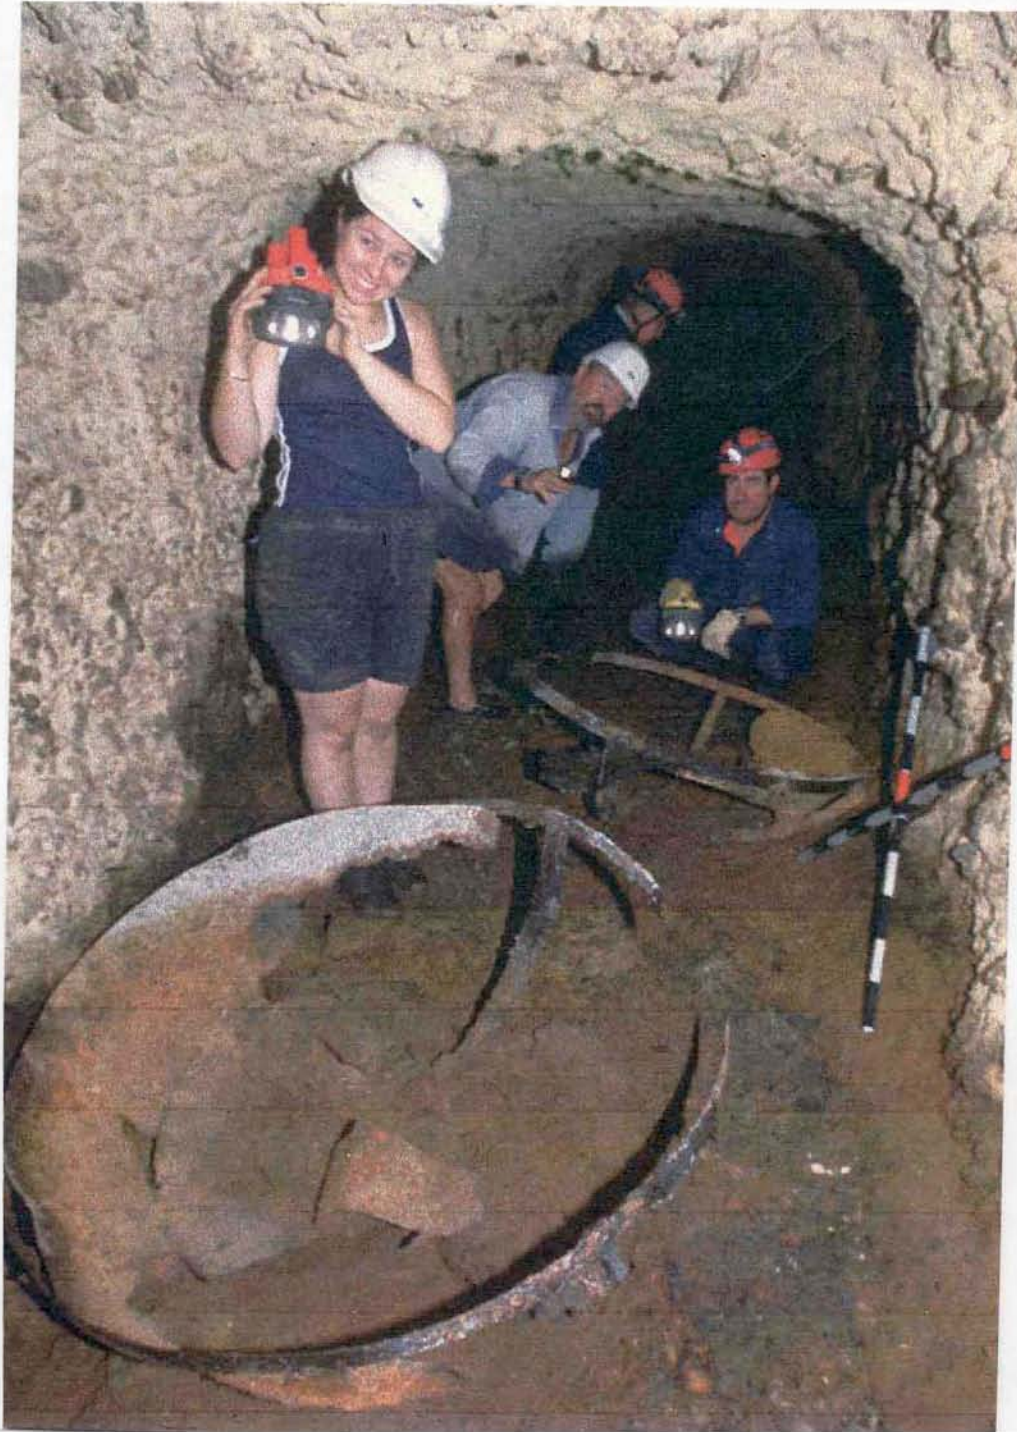
From their form, mode of construction and much-corroded state, it was considered that they were old, most likely dating back to the early 20th Century at least. Further while it was evident that while they could support the weight of one person needing to keep their feet dry (e.g. a guard) they were equally and perhaps most likely used to ferry tools, food and the like as the prisoners and their guards waded through the water in the complex. In that respect the term 'coracle' could prove problematic, providing the potentially false impression that they were used to transport people rather than goods or equally possibly detritus from the tunnelling itself. At present the term best provides an indication of their form.

Figure 4b. Photo of the iron vessels with part of the inspection team. [Patrick Baker].

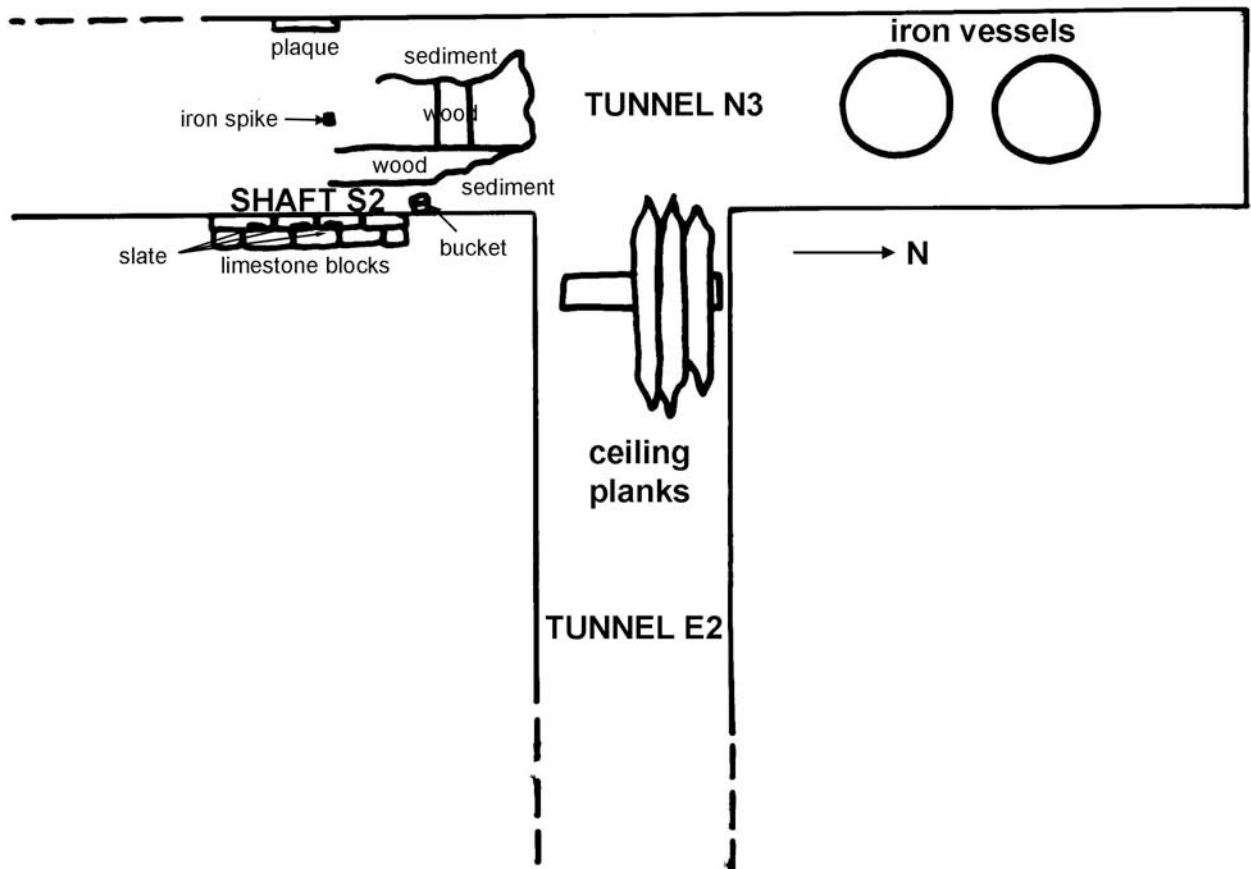
Figure 5. Sketch of shaft S2 and ceiling E2 area [Vicki Richards].

Opposite was a commemorative plaque fixed to the western wall, its wording barely legible in the poor light. The shaft opening had been enclosed with large limestone blocks and mortar. Amongst the joins between the blocks, some pieces of loose slate were also

found. In addition, a square headed iron spike, standing about 5cm proud of the tunnel ceiling, was located between shaft S2 and the plaque. Timbers were located on the floor approximately 3m south of the junction with tunnel E2, partially buried with sediment. These were in good condition and appeared to be in a track-like arrangement.

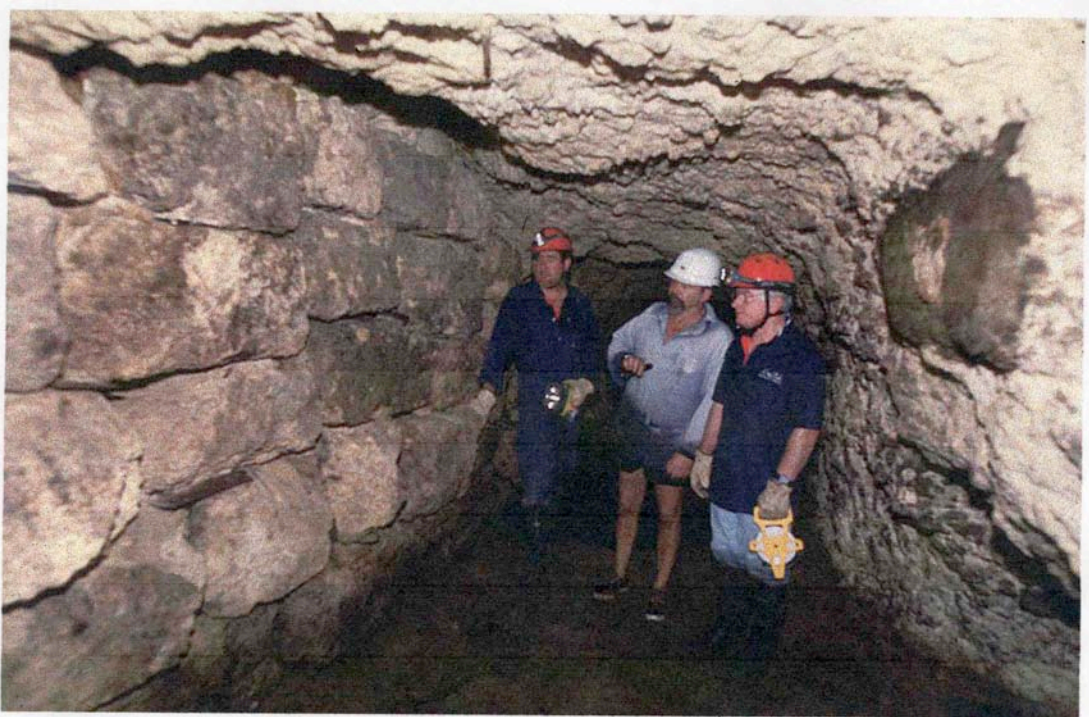
Figure 6. Photo of the limestone wall at shaft S2. The plaque is on the wall opposite [Patrick Baker].

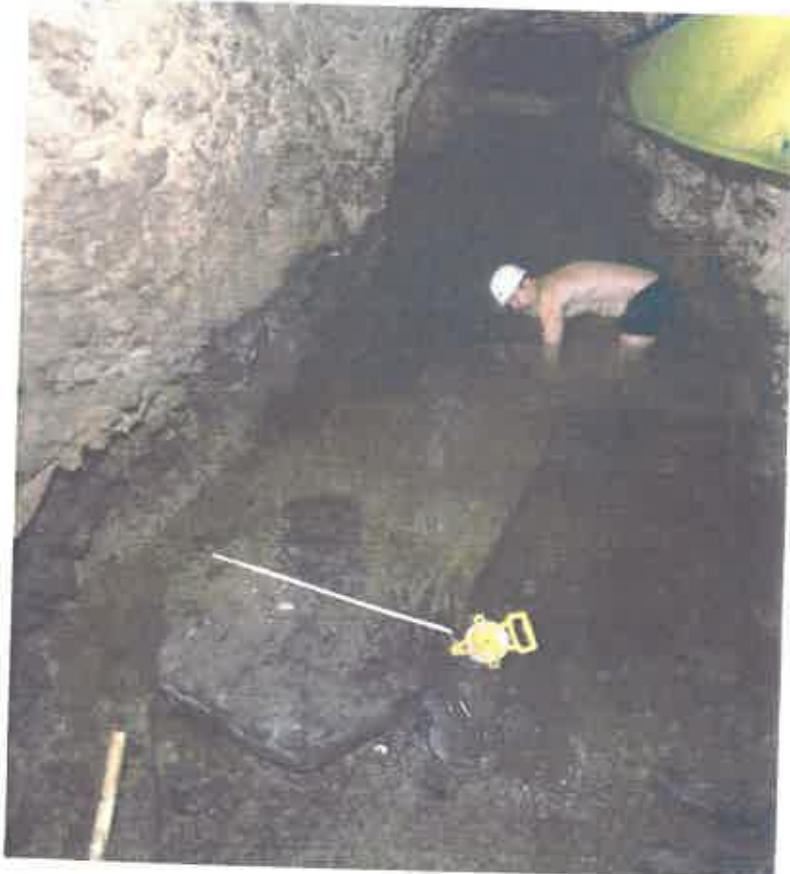
The remains were built to imperial measurements measuring 9ft (2.74 m) in length and 3ft (0.9 m) wide at the widest section; all constructed from two large timbers 9ft (2.74 m) in length, 1ft 6" (45.7 cm) wide and approximately 9" (22.8 cm) deep. These two timbers were fastened with two square headed iron fastenings positioned about half to 1 m from either end, traversing the entire width of both timbers. The ends of the timbers were cut off at an angle on both sides, encrusted with about 3mm of damp anaerobic sediment and approximately one third of its length exposed to the atmosphere with the remainder immersed in fresh water. The wood, tested by the conservator, appeared to be in an excellent state of preservation.

Constructed of two very thick pieces of what appeared to be a softwood, fastened with two iron through bolts, having shaped ends, lying totally waterlogged, partly on the bottom and half-way up the slope, it appeared to be a raft capable of carrying equipment and two people. Certainly it fitted the description 'punt' given to it by prison staff. In contrast, however, to the 'coracle site' and the adjacent 'plaque site' in tunnel N3, evidence of convict related activity was not apparent.

Figure 7a. Photograph of the 'raft'. Patrick Baker.

The preferred conservation treatment for waterlogged wood is impregnation with different grades of the water-soluble wax, polyethylene glycol (PEG), followed by freeze-drying. This wooden vessel, however, appears to be in excellent condition and therefore, total immersion and impregnation would not be necessary. Surface consolidation by PEG would be adequate to stabilise the outer surfaces, followed by slow air-drying.

The vessel should be kept wet at all times prior to the commencement of the conservation treatment. The vessel should be mechanically cleaned of all surface detritus. An aqueous solution of PEG 3350 (15%v/v) should then be applied to all surfaces. Four to five coatings would be the minimum required. The vessel should be wrapped in plastic after each coat to maximise penetration and minimise drying. Over the course of a few weeks the plastic should be removed in stages and the vessel allowed to dry very slowly to minimise cracking, warping and checking of the wood. The heads of the iron fastenings should be protected with a surface coating.

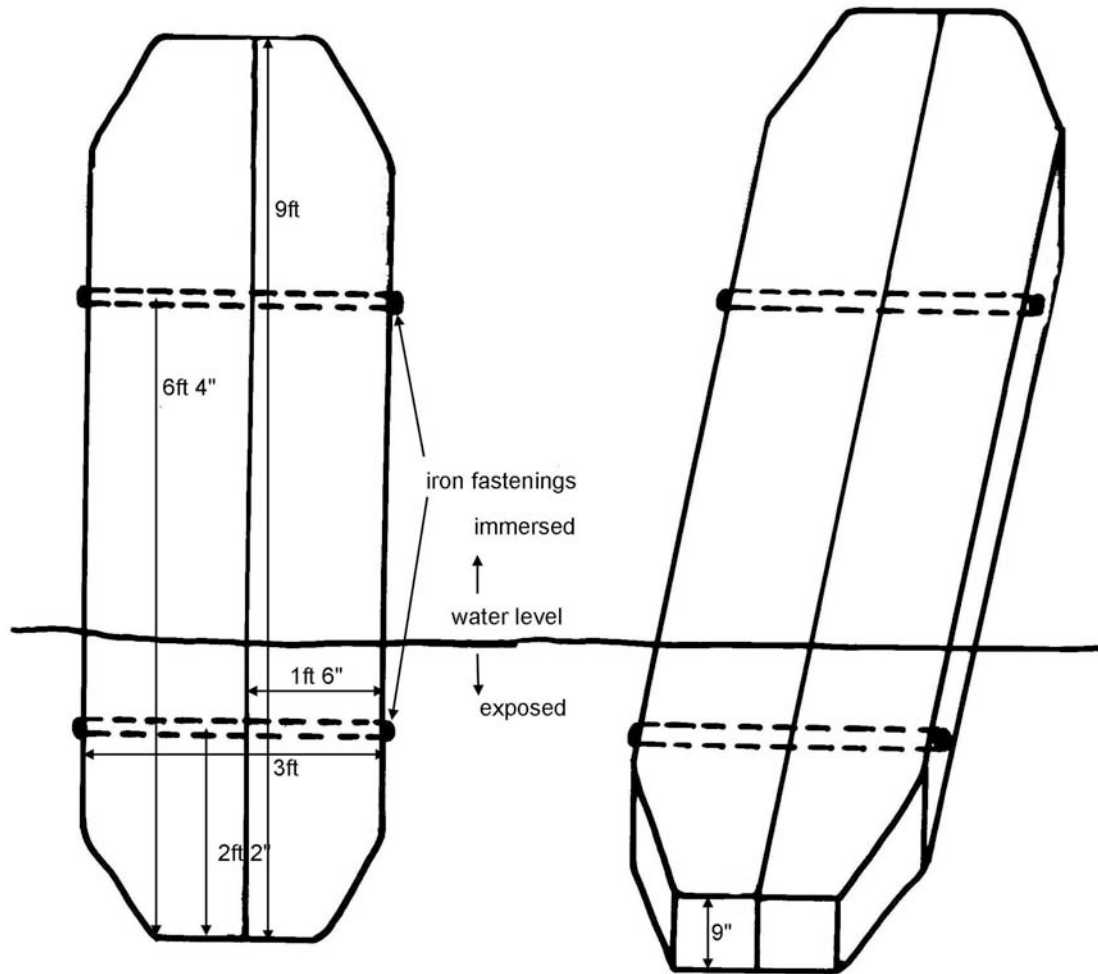
Figure 7b. Sketch of the wooden raft located in tunnel E5 [Vicki Richards].
