P877 Warders' Cottages  
Artefact Recovery from under Rear Verandahs W3

Dr Kelly Fleming, Senior Heritage Officer, Department of Planning, Lands & Heritage (State Heritage)

November 2017

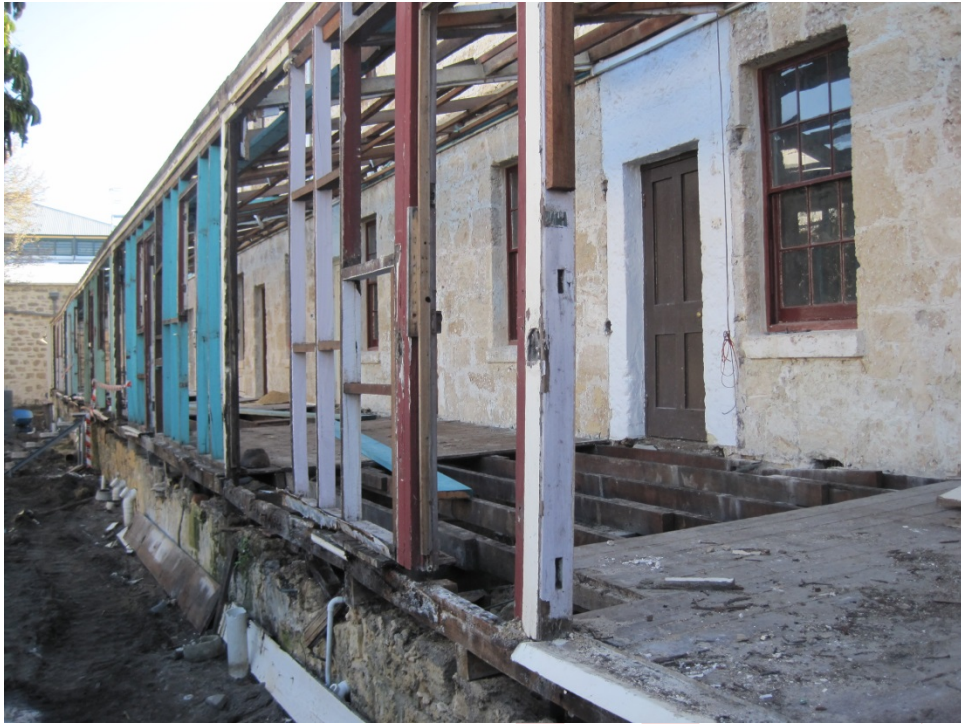
The area beneath the rear verandahs was subsequently inspected and it was found to contain a large quantity of refuse (Figures 2 & 3) which appears to have been disposed of through holes that had opened up in the stone and brick wall built to block off the underside of the verandah at its southeast terminus. The wall is understood to have been constructed c.1900 but has deteriorated and been repaired in a haphazard fashion over time.

In addition, there was evidence to suggest that the sub-verandah area has been subjected to continual disturbance with a number of services (PVC and metal pipes) having been added at various intervals.

Figure 2 - P877 Warders' Cottages – rear verandahs W3 showing limestone and brick wall

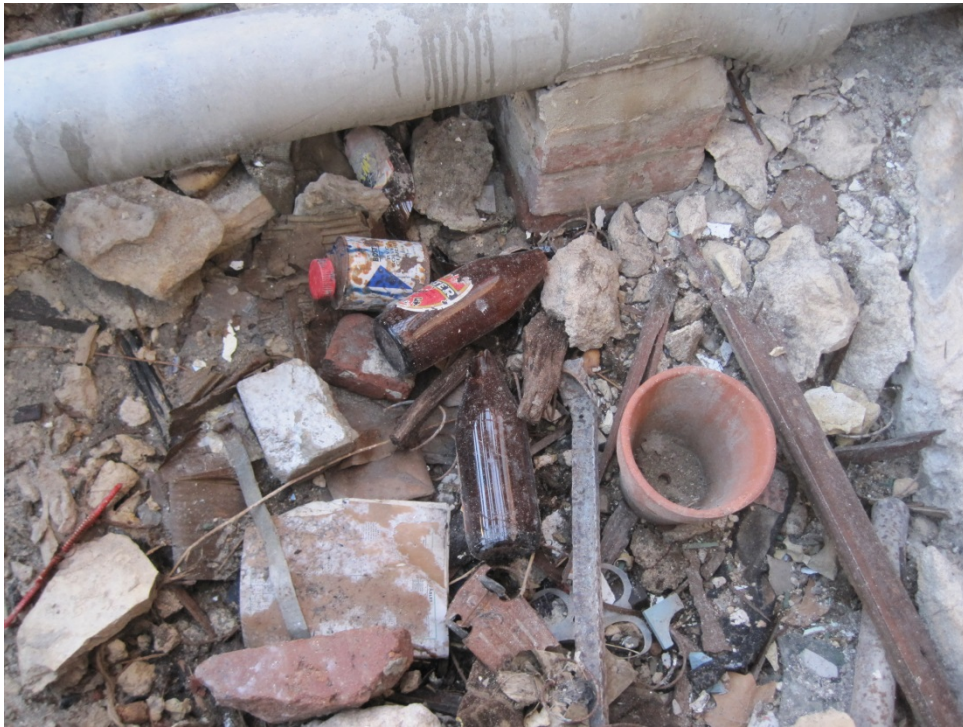
Figure 10 – P877 Warders' Cottages – rear verandah showing example of material under floorboards, including terracotta flower pot, and c.1980 beer bottles

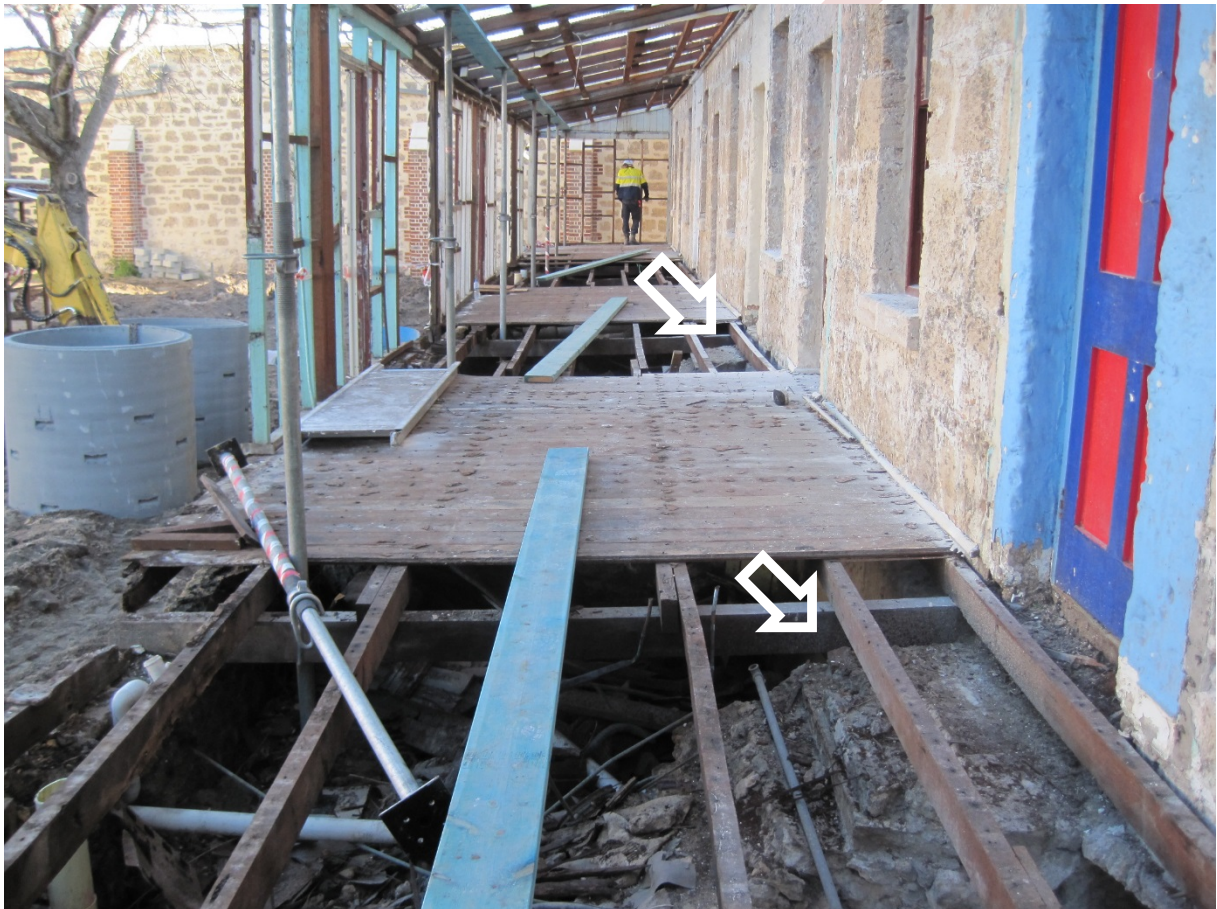
Figure 11 – View of rear verandahs showing location of some of the original rear steps

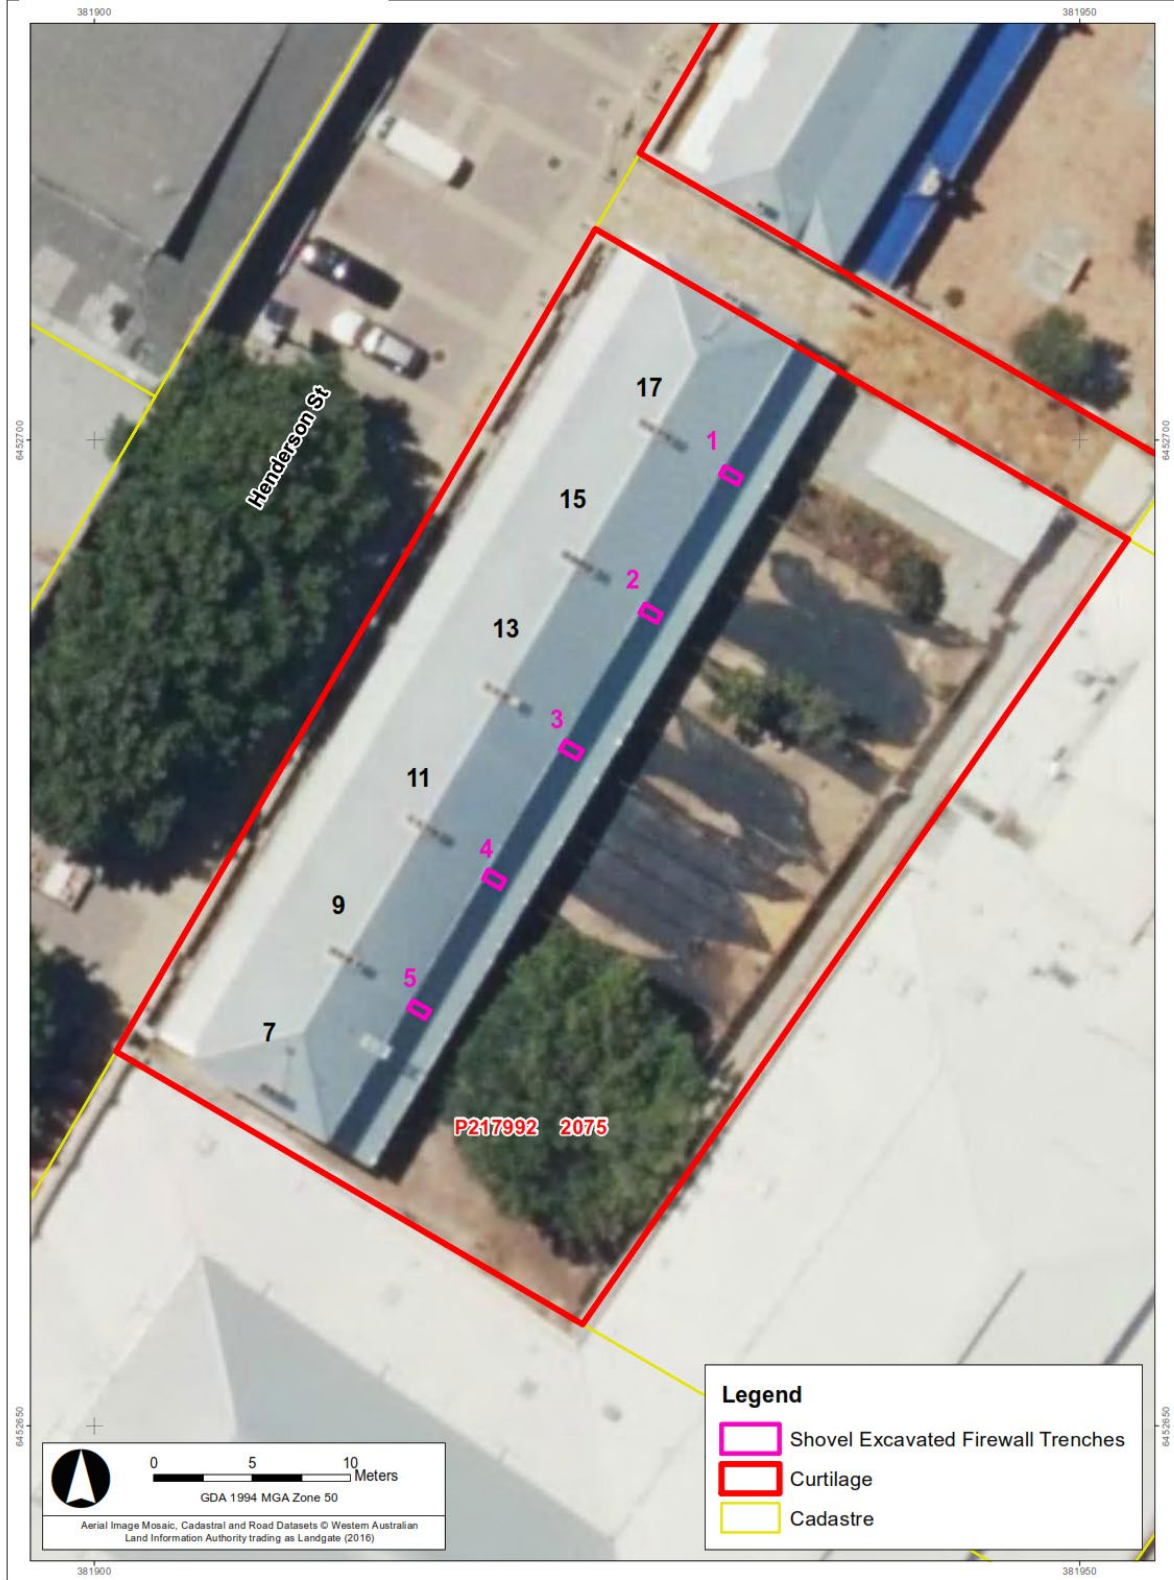
**P877-0 WARDERS COTTAGES**  
**ARCHAEOLOGICAL SALVAGE 8-9 SEPTEMBER 2016:**  
**EXCAVATION TRENCHES**

Figure 12 – Locations of the five firewal trenches

As noted five trenches were excavated (Figure 12) by the labourers provided by the contractor monitored by SHO archaeologists. Trenches 1 & 2 (at the northern end) contained little or no material and appeared to be quite disturbed deposits. However, trenches 3, 4 & 5 comprised less disturbed deposits with a small number of artefacts in-situ.

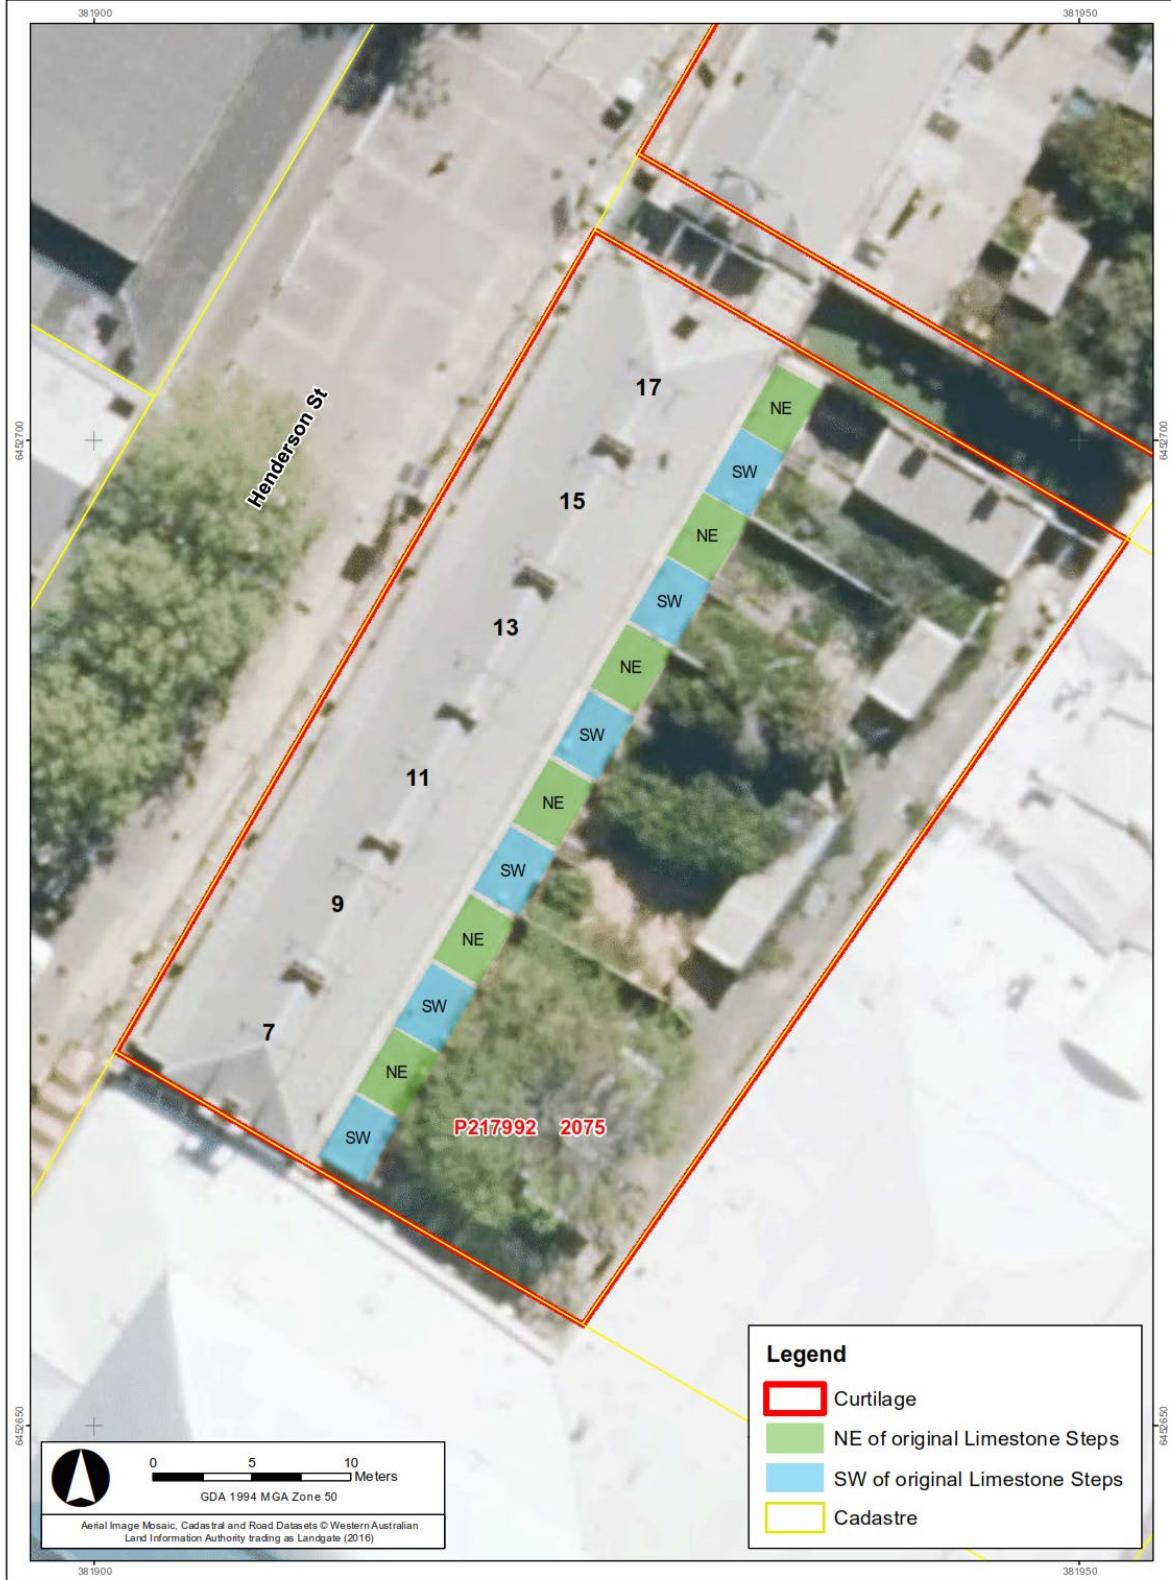
**P877-0 WARDERS COTTAGES**  
**ARCHAEOLOGICAL SALVAGE 8-9 SEPTEMBER 2016:**  
**SUB-VERANDAH AREA DESIGNATIONS**

Figure 14 – Map showing cottage and quadrant designations

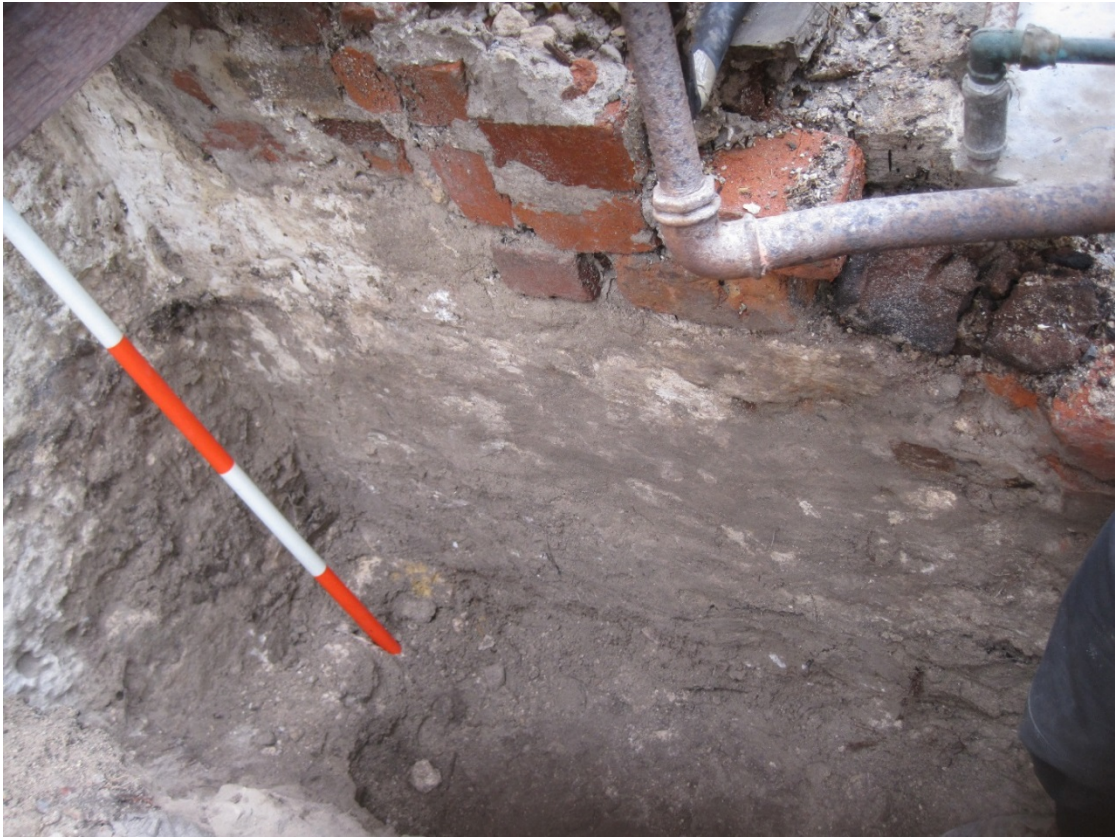
Trench 3 was situated directly adjacent (NE) to the original rear steps for Unit 13, with the rear yard of Unit 11. The uppermost layers were mixed with amber bottle glass fragments found just below the original bottom step. As the trench was excavated further a small whiteware bowl fragment was recovered and in the layer beneath this was a glass perfume bottle (approx. 1150mm below the bottom step)

and transfer-printed earthenware fragments (approx. 1250mm below the bottom step; Figure 27).

Figure 27 – Firewall trench 3, final excavation depth

With regard to the artefacts recovered from the lower level of the firewall trenches, these appear to be in-situ deposits dating to the early occupation of the cottages. Should further ground disturbance be proposed for these areas, recovery via controlled archaeological excavation, by suitably qualified and experienced historical archaeologists, is recommended.

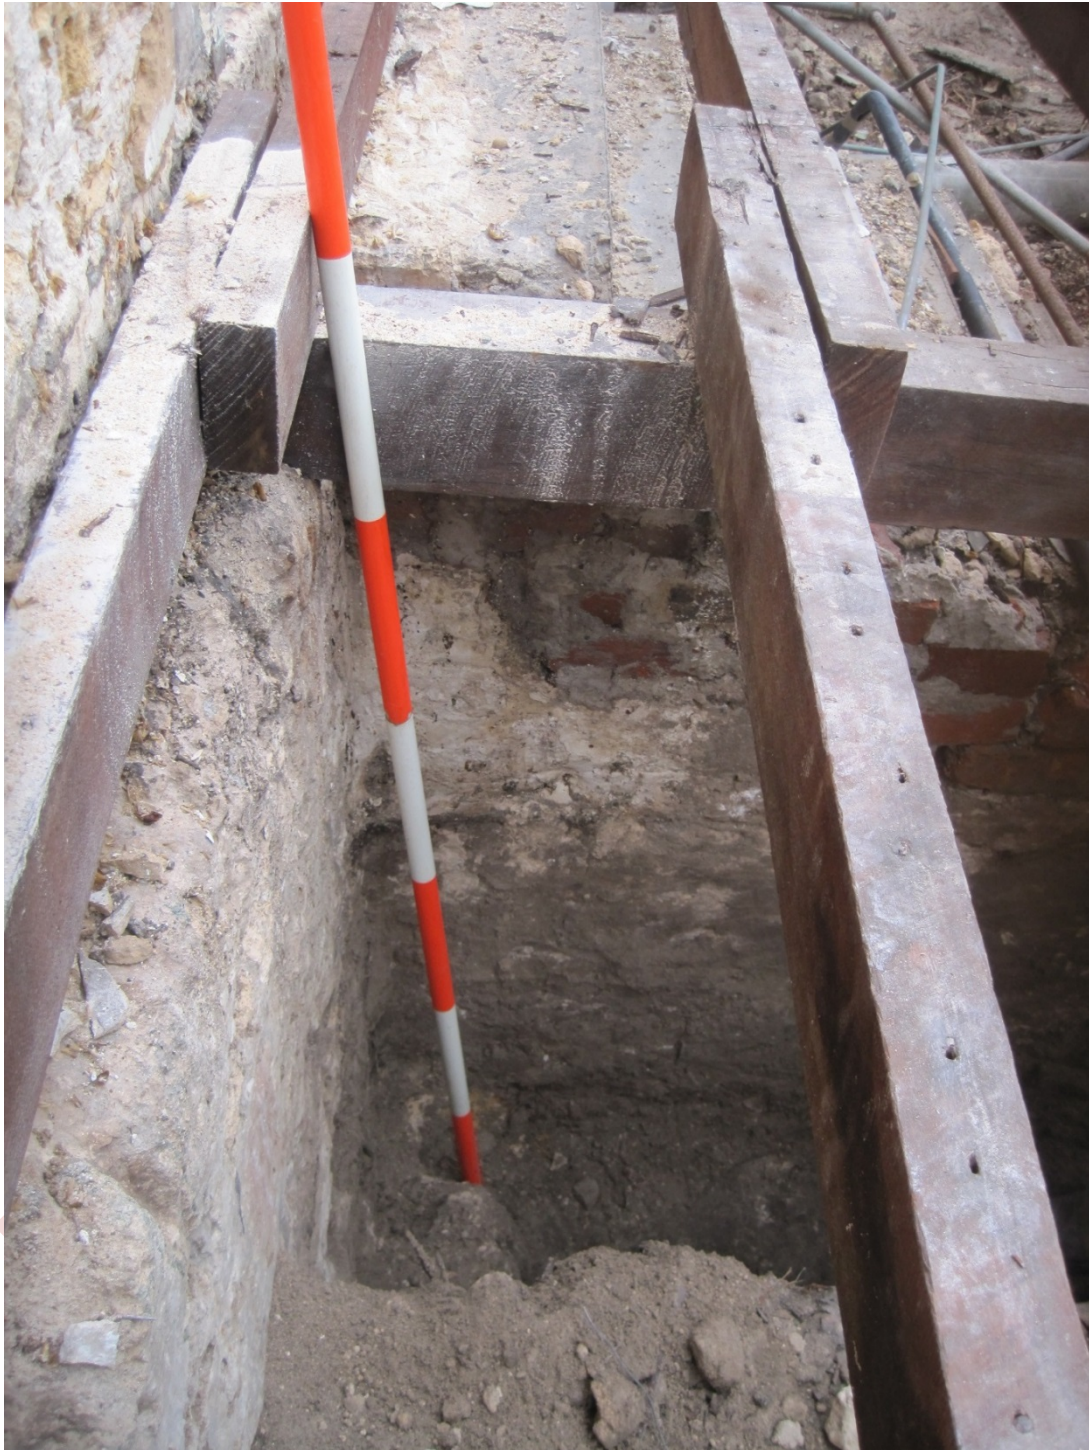
Trench 4 was situated directly adjacent (NE) to the original rear steps for Unit 11, with the rear yard of Unit 9. The top layers were again mixed, with a butter knife being recovered just below the original bottom step. As the trench was excavated little material was encountered until at approximately 1280mm below the bottom step (Figure 28) a clay pipe bowl was recovered which was inscribed 'BEN NEVIS'.

Figure 28 – Firewall trench 4, final excavation depth

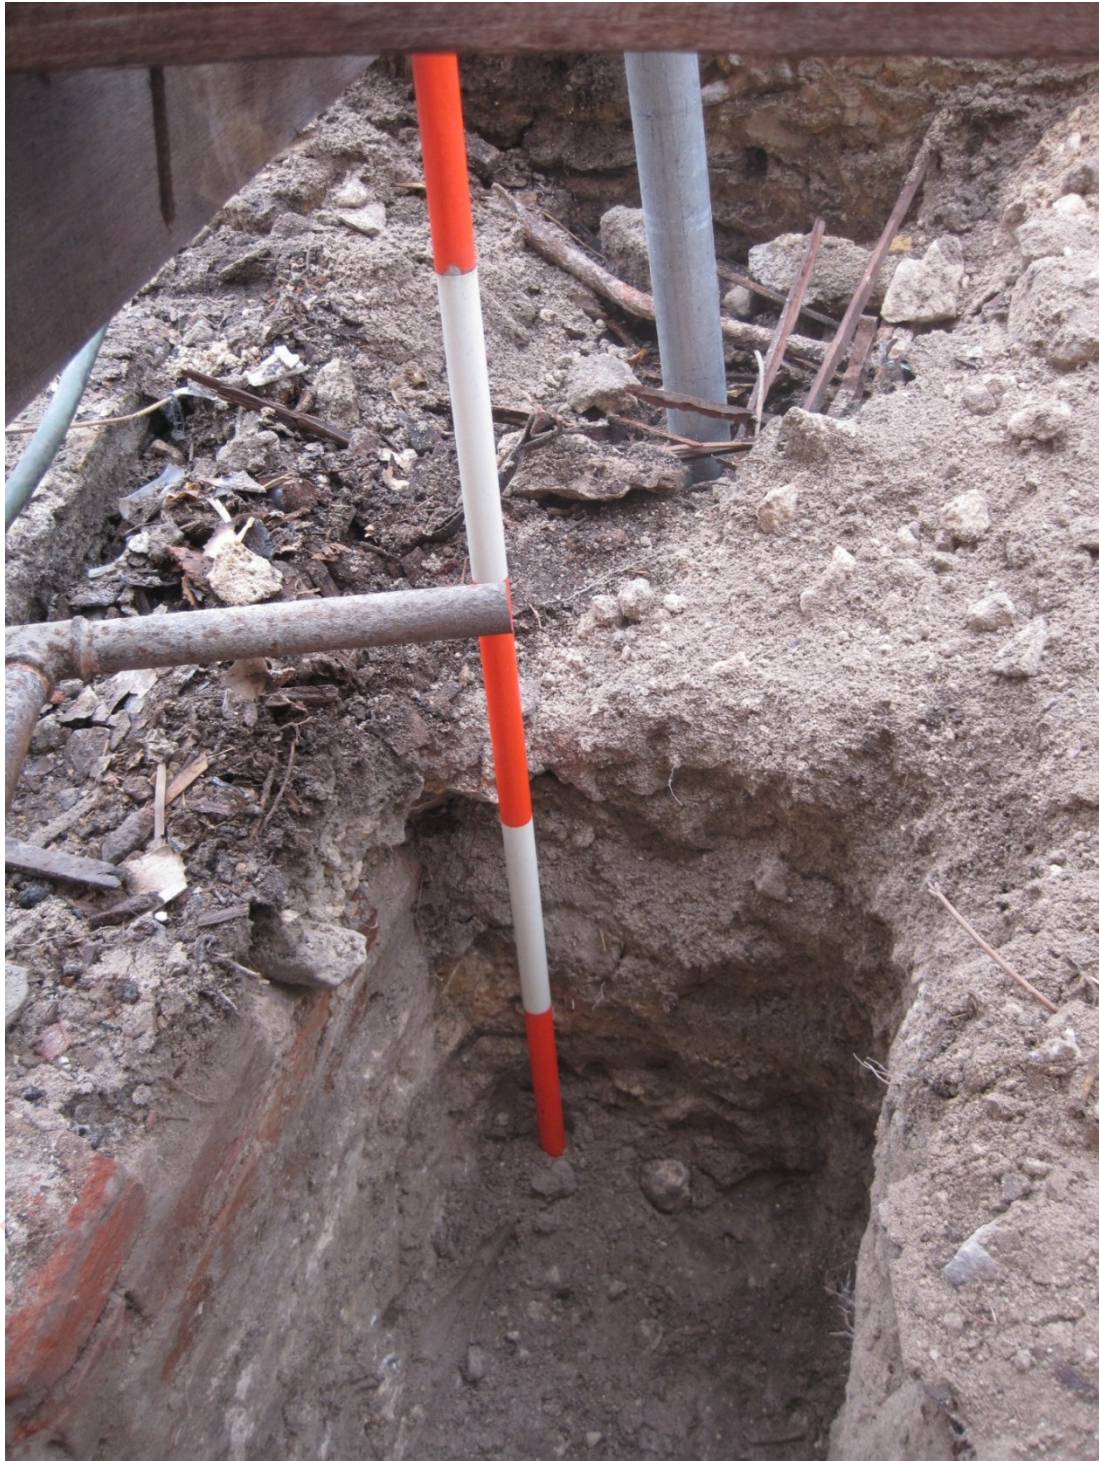
Trench 5 was situated directly adjacent (NE) to the original rear steps for Unit 9, with the rear yard of Unit 7. The top layers were again mixed, with metal fragments and amber bottle glass recovered just below the original bottom step. At approximately 1220mm below the top step (Figure 29) a mixture of transfer-printed earthenware tableware was recovered along with an olive bottle glass fragment.

Figure 29 – Firewall trench 5, final excavation depth

The material recovered from firewall trenches 3, 4 & 5 would indicate that the lower levels may represent in-situ deposits possibly dating to quite early in the occupation of the cottages. The BEN NEVIS clay pipe, and fragments of transfer-printed earthenware would be consistent with a c.1880-1910 occupation date, whilst their position, at the base of deposits directly adjacent to the original rear steps, would also be consistent with items common to 'sweep zones', or areas outside the home where material swept out the back door, such as fragments of broken tableware,
