**FREMANTLE PRISON, NUMBER 14, THE TERRACE
ARCHAEOLOGICAL WATCHING BRIEF AND
EXCAVATION RESULTS**

Philip Griffiths Architects and Fremantle Prison

February 2011

Eureka Archaeological Research and Consulting, UWA

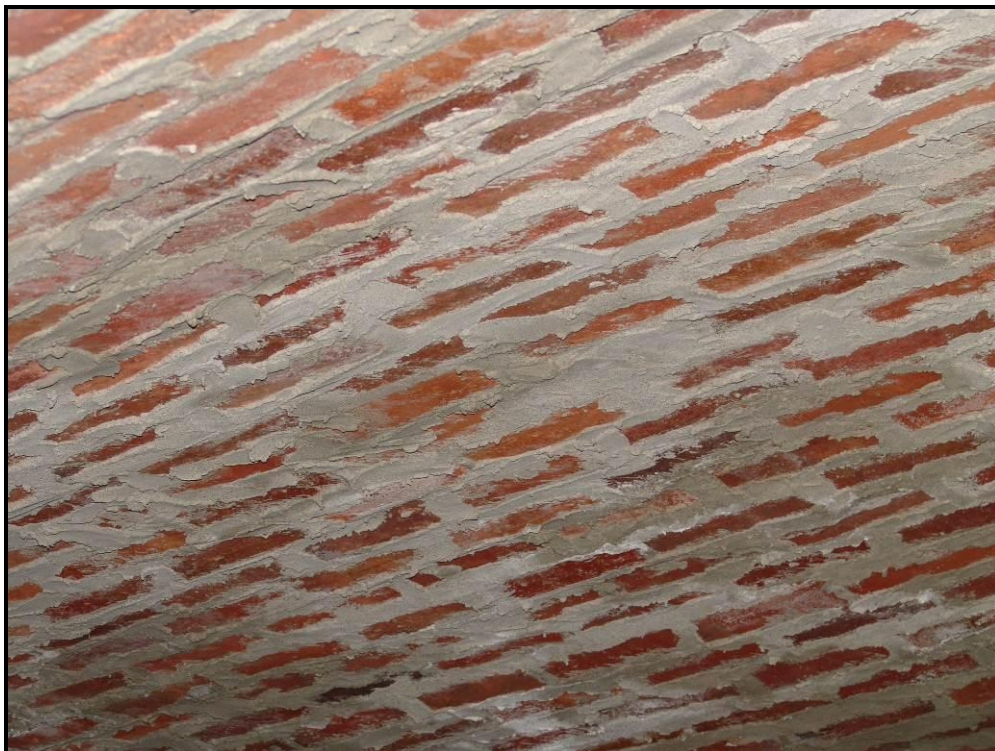
Plate 2: Arched brick ceiling in No. 14 cellar

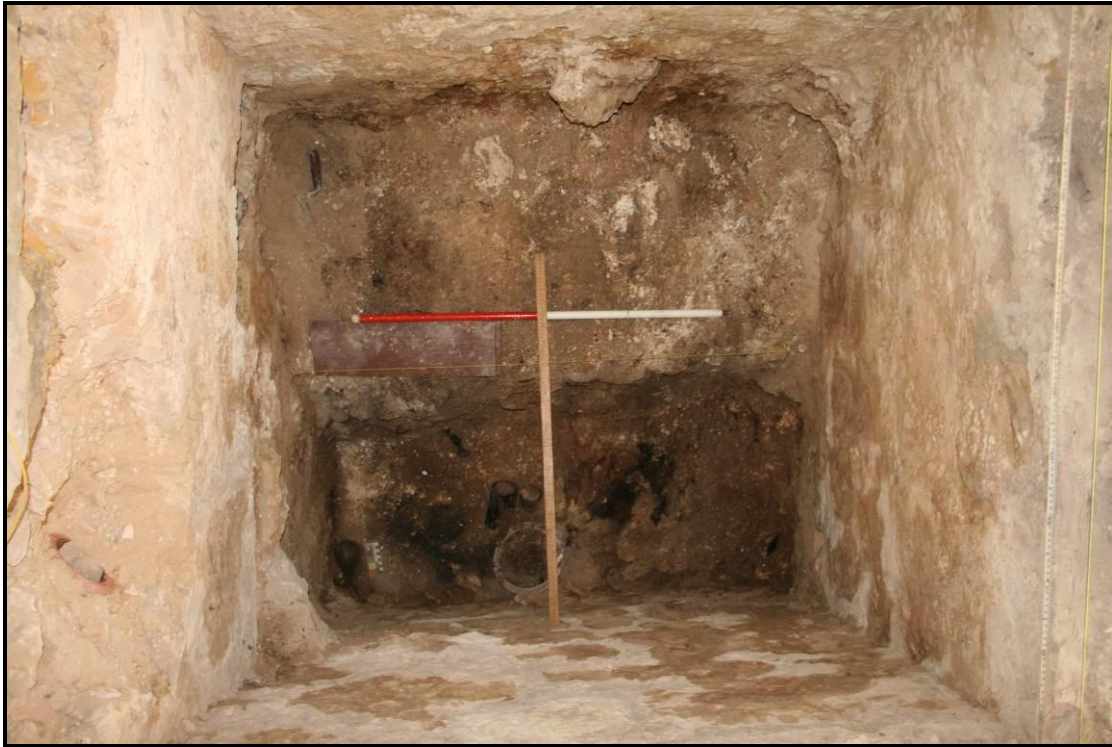
Plate 3: Vertical photograph of toilet during excavation

Following the excavation of the cellar at the western end of No. 14, attention was turned to the toilet, initially constructed as an earth closet and marked on prison plans as early as 1855. As the excavation progressed, the toilet was found to have walls cut into the limestone bedrock, and like the cellar, to have later been backfilled. The fill was excavated stratigraphically and a significant assemblage of artefacts recovered.

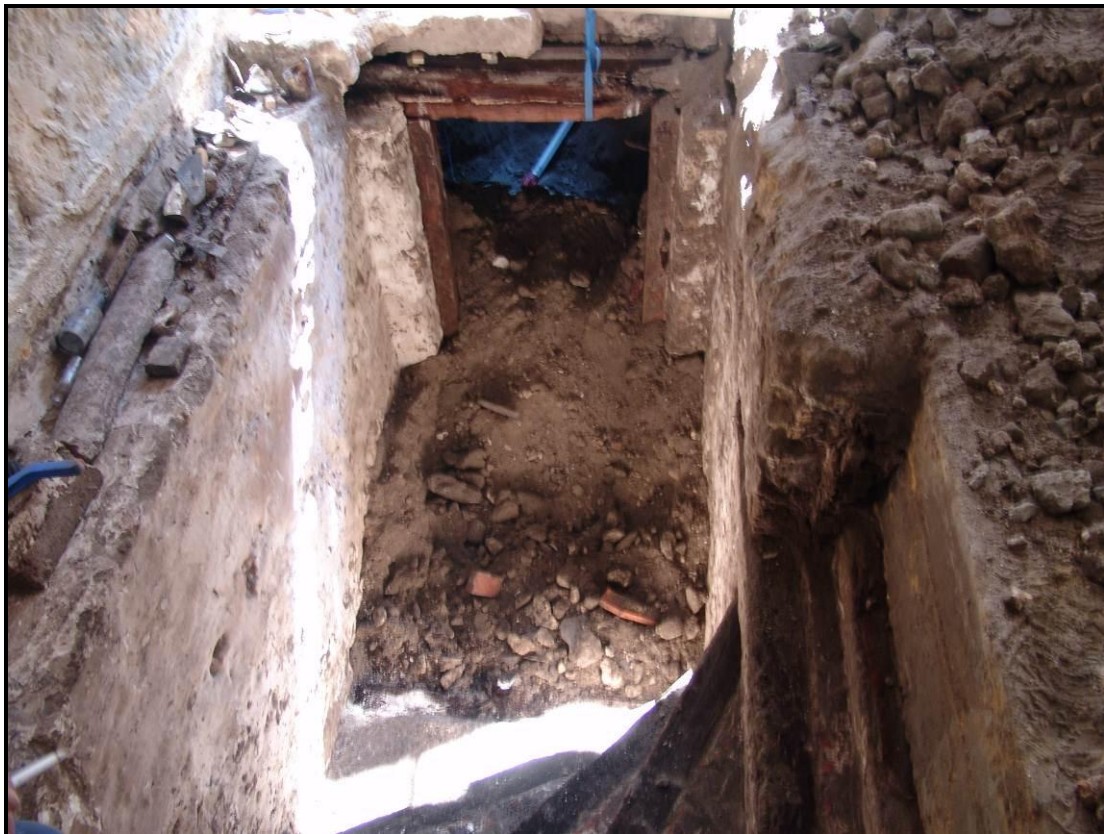
Plate 4: View west down stairwell to cellar door

Further excavation revealed a stairwell that has been cut into the limestone bedrock, with multiple coats of lime wash covering the walls. After the removal of approximately 1.5m of backfill deposit, the complete stairwell was revealed, with a timber door frame at the bottom (Plate 4). The jarrah lintel was removed due to its fragile condition, but retained so that the doorway can be reconstructed in the future. The limestone capping above the lintel was also removed because the mortar was damp and degraded, and as the excavation continued, would become a safety hazard.

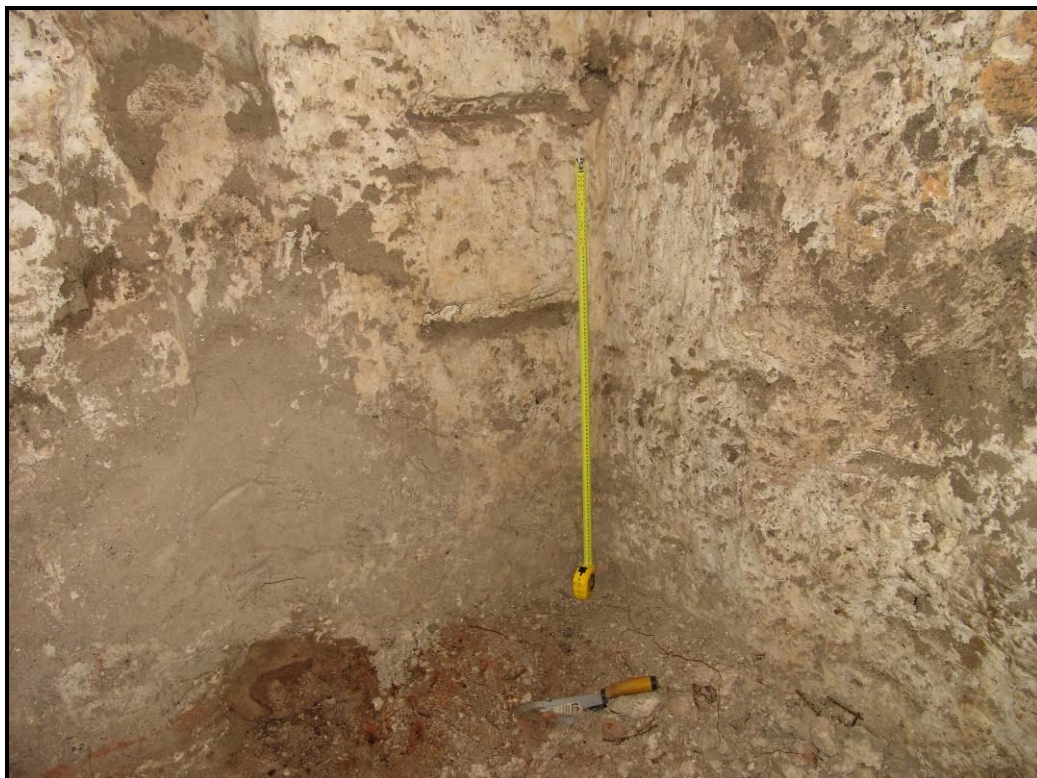
Plate 5: Notches for shelving cut into cellar wall

During the course of the excavation it became apparent that the fill was slumped towards the back of the cellar, indicative of the backfilling process. A vent cut into the limestone at the back of the cellar is angled up towards the front window of what is now the exterior wall of No.14. The vent is approximately 60cm deep and angles up for 1m to the original floor layer. Four notches were recorded in the east wall of the cellar, perpendicular and close to the doorway. The west wall displays a matching set of notches. This is consistent with what would be required to fit a set of timber shelves into the interior of the cellar (Plate 5). Holes cut into the cellar's limestone floor appear to have accommodated posts to support the shelves.

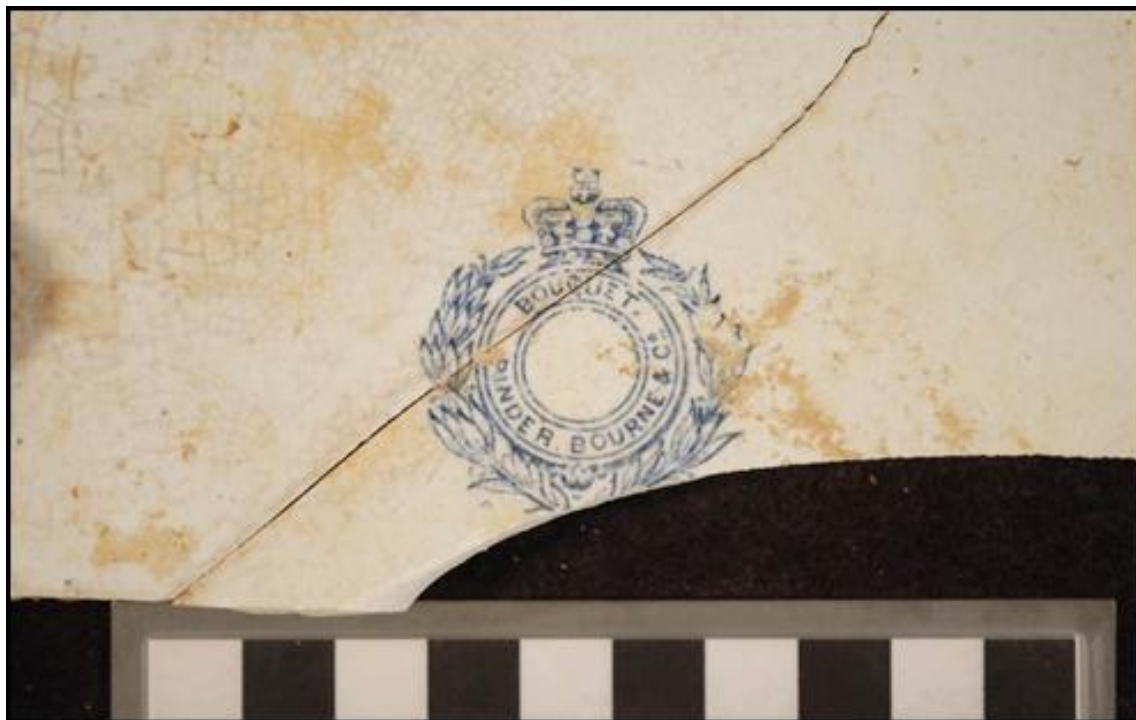
Plate 6: Pinder Bourne & Co. pottery mark, WC 003

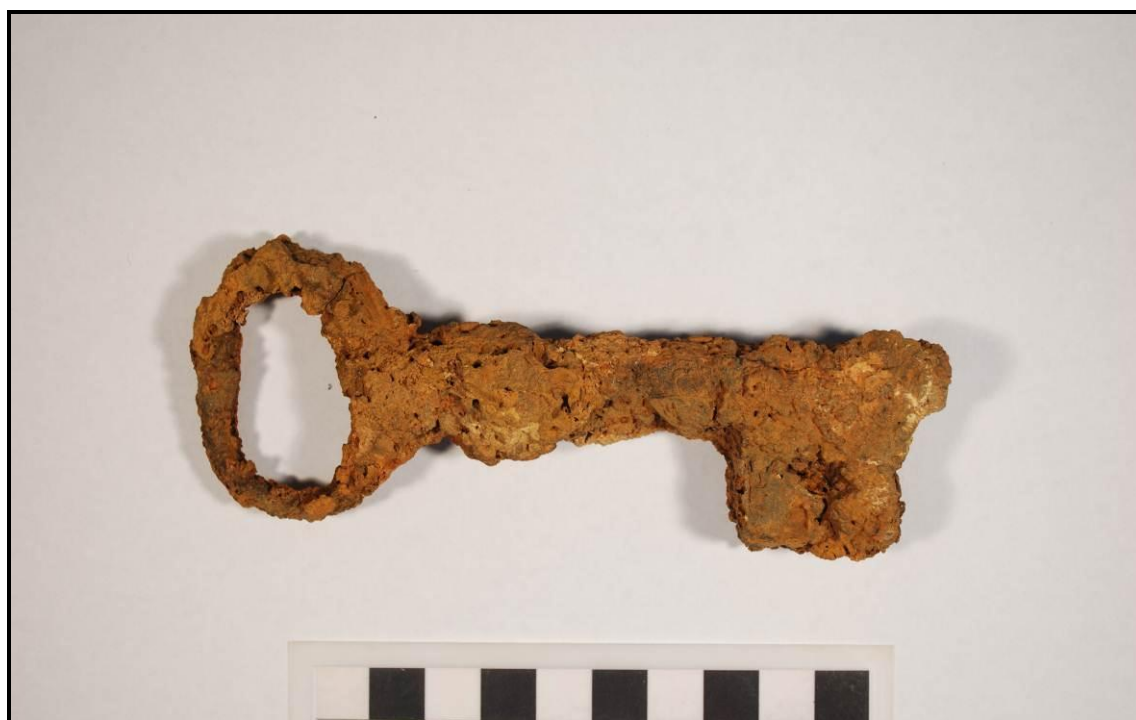
Plate 7: Iron key, WC 003

The metals recovered from WC 003 are varied and largely comprise corroded scrap iron and assorted fittings and fastenings such as nails and spikes. There is also one large iron key, an interesting find in the prison context (Plate 7).

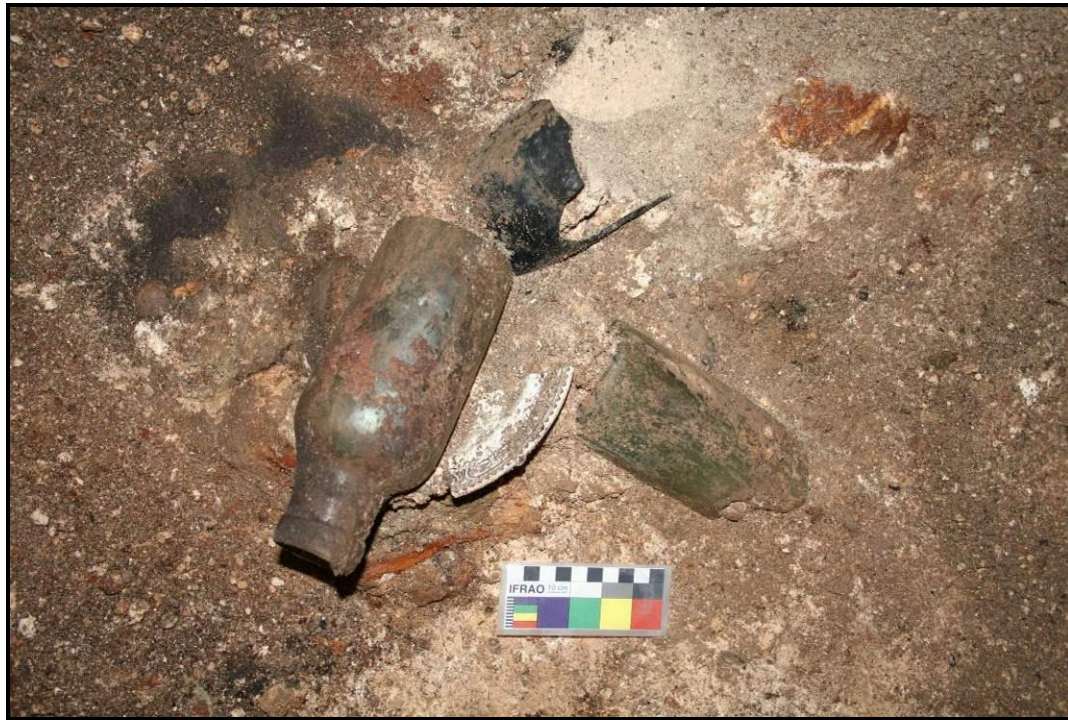
Plate 8: Clear glass chutney bottle during excavation, WC 003

A significant quantity and variety of glass was also recovered from WC 003. Examples of clear glass include plate window glass and bottle sherds, as well as complete ornamental vinegar or salad oil bottles and wide necked bottles used for chutney (Plate 8).

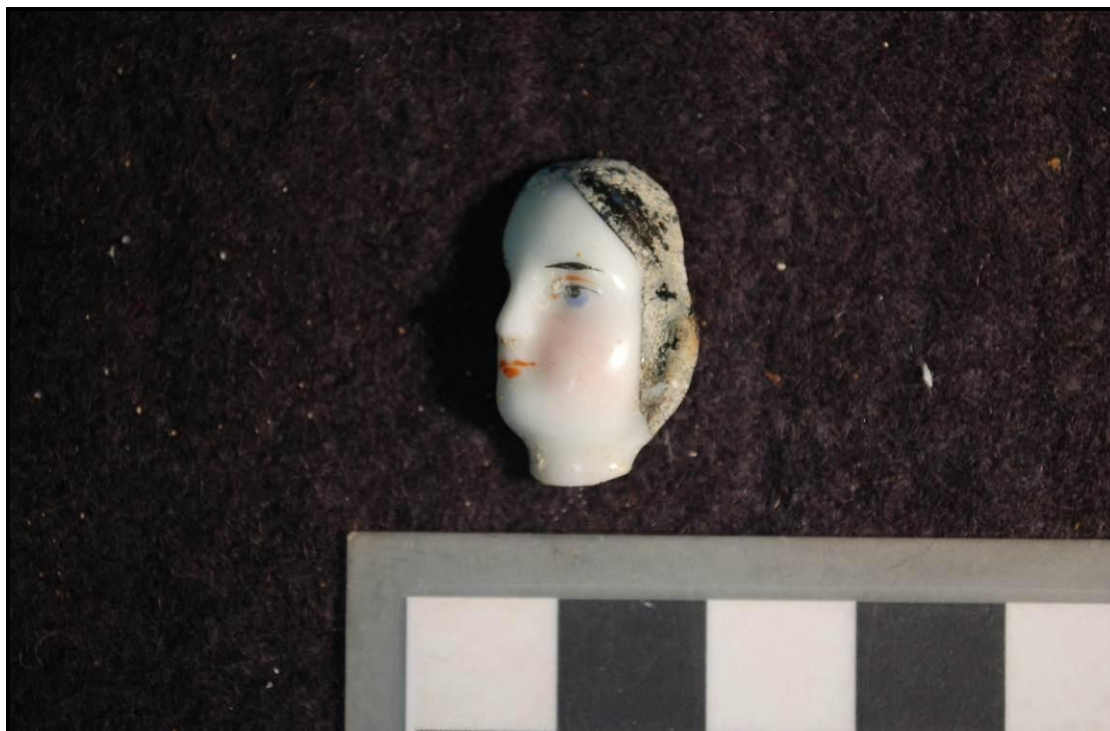
Plate 9: Broken porcelain doll's head, WC 003

Amongst the most unusual finds from WC 003 are a broken ceramic cup and saucer from a child's doll set and a broken porcelain doll's head (Plate 9). Other domestic items include a toothbrush head and a porcelain toothpaste jar of the John Gosnell & Co. London brand (Plate 10).

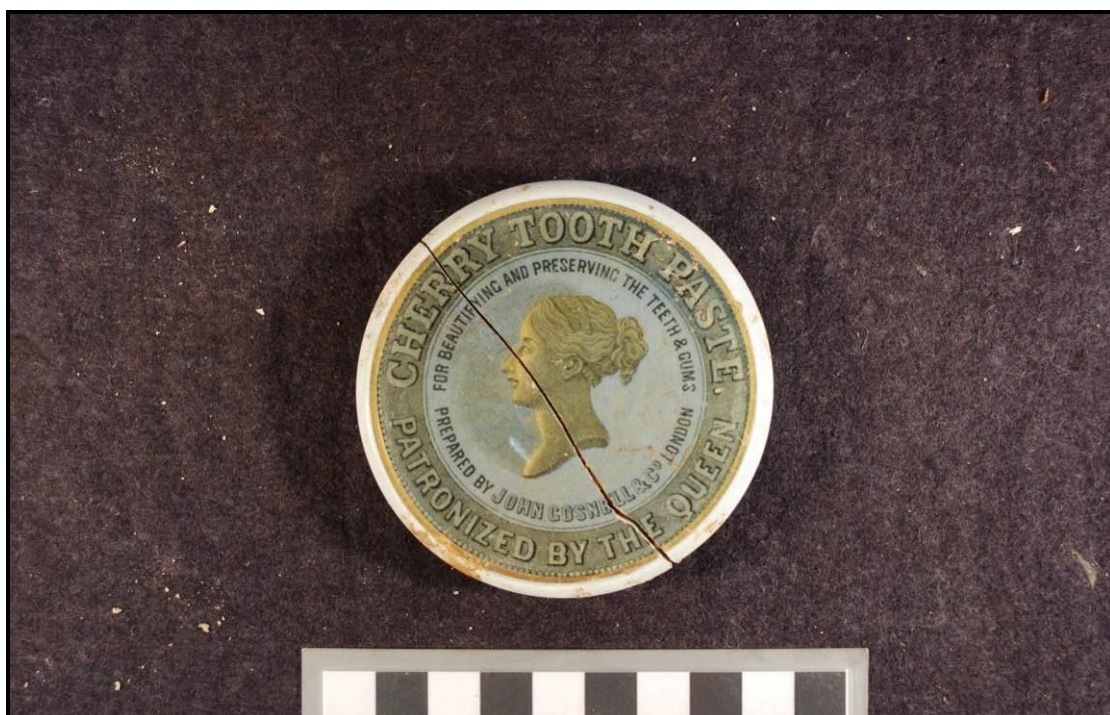
Plate 10: Gosnell & Co. porcelain toothpaste jar lid, circa 1860, WC 003

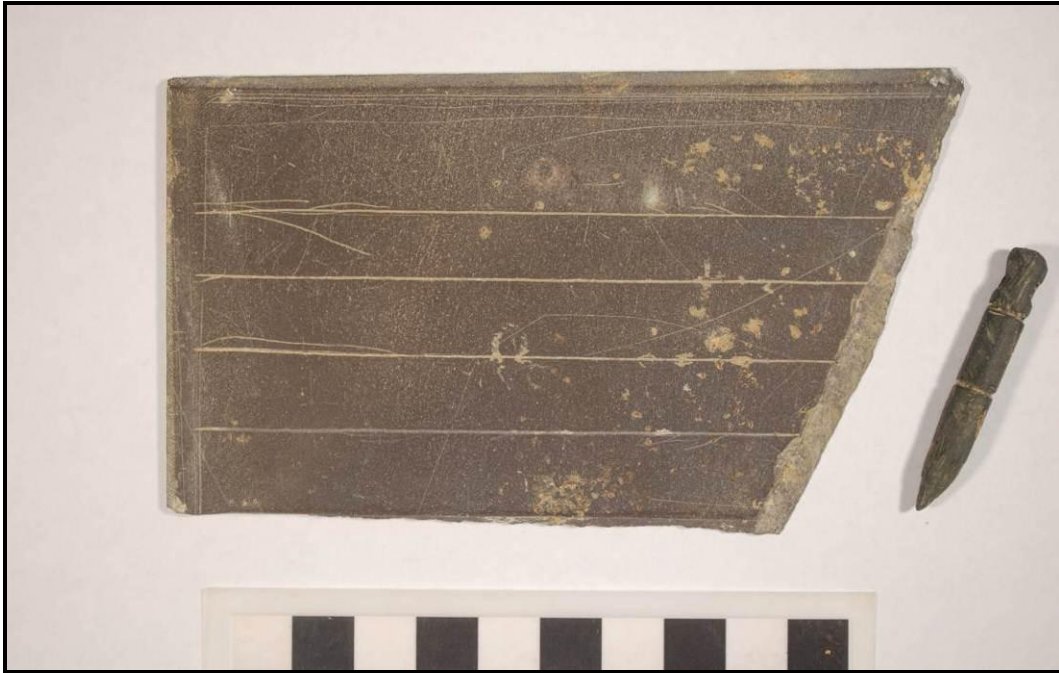
Plate 11: Slate writing tablet with stylus, WC 003

Another small ceramic lid for a jar or tub is decorated with a cherub. The unit also produced good examples of slate writing tablets and graphite styli (Plate 11).

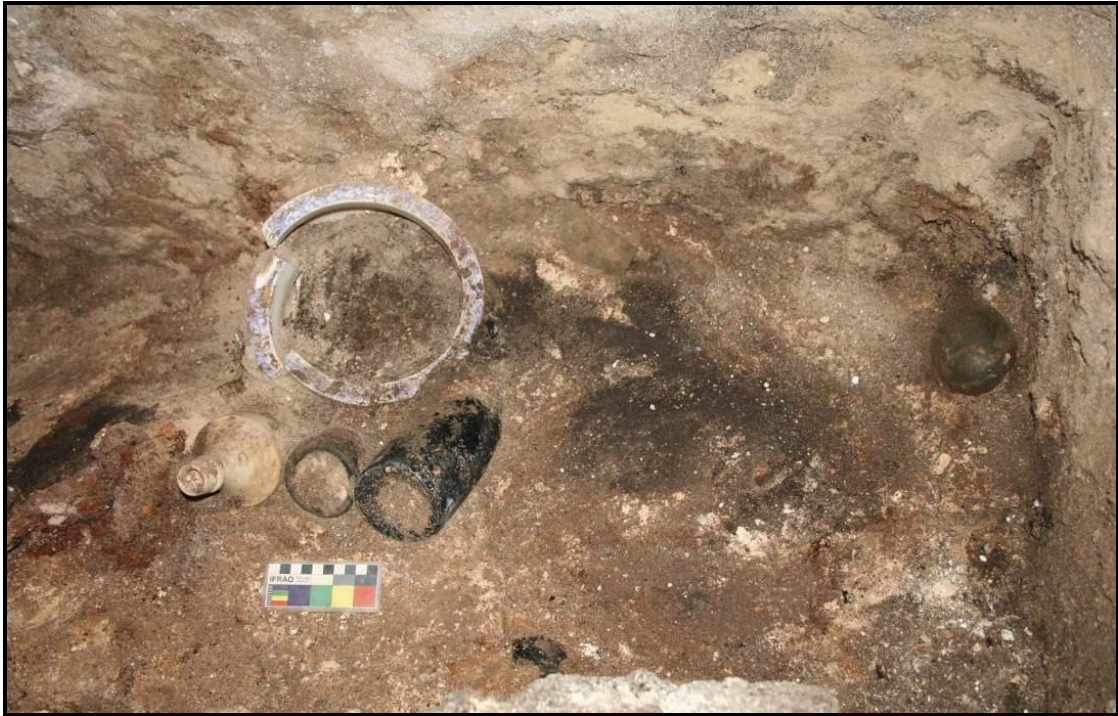
Plate 12: Excavated artefacts in situ, WC 004

Artefacts recovered from WC 004 include a stoneware flask, clear glass chutney bottles, a blue glass medicine bottle, a stoneware inkwell and a large broken chamber pot that could possibly be reconstructed (Plate 12). A small ceramic rim sherd with the names 'Tom and Eva' refers to the characters Uncle Tom and Little Eva from Harriet Beecher Stowe's American anti-slavery novel entitled 'Uncle Tom's Cabin' (1852).

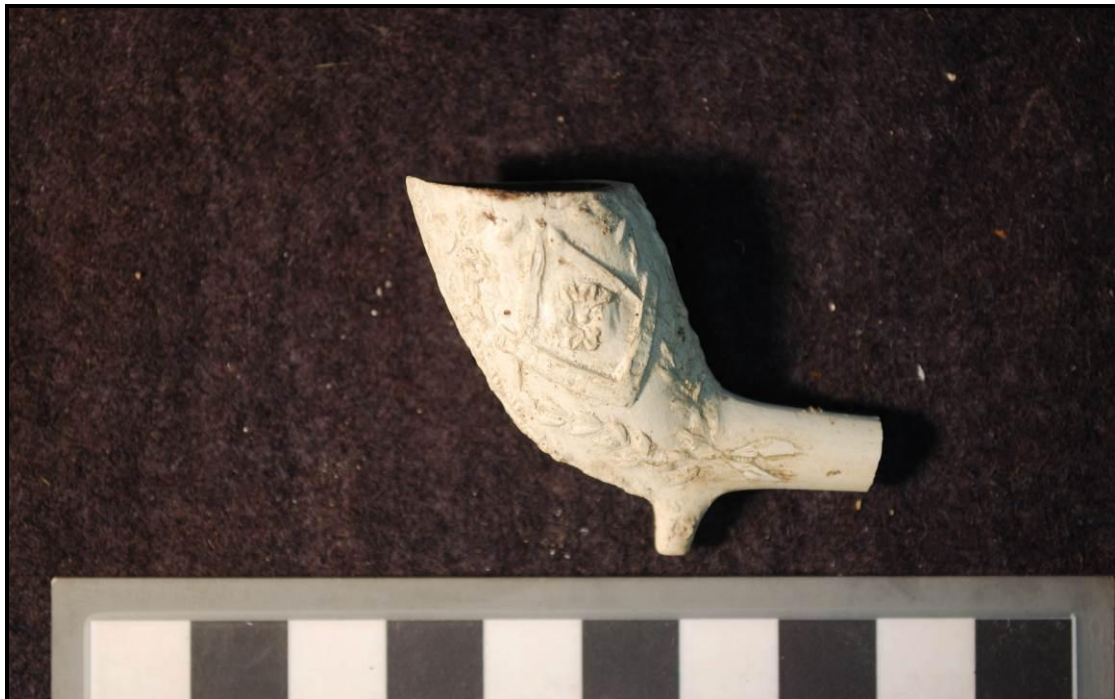
Plate 13: Clay tobacco pipe with the Freemasons square and compass motif, WC 004

In addition to another 'Ben Nevis Cutty' clay tobacco pipe, a second clay pipe has an acorn design and Freemasons' square and compass motif (Plate 13). Similar tobacco pipes were recovered from the wreck of the barque *Eglinton* (1852) off Quinns Rocks and are typical of imported pipes from the 1840-1880 period (Stanbury 203:128). As stated earlier, this clay pipe is found throughout Australia in the nineteenth century.
