FREMANTLE PRISON, KNUTSFORD STREET RAMP ARCHAEOLOGICAL WATCHING BRIEF AND EXCAVATION RESULTS

Philip Griffiths Architects and Fremantle Prison

August 2011

Eureka Archaeological Research and Consulting, UWA

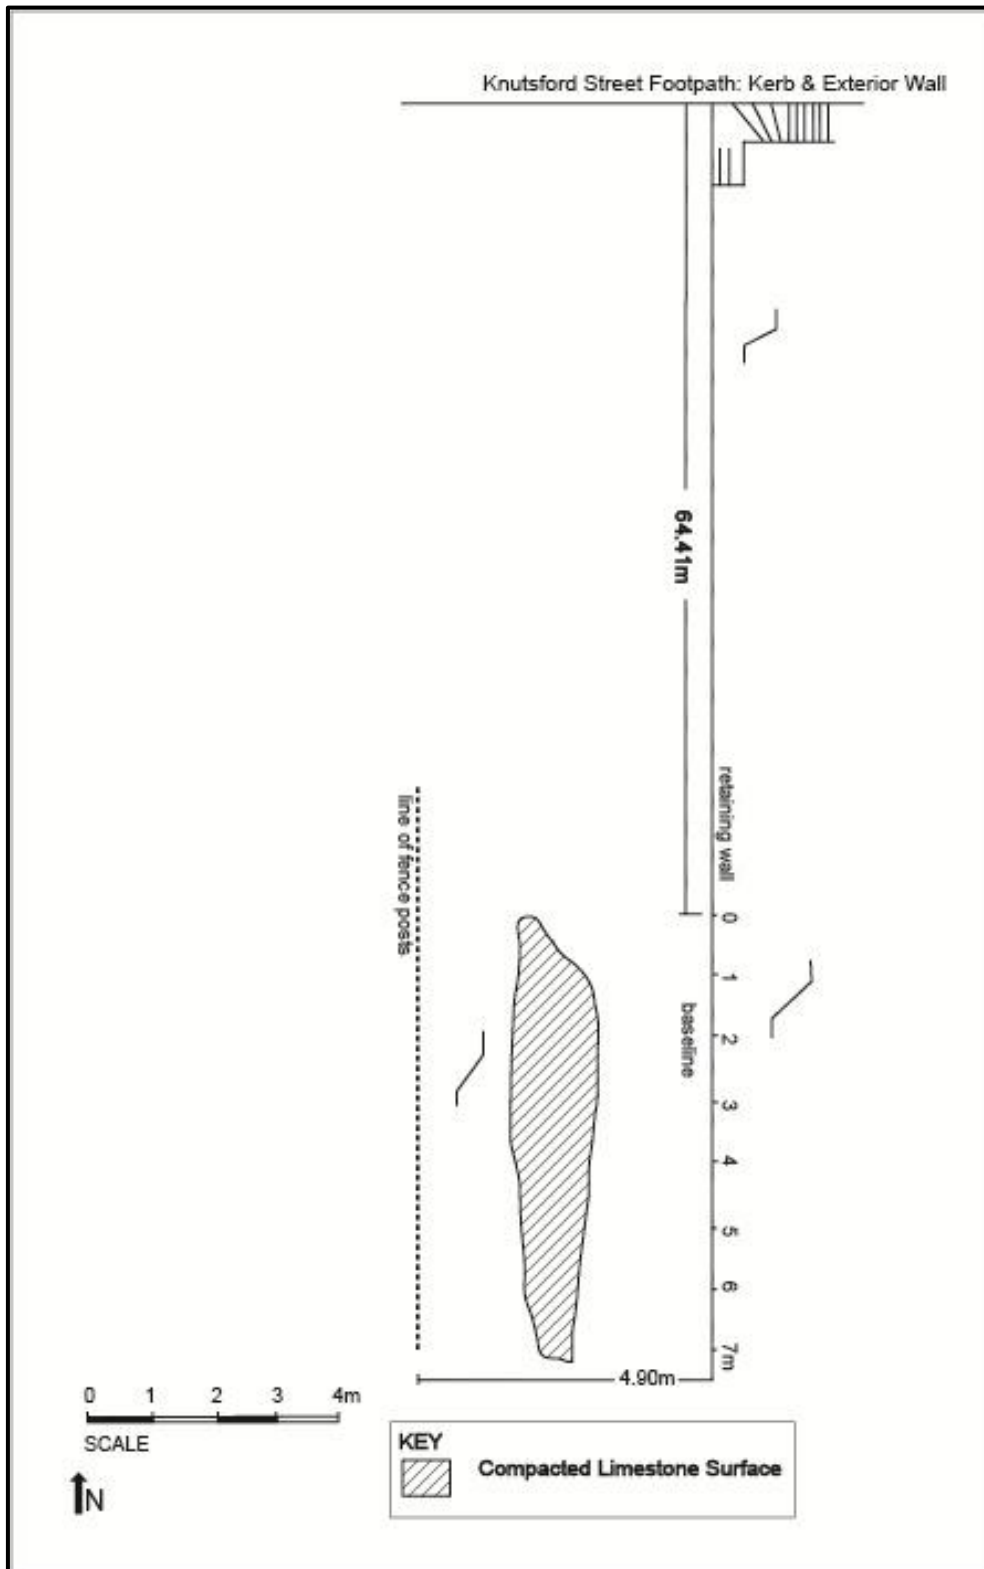
Figure 2: Plan showing exposed section of limestone surface on Knutsford Street Ramp, Fremantle Prison

The crushed limestone surface that was exposed on the Knutsford Street Ramp was highly deteriorated (Figure 2). The surface comprises patchy and crumbling pieces of limestone interspersed with medium grey soil and porous crumbling pieces of brick. Only three small pieces of brick were observed in this limestone surface. Also present were eight pieces of freshly broken slate, ranging from 30mm to 40mm in length; the breakage was the result of the initial scraping of the surface by the *Bobcat*. The slate was left *in situ*.

The surface was photographed, planned and covered with 50mm of a stabilised soil mixture. The plan was drawn using fixed features as reference points – i.e. measurements were taken from the corner of the retaining wall and the exterior wall on Knutsford Street. A baseline, running from 64.41m to 75m from this point was used and is shown in Figure 2. The process of recovering the limestone surface was closely monitored to ensure that the machinery did not impact upon the archaeology. The recovered ramp surface was not compacted with the roller at this stage.

- The exposed section of limestone pathway should be covered with stabilised soil mixture to a depth of 100mm and compacted to protect and conserve it pending further discussion and investigation.

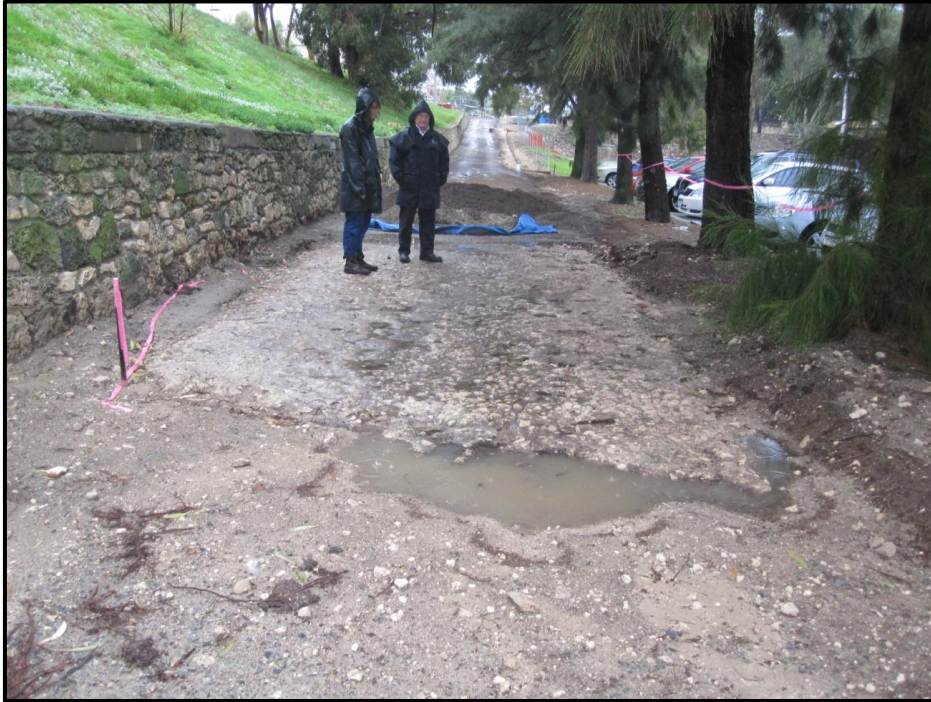
Plate 3: Northern edge of exposed limestone surface at north end of Knutsford Street Ramp

Contrary to expectations, the original compacted limestone ramp surface was identified less than 100mm below the existing ground surface at the northern end of the ramp. On the slope 40 metres to the south of the footpath kerb at the northern end of the ramp, the original ramp surface was identified at a depth of approximately 100mm (Plate 3).

Inspection of the exposed surface after rain showed a flat, compact, well drained surface made up of medium sized limestone cobbles with well defined edges on the east and west (Plate 3).

- Further archaeological investigation of the northern section of the Knutsford Street Ramp and limestone pathway be planned for the future.

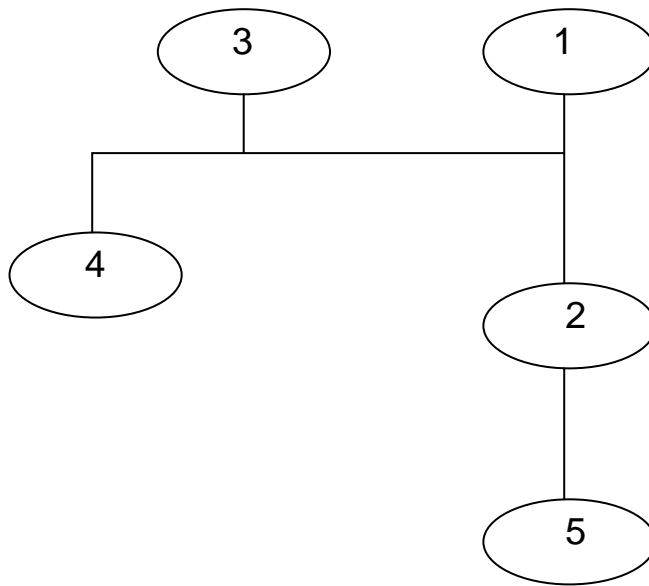
Figure 3: Harris Matrix for slot excavated through northern section of exposed ramp surface

A rectangular slot was also excavated at the western border of the limestone pathway. The slot measured approximately 550mm x 430mm and commenced at 177mm to 595mm depth below the datum point in the southeast corner (a total depth of 418mm). The slot was excavated stratigraphically, photographed and the east and north sections were drawn. A Harris Matrix was completed to show the relationship of the stratigraphic layers (Figure 3).

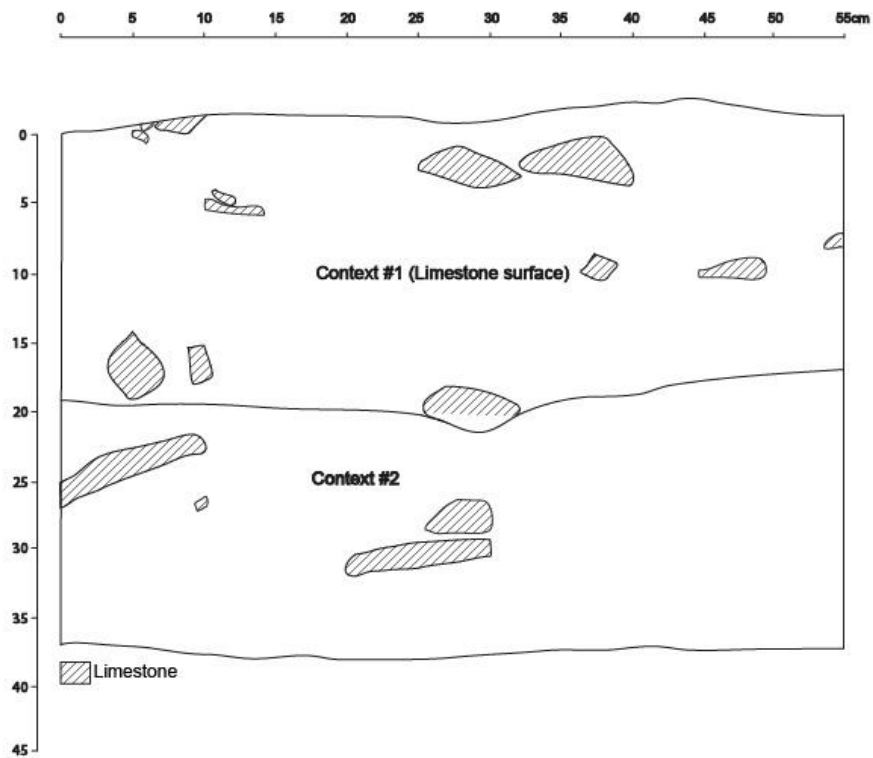
Figure 4: East section drawing, excavated slot, Knutsford Street Ramp

The rectangular test slot measured approximately 550mm x 430mm and was excavated to a depth of 450mm. The limestone surface was found to range in depth from 200mm to 260mm and overlay a layer of compact yellowish white sand with limestone inclusions (Figure 4). The area to the west comprised more mixed deposits, with the intrusion of topsoil from the garden beds (context #3), and a thin humic layer (context #4) above the same compact yellowish white sand found under the limestone surface. In addition, a probable cut and fill (context #5) was sealed by this layer, suggesting further cultural activity prior to this possible foundation layer (Figure 5).
