**ARCHAEOLOGICAL ASSESSMENT OF THE SUB-
FLOOR POTENTIAL, COMMISSARIAT BUILDING,
FREMANTLE PRISON, WESTERN AUSTRALIA**

Philip Griffiths Architects and
Building and Management Works

November 2010

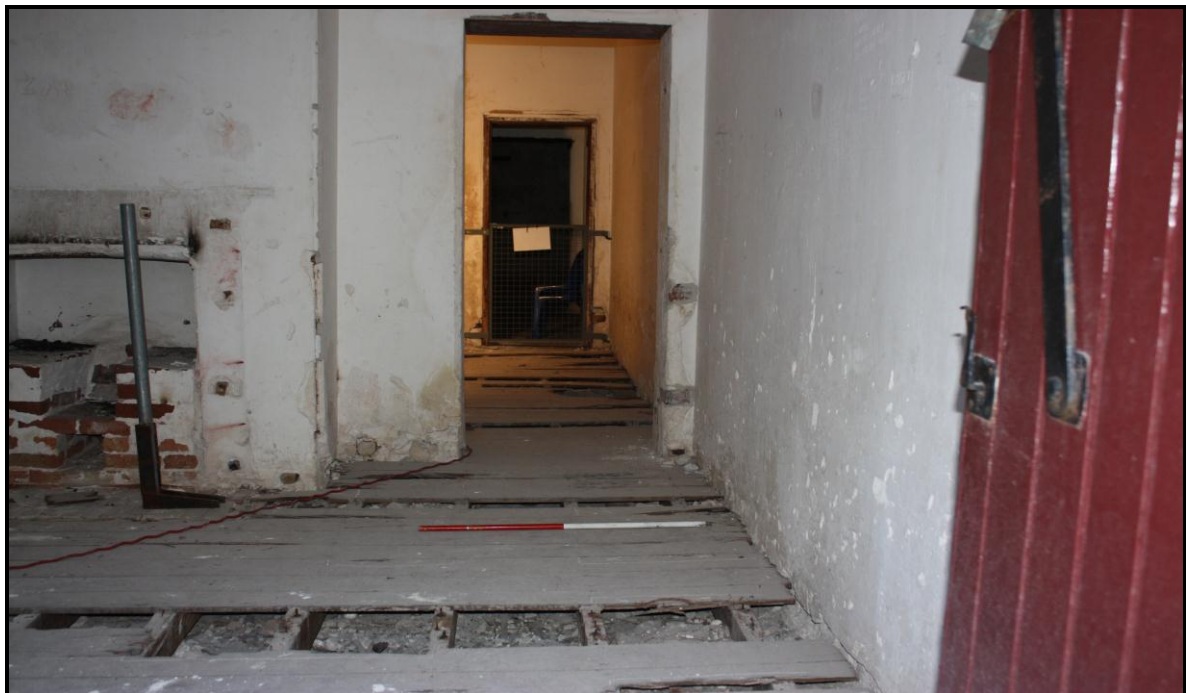
Plate 1. View east through the steward's office to the clerk's office (Scale = 1m)

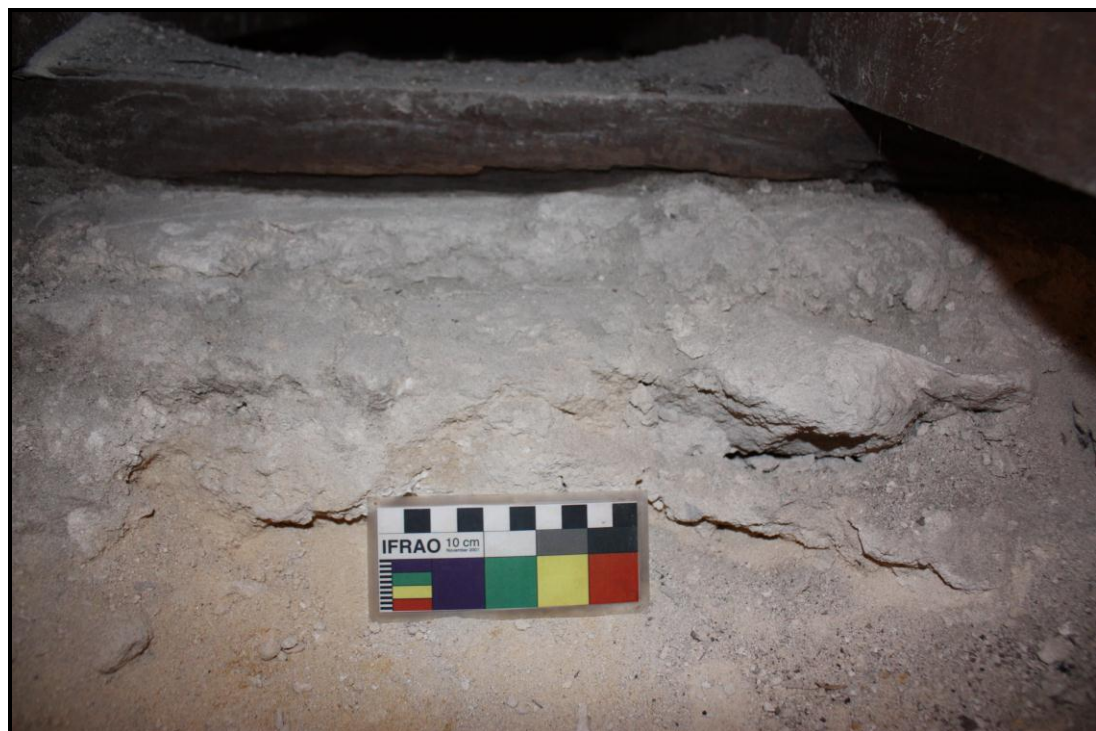
On inspection of the sub-floor construction, a joist-bearing jarrah beam (115mm x 50mm) was exposed that had been bedded into a lime mortar pad on top the limestone levelling layer (Plate 3). These timbers are of the same dimensions as the floor joists, but are used with their wider side facing downwards.

Plate 3. Slot 1, profile showing jarrah beam and lime mortar pad, view west (Scale = 10cm)

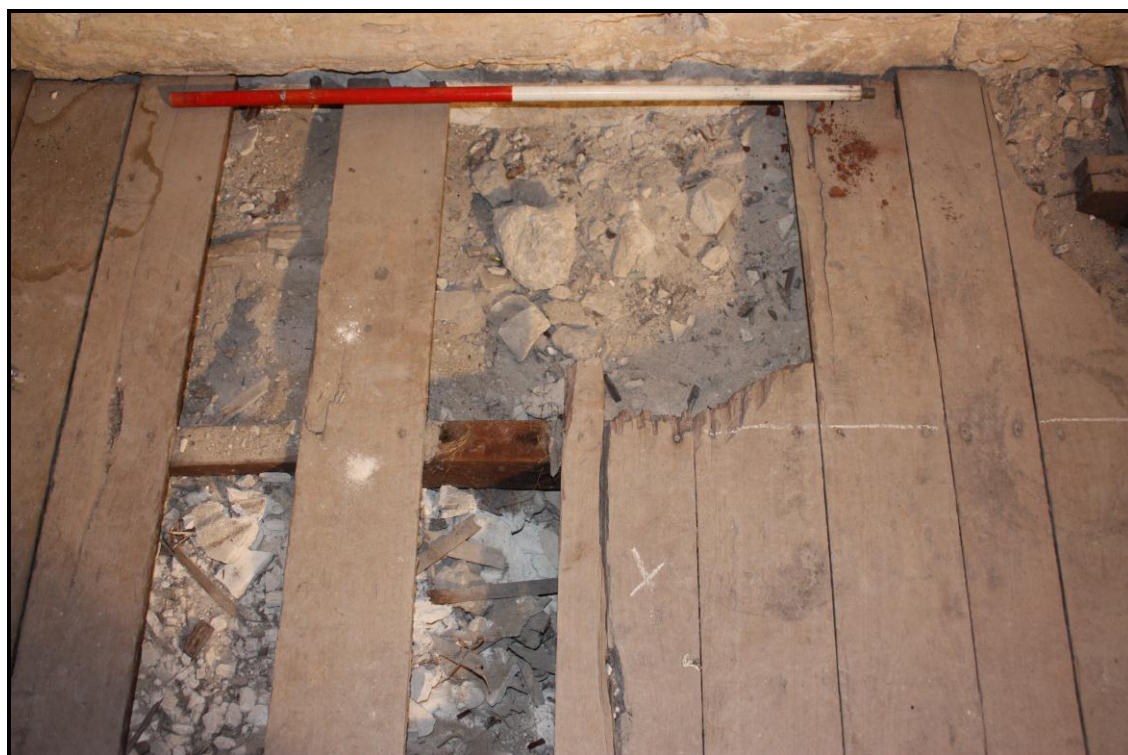
Slot 2 was excavated within a section of three broken floorboards against the southern wall of the clerk's office. The slot measured approximately 0.65m (north-south) by 0.50m (east-west) (Plate 4).

Plate 4. Slot 2, view south pre-excitation (Scale = 1m)

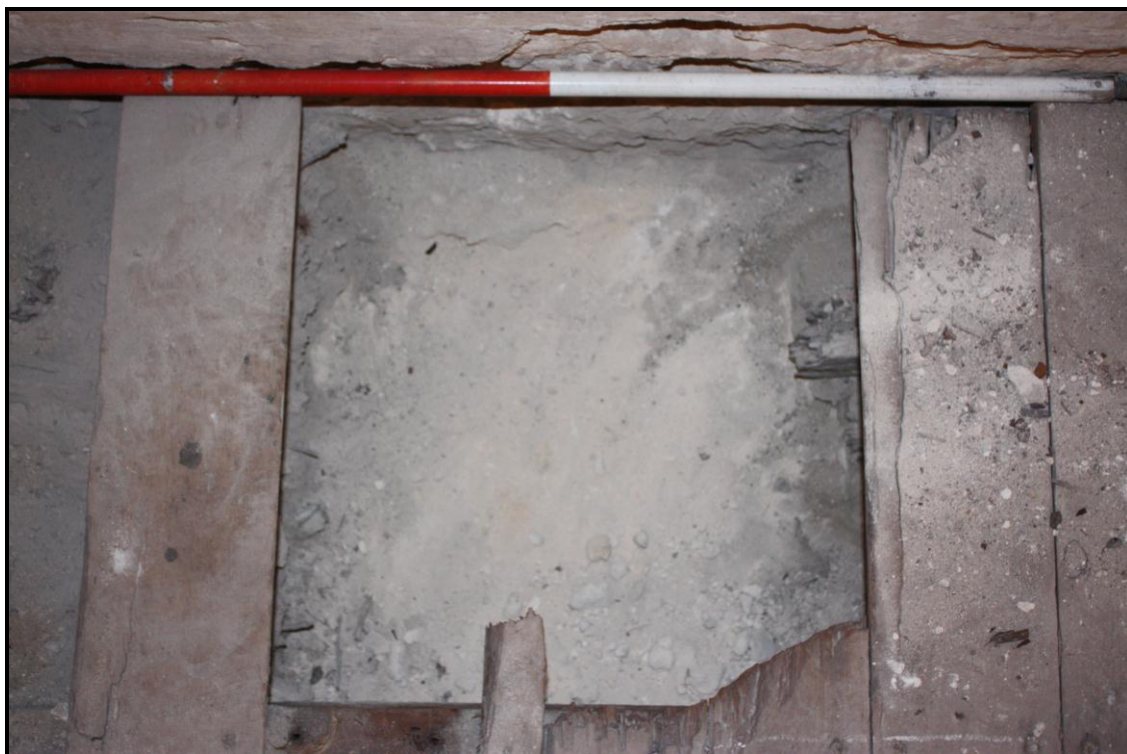
Excavation proceeded directly onto a thin degraded limestone deposit (30mm), with no trace of the possible sub-floor deposit that was noted in Slot 1. Again, no sub-floor deposit was visible in the collapsing sections. A small sondage was excavated onto limestone bedrock at the centre of the slot.

Plate 5. Slot 2, top of degraded limestone layer (Scale = 1m)
