## **Archaeological Management Strategy**

### **Warders' Cottages (FMR)**

**7-41 Henderson Street, Fremantle W.A.**

August 2015 | John Marrell & Tony Bartlett

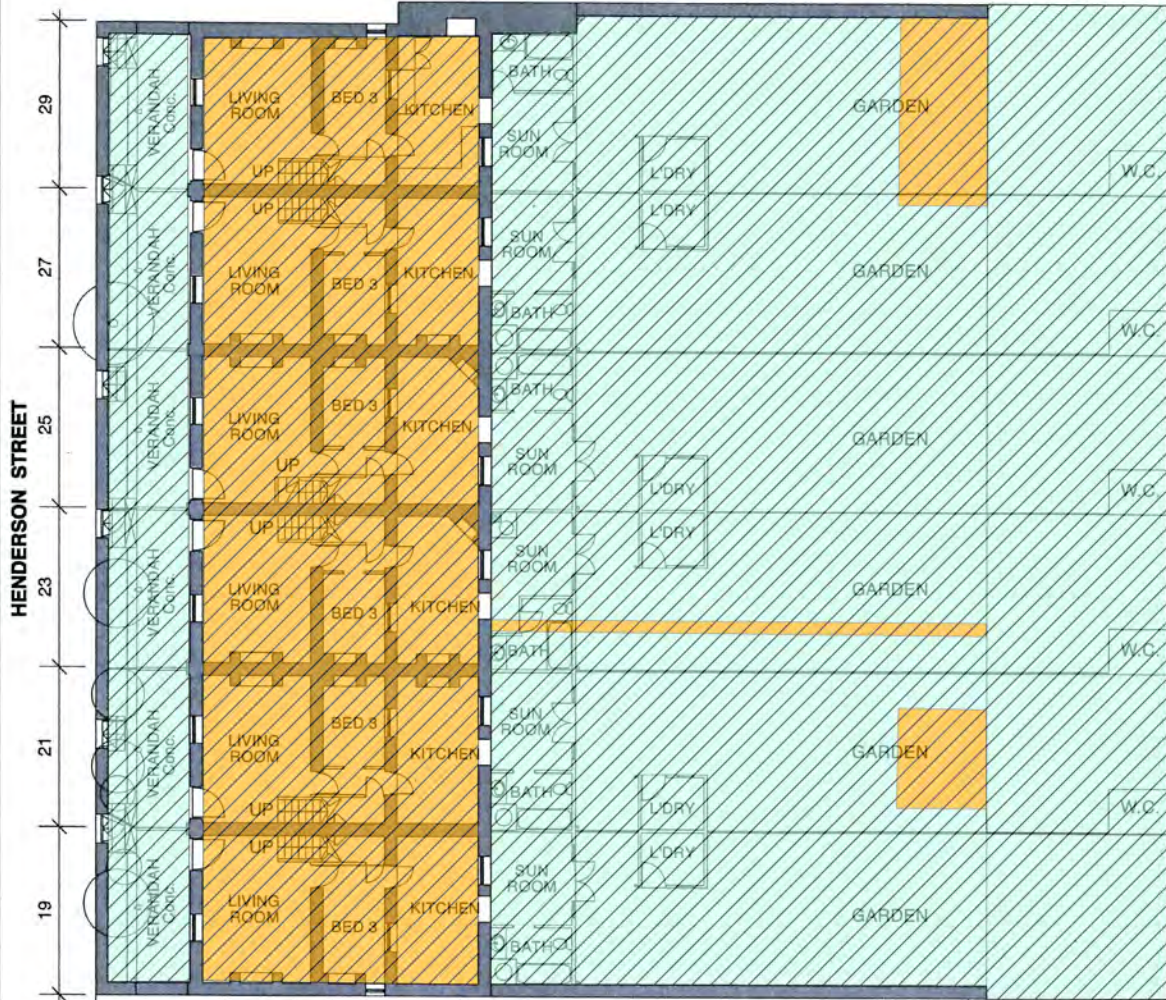
WARDERS  
COTTAGES  
BLOCK W3 (1858)

High Archaeological Potential

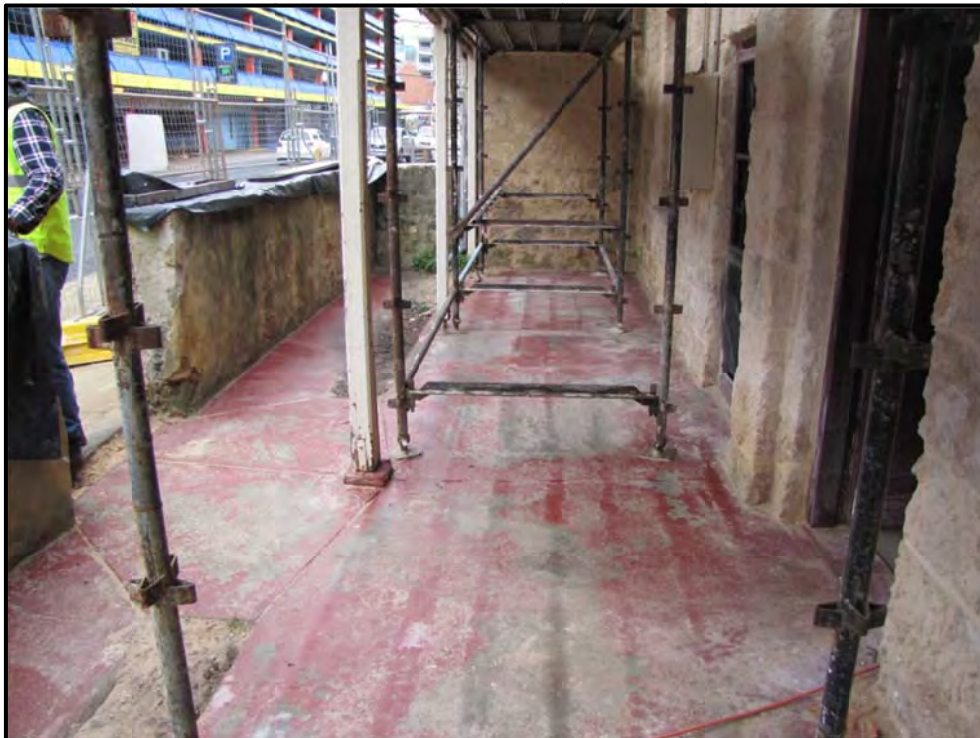
**Plate 1: View NE of concrete front verandah, block W2, house 39/41**

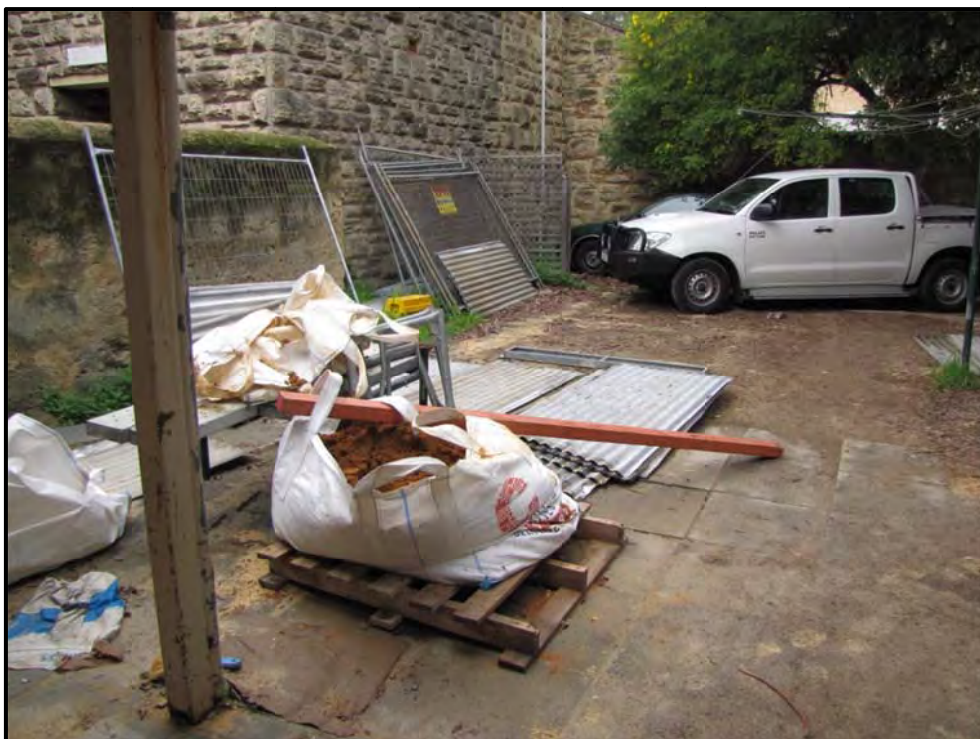
**Plate 2: View E of rear yard, block W2, house 39/41**

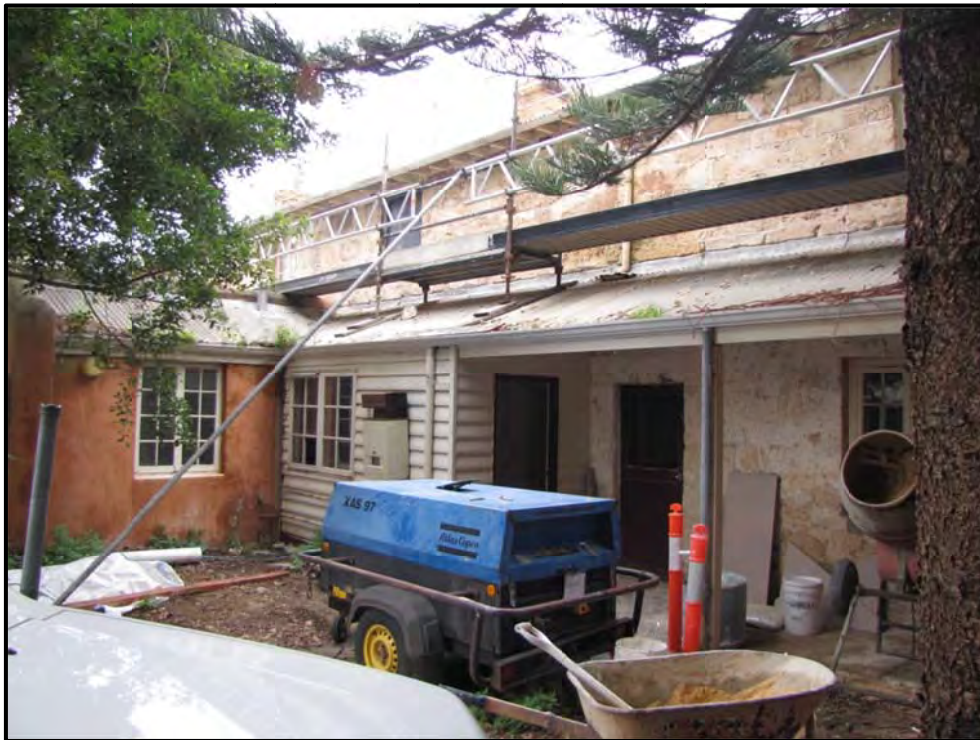
**Plate 3: View of W of rear yard and façade of cottage, block W2, house 35/37**

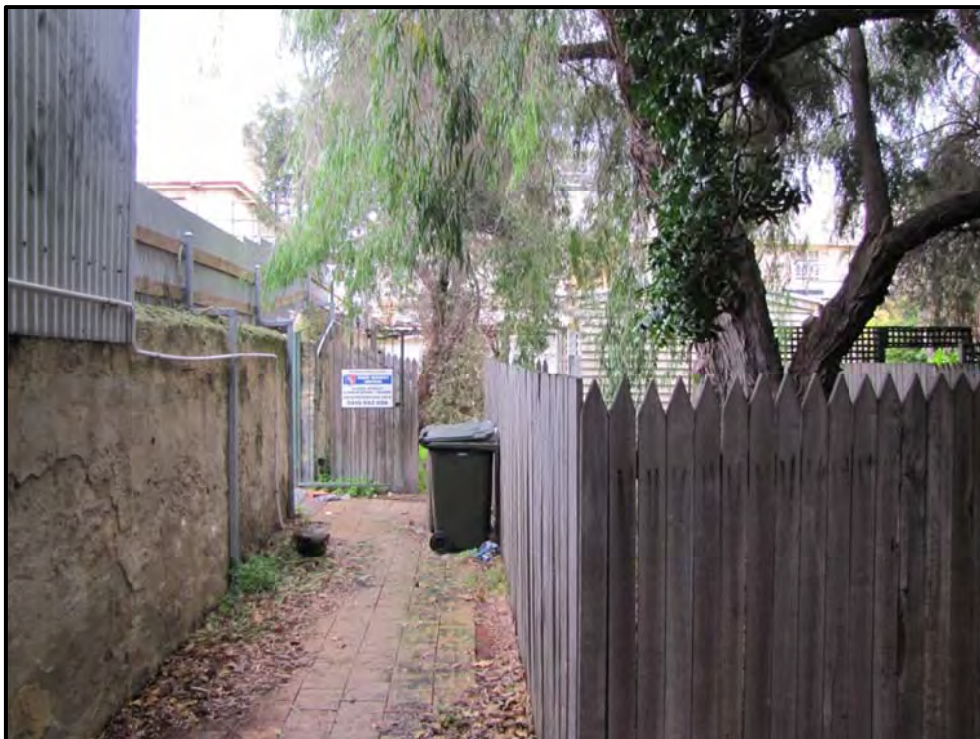
**Plate 4: View W/NW of laneway leading to the Fremantle Market ROW, block W1, house 19**

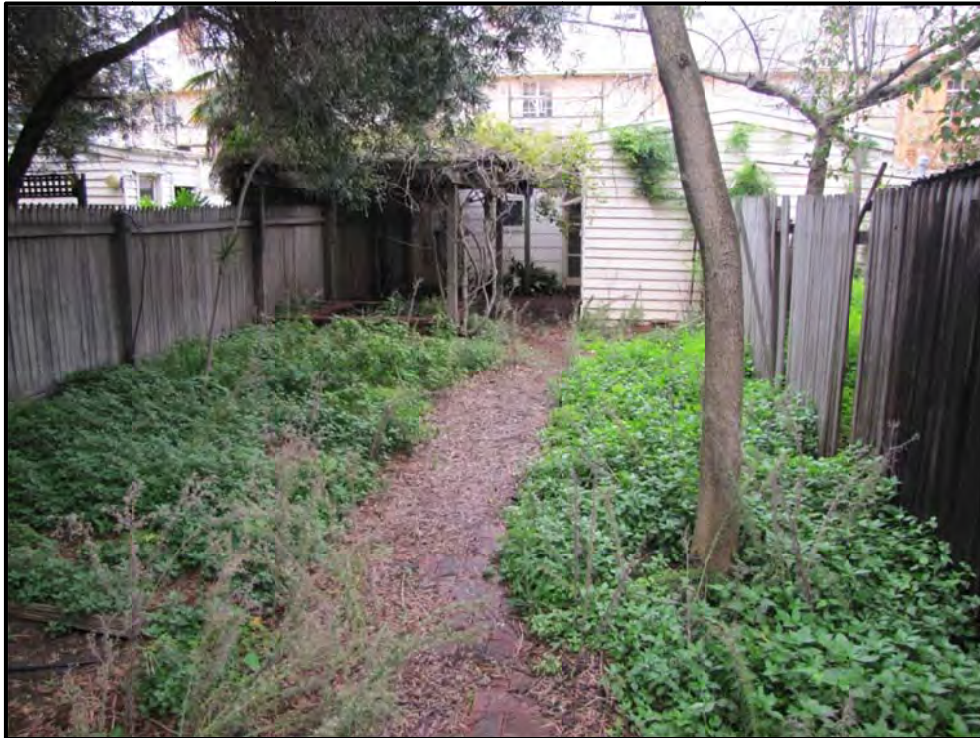
**Plate 5: View NW of rear yard, block W1, house 23**

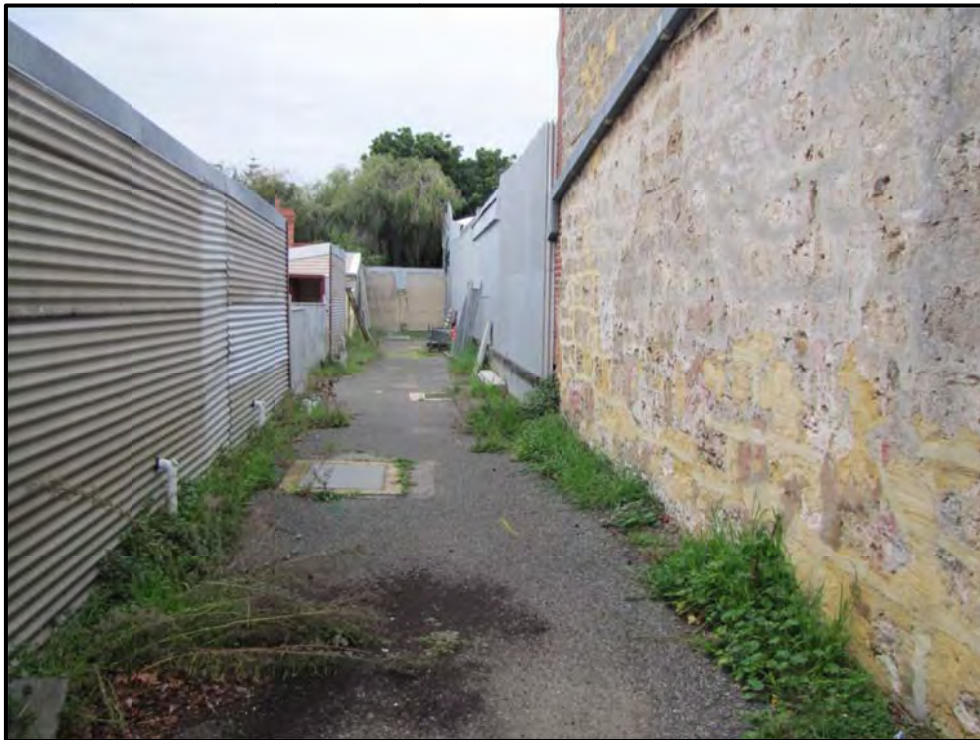
**Plate 7: View NE of ROW between the rear of the W3 cottages and Fremantle Market**

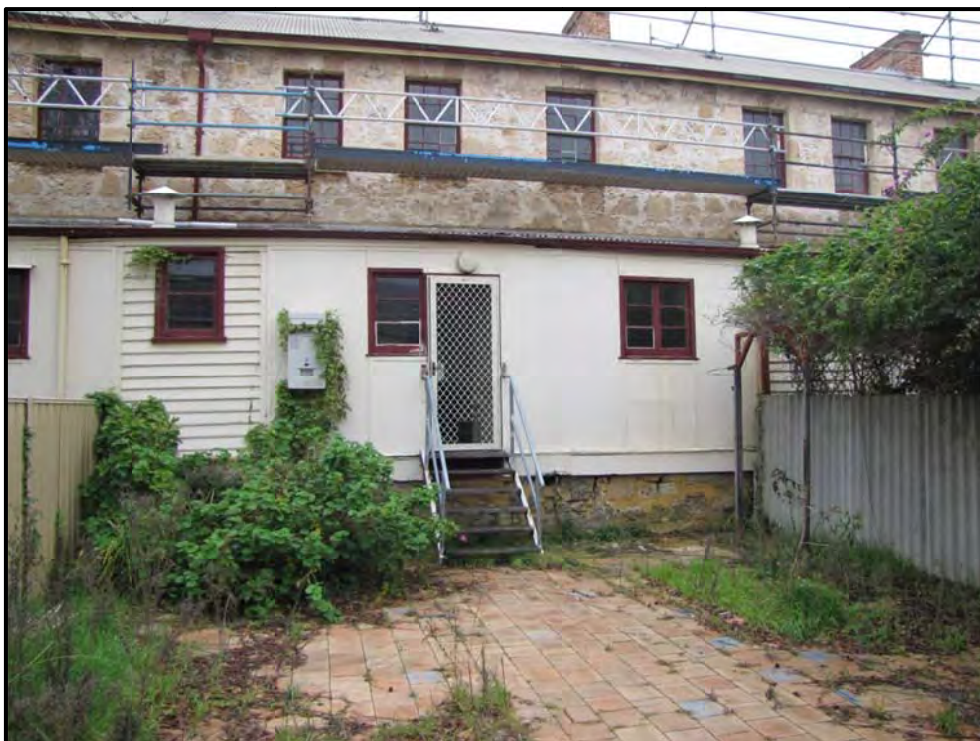
**Plate 8: View NW of rear yard and façade of cottage, block W3, house 11**

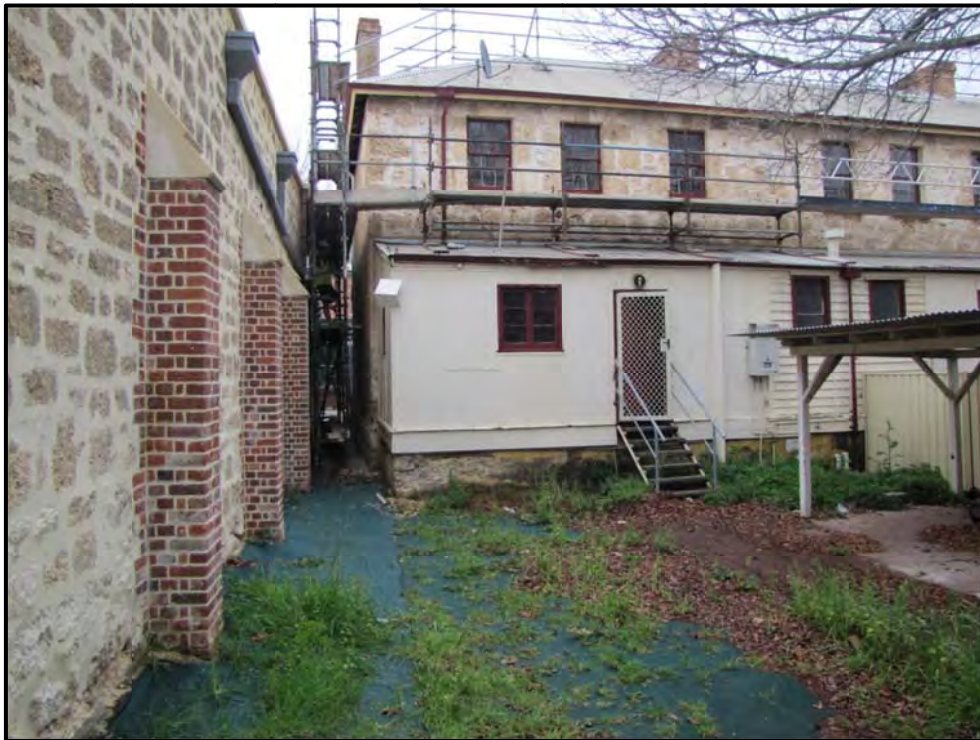
Plate 9: View NW of rear yard of cottage, block W3, house 7

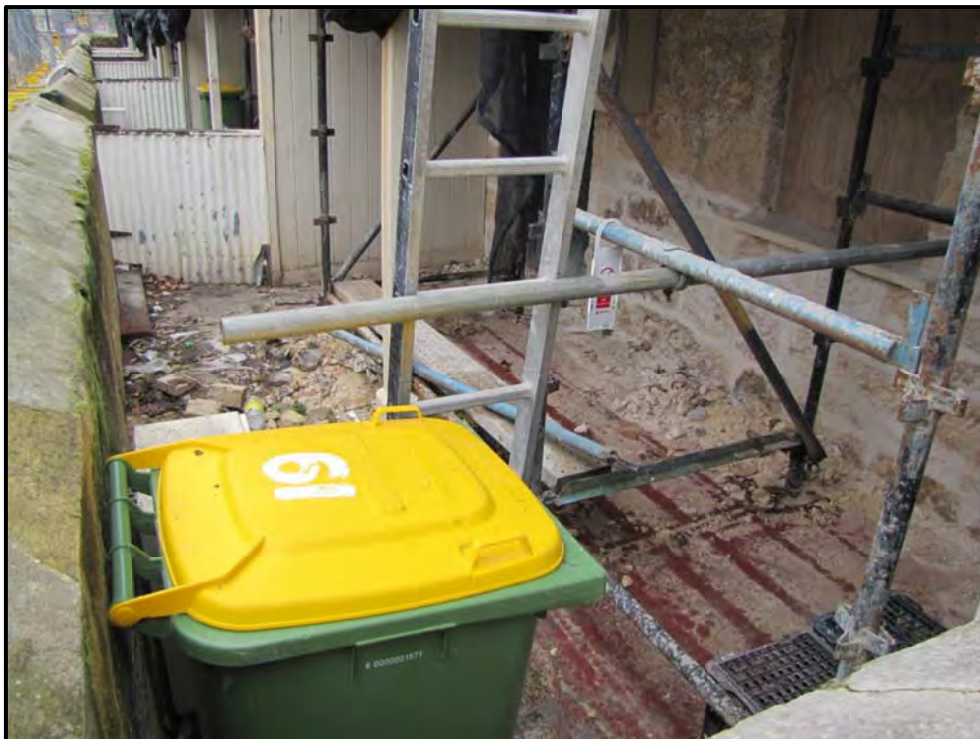
Plate 10: View E/NE of concrete front verandah, block W1, house 19

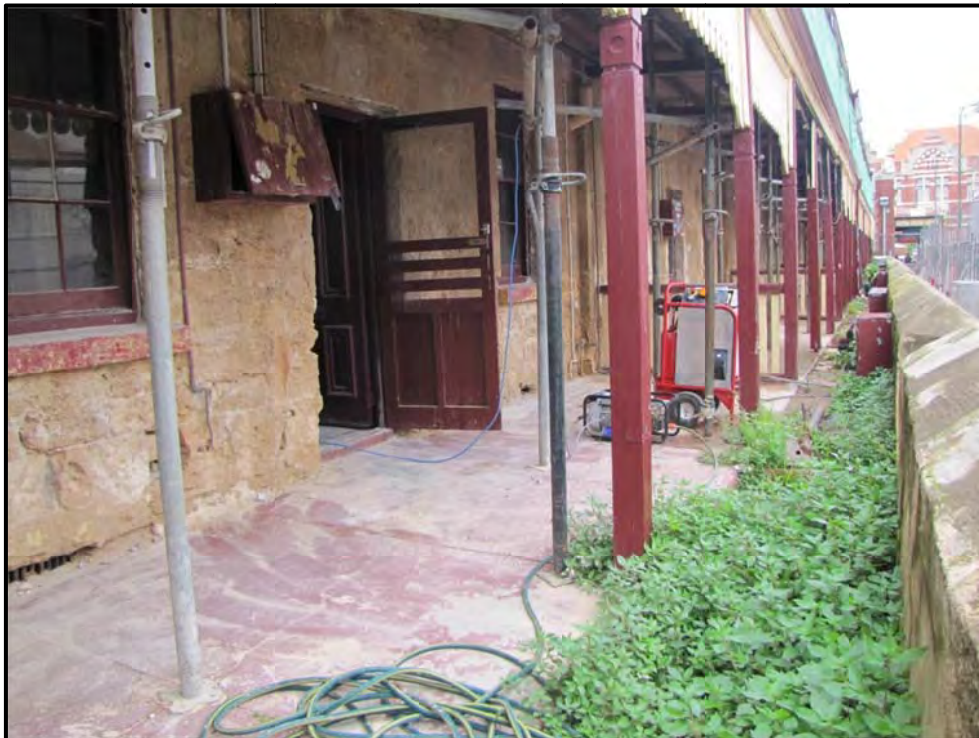
**Plate 11: View SW along concrete front verandahs of block W3**

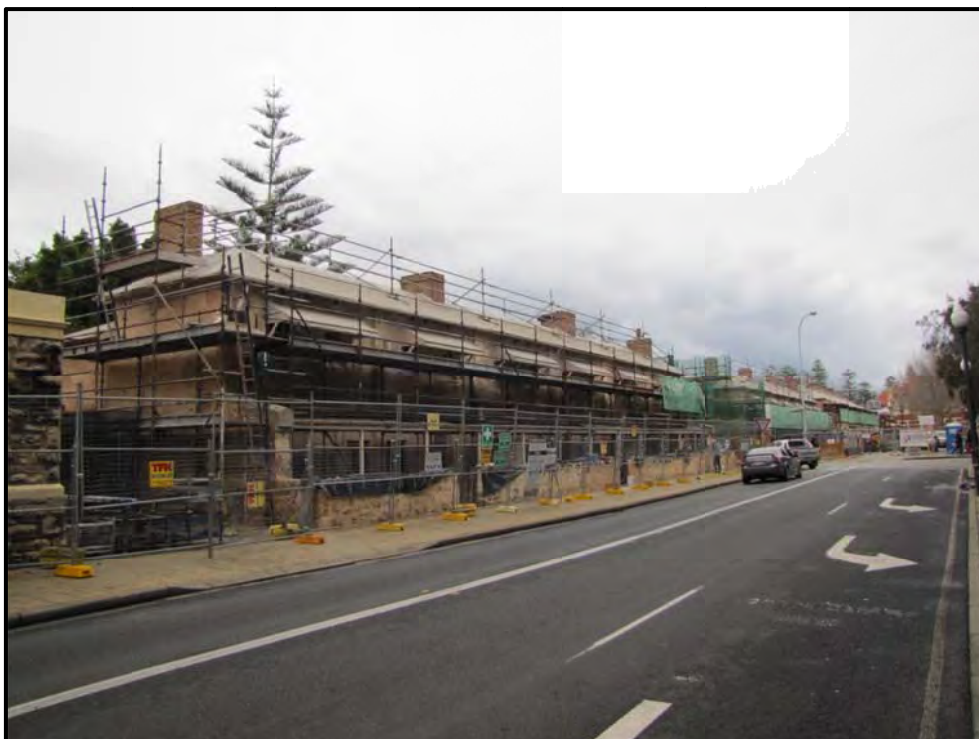
**Plate 12: View S/SW along all the front of all three Warders' Cottages (7-41 Henderson Street)**
