4.0 Function and Physical Fabric

4.1 Current Conservation Status

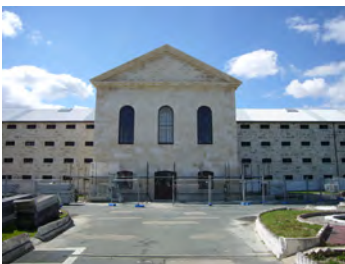
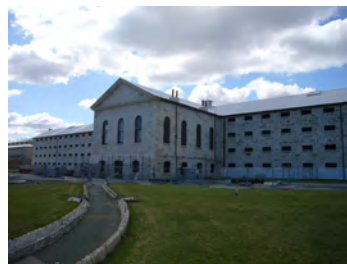
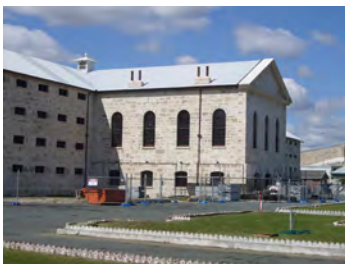
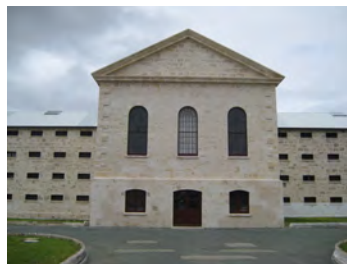
In the case of the restoration of the exterior of the Chapel, members and officers of the Heritage Council attended site to view the physical investigations that were found to reveal the original limestone work beneath the applied render and paint finish. The Heritage Council then considered the heritage impact statement, which outlined the analysis and relevant policies and the proposed conservation works and monitoring regime for the interior murals, prior to supporting the proposal.

Photographic views of conservation works to the Main Cell Block and Chapel, 2007

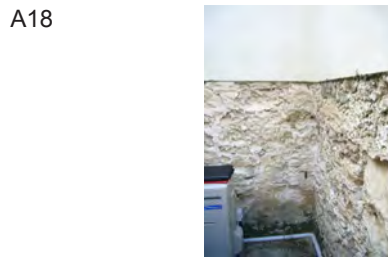
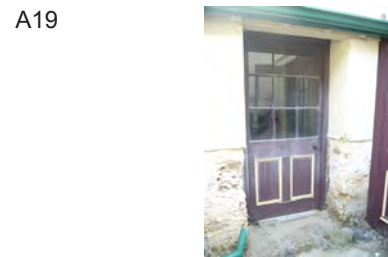
- A15 View looking east towards No. 12 The Terrace
- A16 View looking south along front verandah
- A17 Detail of render failure on courtyard wall
- A18 View of south courtyard showing applied render above shoulder height
- A19 View looking south-west across south courtyard showing deterioration of joinery

- Applied paint externally retarding vapour passage in walls
- Concrete verandah
- Built up ground levels
- Intrusive and damaged electrical services
- Some render failure
- Damage to the west wall of the northern office
- Damage to the floor of the northern office
- Extensive damage caused by damp to the kitchen ceiling
- Some drumminess to the walls of the conference room
- Damage caused by damp to the external toilet and storage space, including lifting of wall tiles in the storage space
- Localised failure of external limestone walls
- Inappropriate concrete render applied to external limestone walls
- Previous repairs to external walls

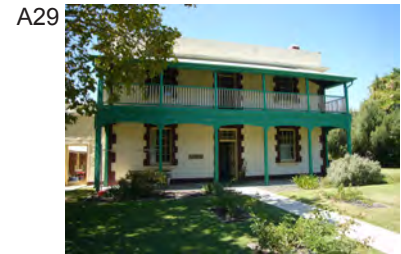
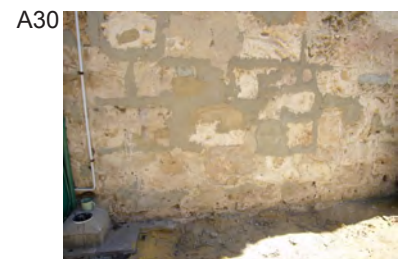
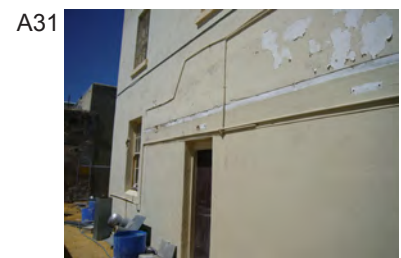
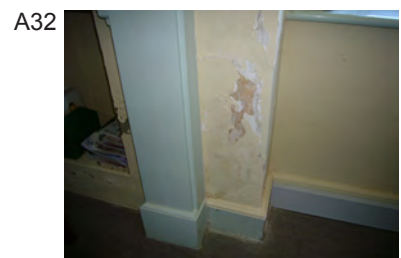
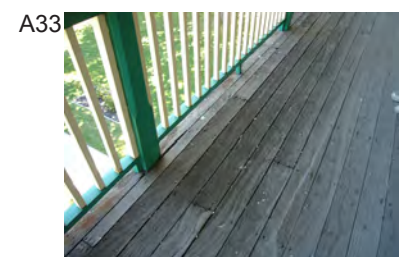
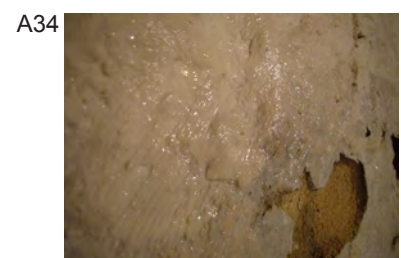
- Applied paint externally retards vapour passage in walls
- Cement pointing to part rear façade
- Cement render applied to external walls
- Reticulation in drainage channel surrounding building, probably over spray onto walls
- Built up ground levels
- Concrete verandah
- Extensive damage caused by damp, particularly at ground floor and basement levels
- Extensive salt deposits on walls of basement with masonry damage
- Dirty chimneys, soot and mortar droppings

A29	View of the front (west) facade of No. 16 The Terrace
A30	Detail of cement pointing on rear facade
A31	Detail of paint failure on north facade
A32	Detail of internal wall failure, ground floor
A33	Detail of weathering of verandah floorboards
A34	Detail of salt deposits, north wall, basement

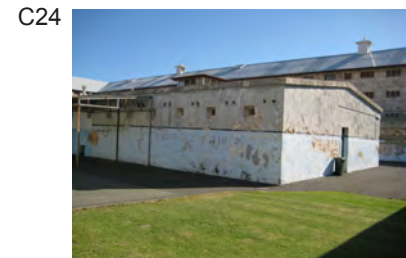
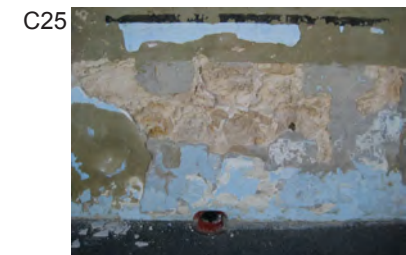
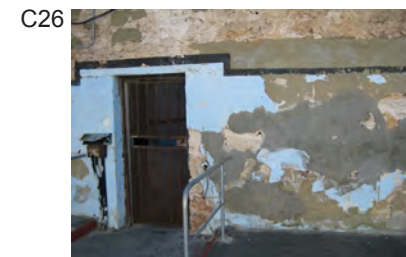
Generally, the Refractory Cell Block is in poor to fair condition.

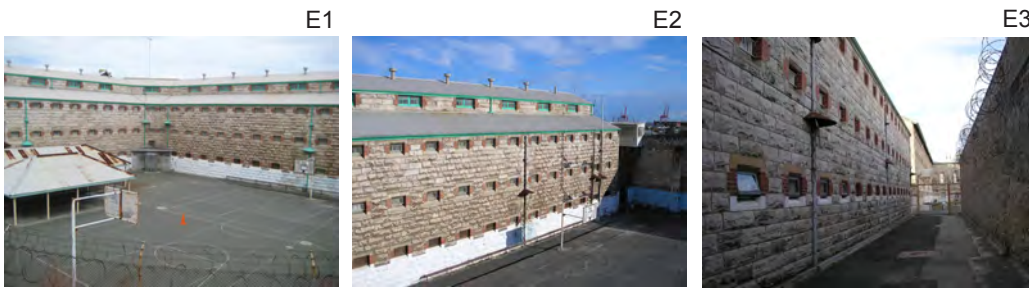
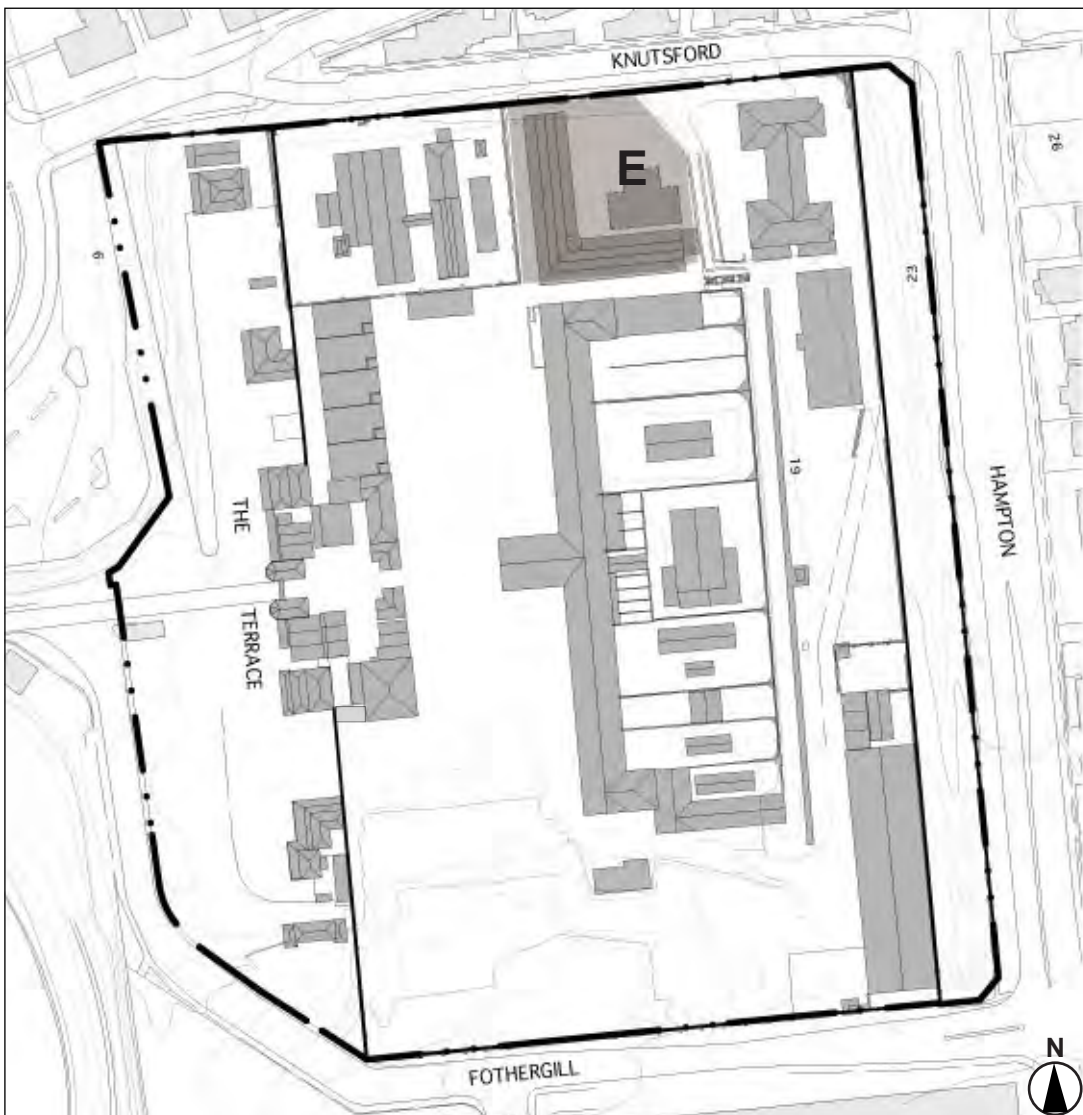
Figure 20. Zone E: New Division

- Some isolated failure of internal walls due to damp
- Localised low level failure of the external walls
- Cementitious pointing failing at low level, with some failure to arris' of stones
- Localised failure of the dado paint finish
- Deterioration of external joinery
- Deterioration of metal window bars

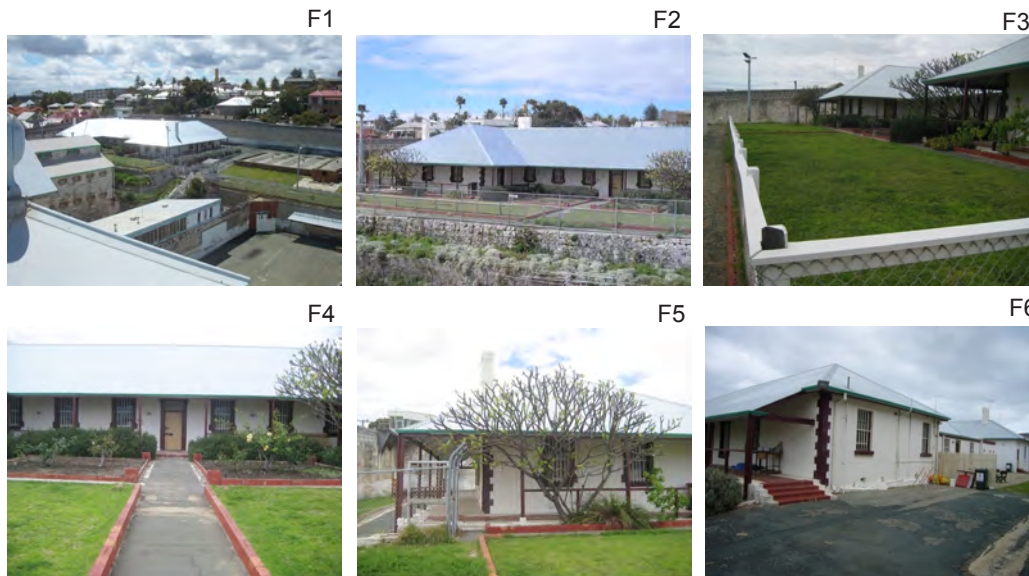
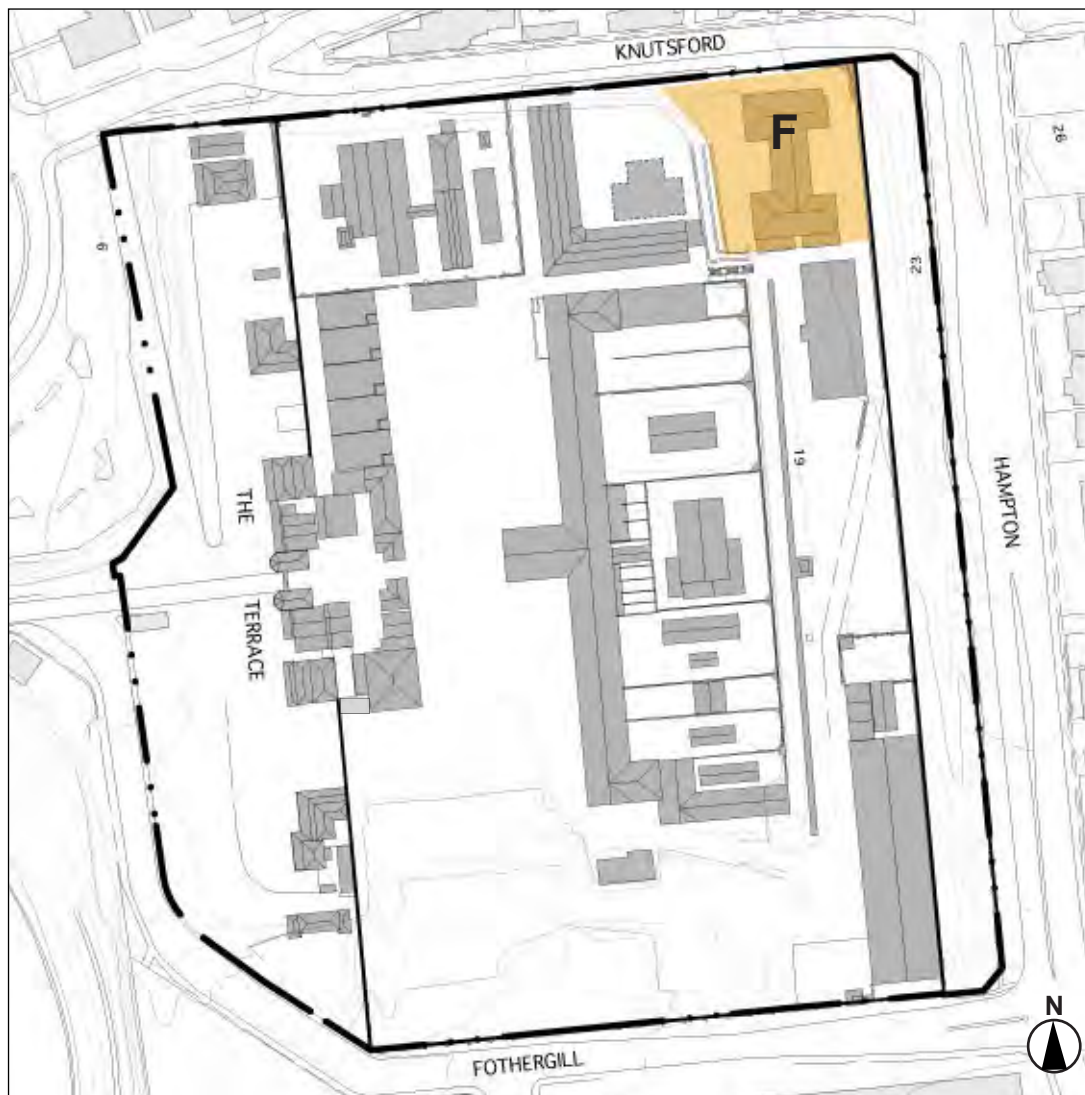
Figure 22. Zone F: Hospital

- Some failure of the acrylic paint applied externally
- Some damage caused by damp internally, particularly at low level
- Some evidence of previous water damage to ceilings

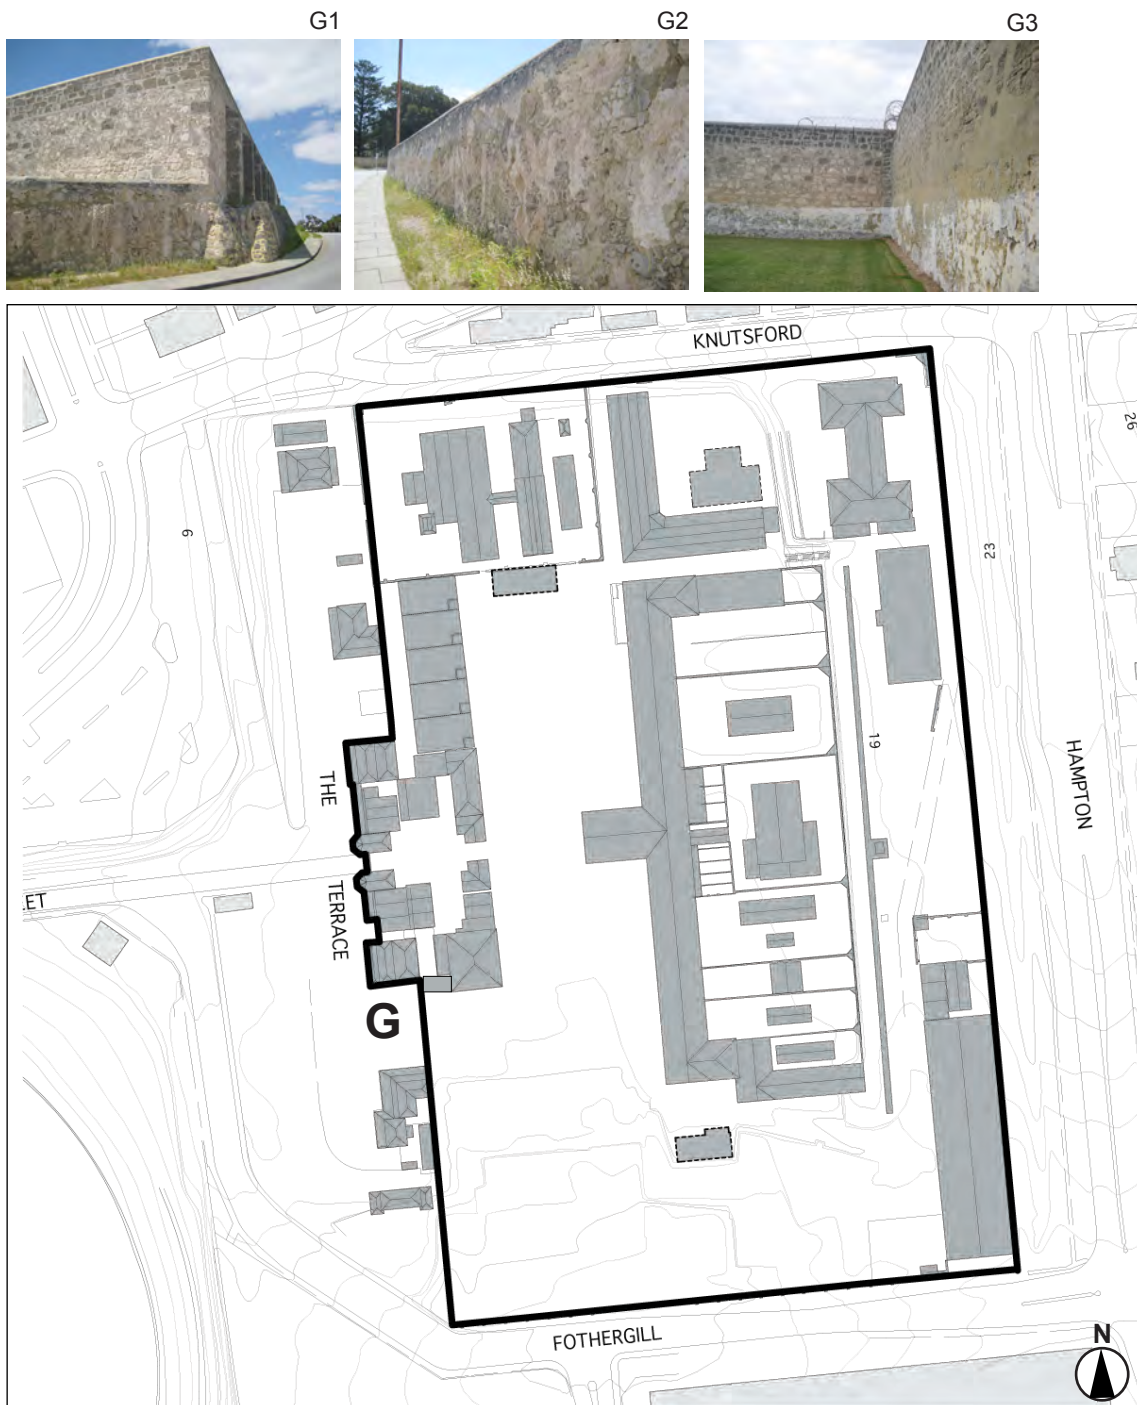
Figure 24. Zone G: Perimeter

- Some failure of the limestone
- Failure of applied renders and mortars
- Failure of embedded metal fixtures causing damage to walls
- Built up ground levels in part
- Growth of flora in and along base of walls and in fissures up the walls
- Areas of visually intrusive and damaging cement render

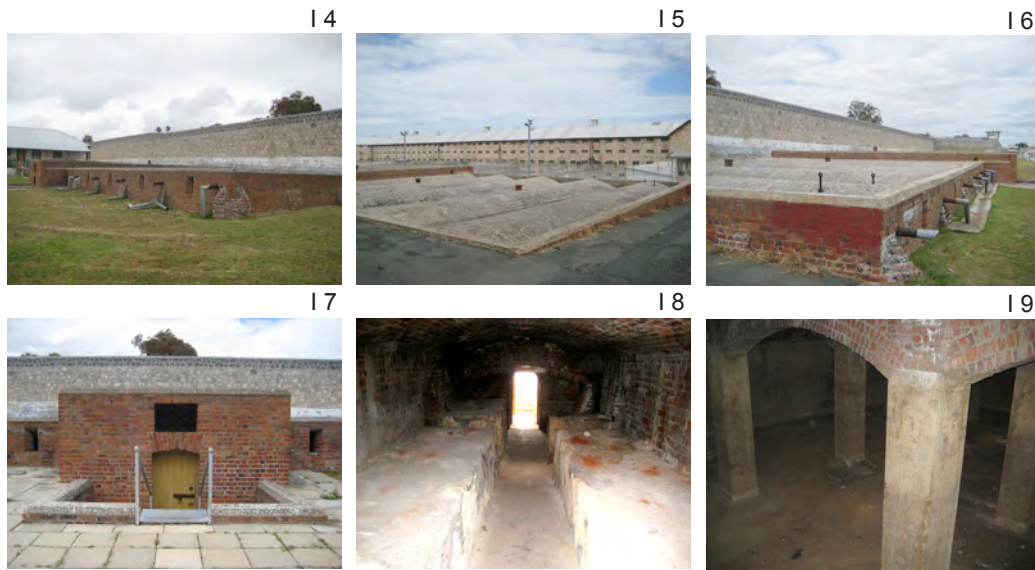
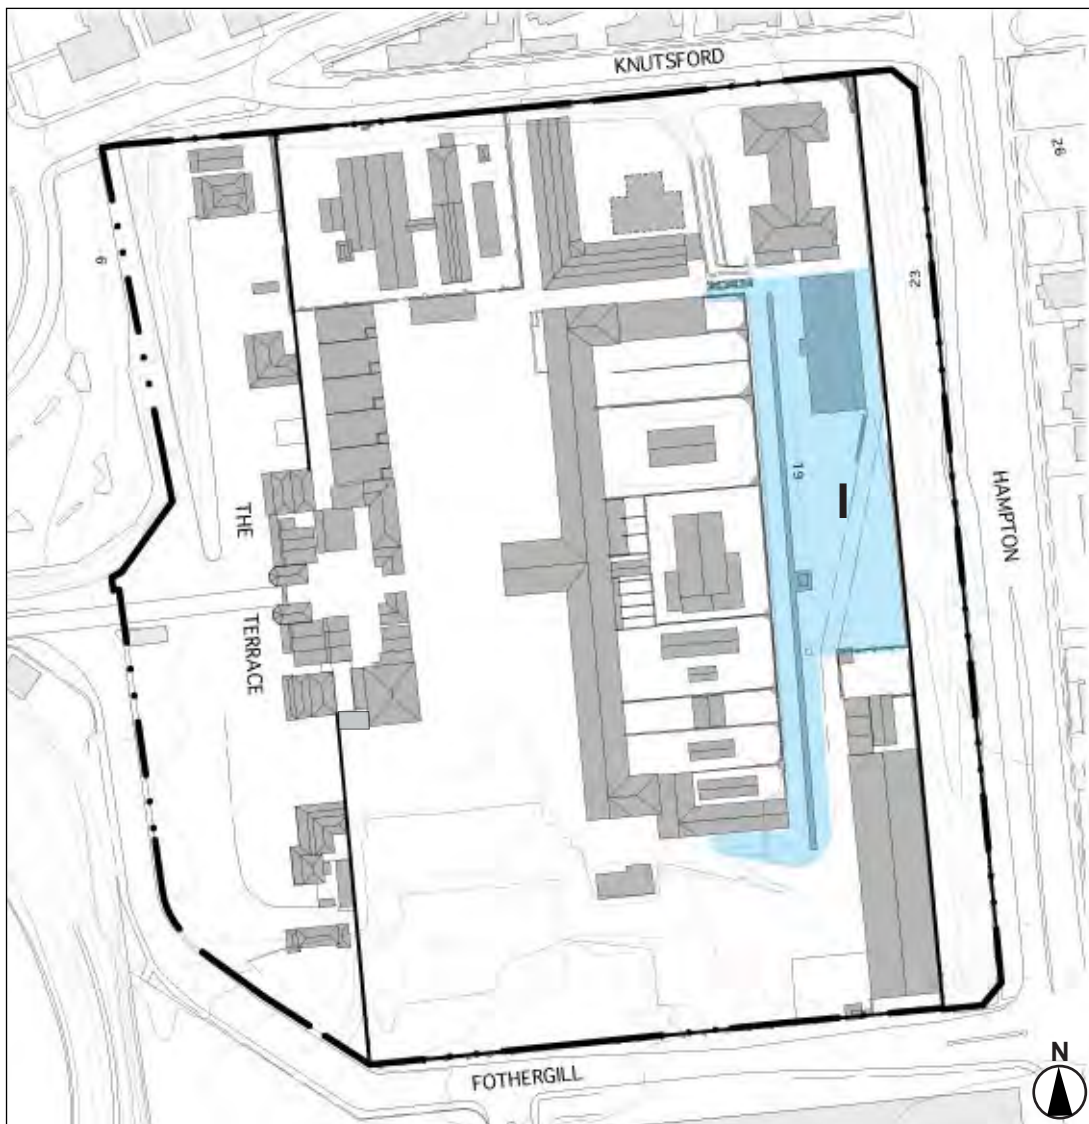
Figure 27. Zone I: East Reservoir and East Terrace

- Failure of the roof drainage system
- Failure of brickwork internally and externally
- Corrosion of many internal metal elements
- Heavy salt deposits on the internal walls and floors
- Deterioration of external joinery

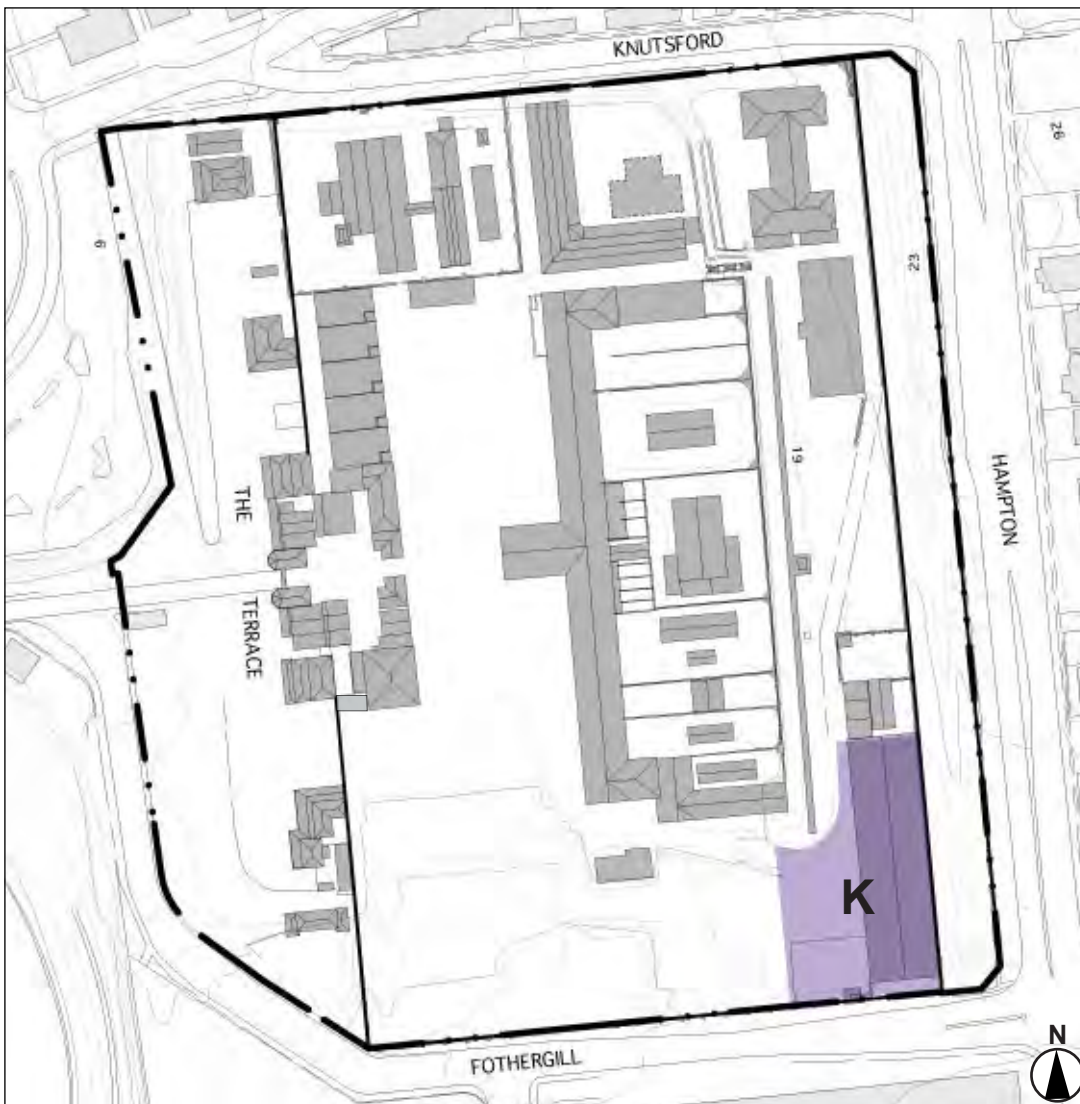
Figure 30. Zone K: East Workshops

- Failure of the limestone walls
- Previous poor repairs
- Deterioration of external joinery
- Deterioration of exposed metalwork

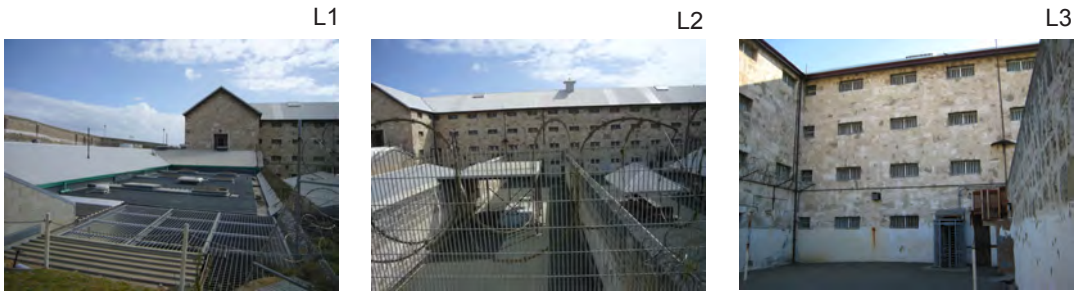
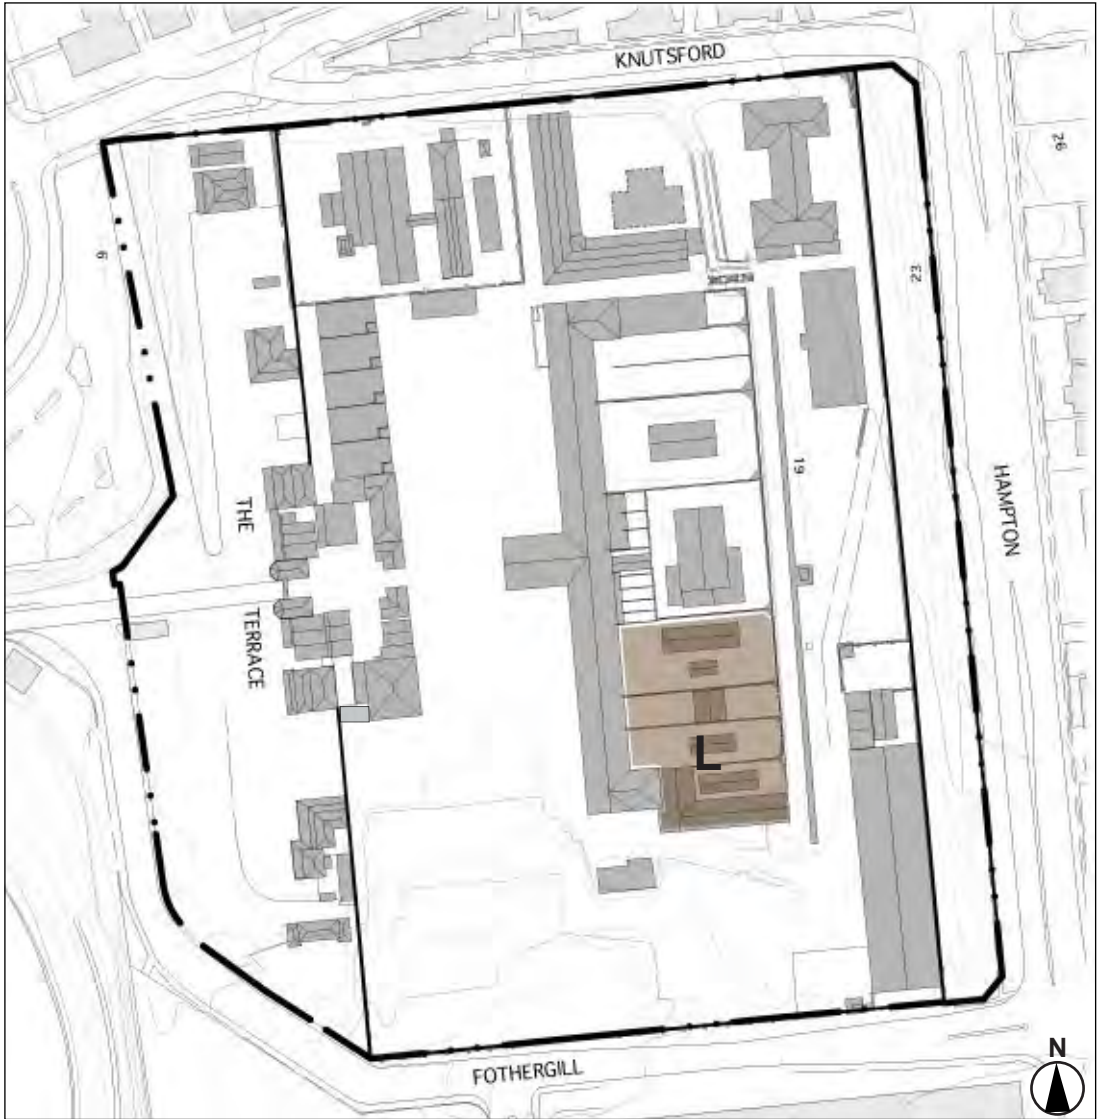
Figure 32. Zone L: Southern End of Main Cell Block

- Failure of the limestone walls
- Previous inappropriate repairs to the walls
- Deterioration of joinery and metalwork elements
- Extensive deterioration of the shelter structure and its cladding
- Damage caused by damp to internal walls
- Damage caused by damp to ceilings
- Deterioration of floor surfaces
- Brickwork to boiler chimney in poor condition

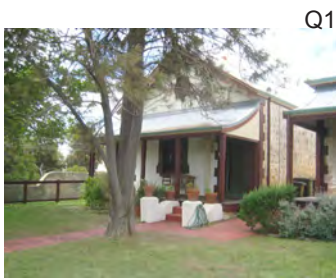
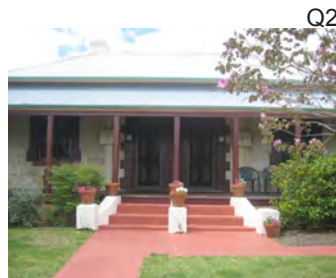
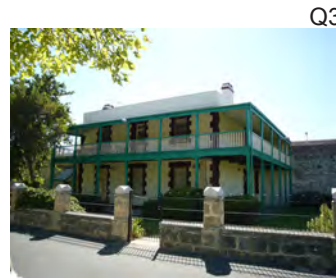
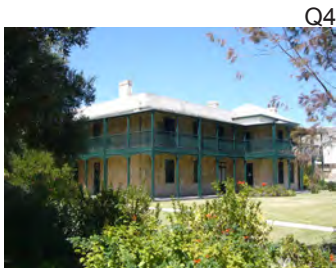
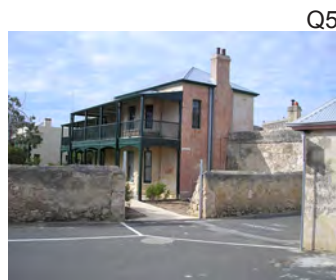
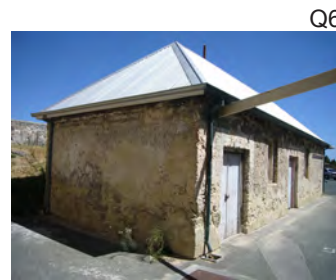
Photographics Views

- Q1 View of the No. 2 The Terrace, looking northeast
- Q2 View of No. 4 & No. 6 The Terrace, looking east
- Q3 View of No. 8 The Terrace, looking northeast
- Q4 View of No.18 The Terrace, looking southeast
- Q5 View of No.18 The Terrace, looking northwest
- Q6 View of the Stables, No.18 The Terrace, looking southeast

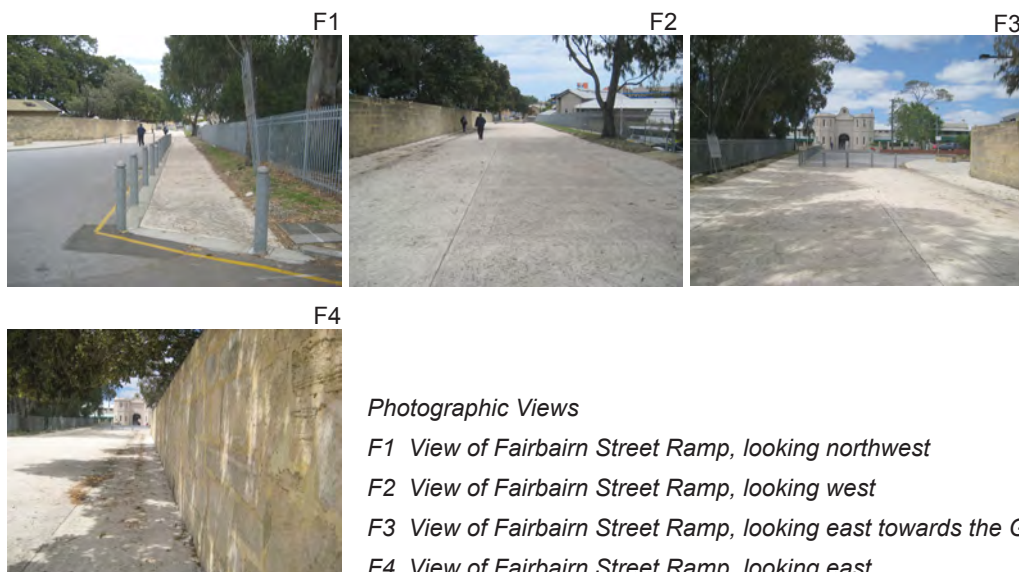
Photographic Views

The lower part of the Ramp at the western end has been removed and comprises a bitumen car park. Limestone stairs and retaining walls have been constructed off the Parry Street bypass, which bisected the ramp. The remaining section of the ramp has been resurfaced in limestone. Large fig trees dominate the southern side of the ramp where it adjoins the Fremantle Oval. Eucalypts dominate the northern bank adjacent to the Parry Street car park.

F1 View of Fairbairn Street Ramp, looking northwest

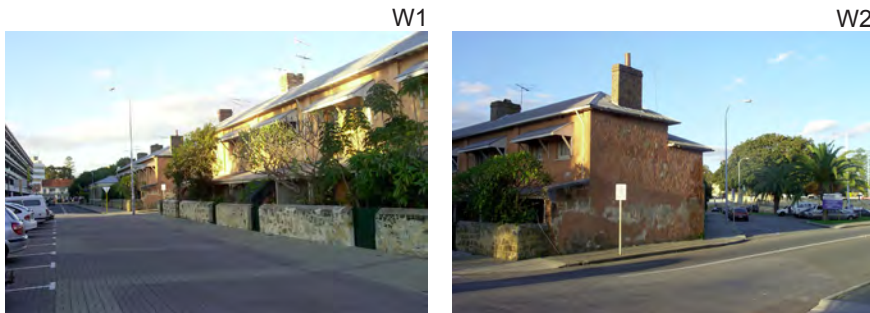
Photographic Views

W1 View of Warder's Cottages, looking northeast
