Watercraft In The old Fremantle Prison Tunnels

Maritime Heritage Site Inspection Report

**Report - Dept. of Maritime Archaeology
WA Maritime Museum, No 191.**

Date of Inspection: 20 February 2004

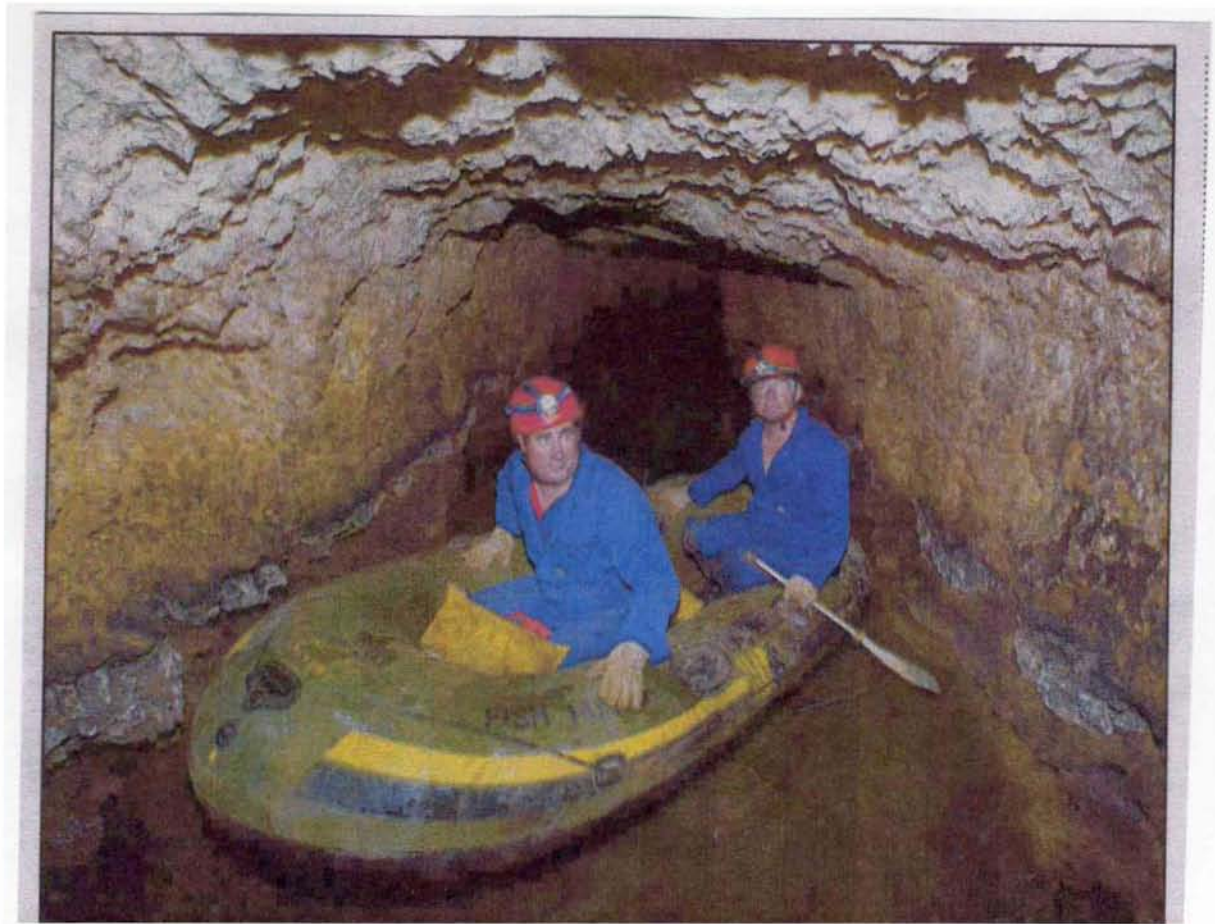
While some of the tunnels were dry others contained varying levels of fresh water. The atmosphere was damp and the relative humidity was considered to be very high. The substrate into which the tunnels were driven appears to be strong, well aggregated porous limestone, which is easily damaged. The water level in the tunnels was relatively low during the inspection period allowing access to some features and cultural materials that are usually difficult to inspect when the water levels are higher. Through-water visibility was surprisingly good allowing objects in the water column to be clearly seen.

Figure 1. Two of the inspection team travelling in the tunnels. (WA Newspapers)

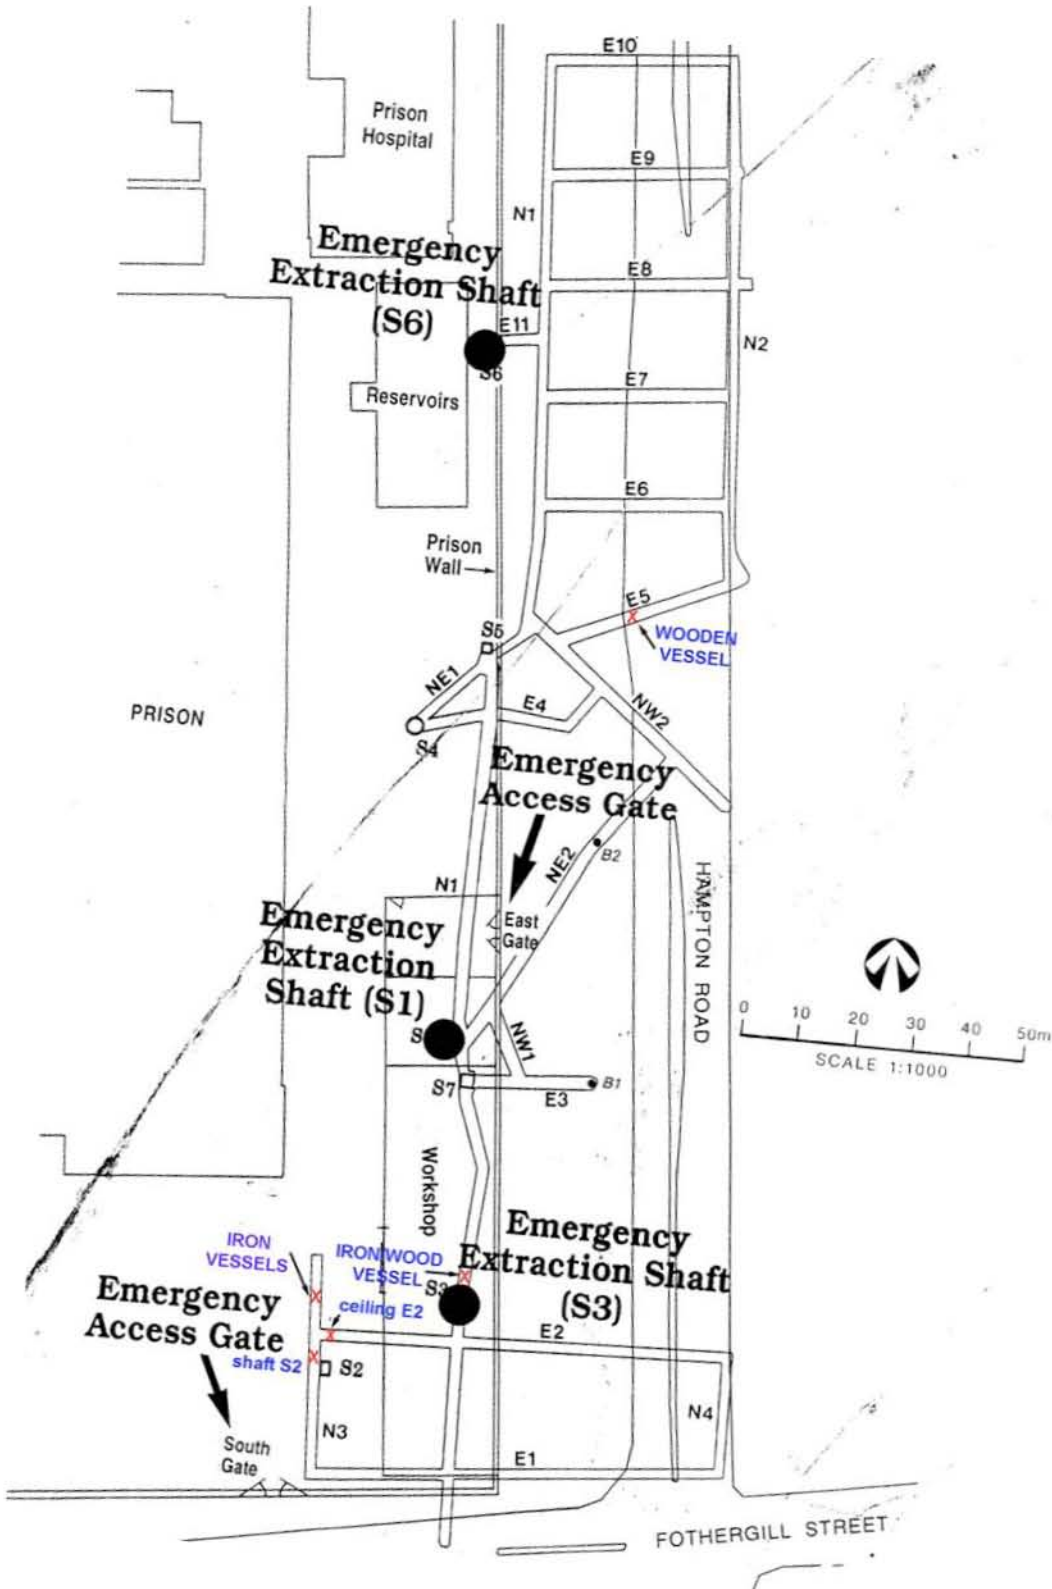
Figure 2. The Dames and Moore plan showing the progress of the inspection team as described below.

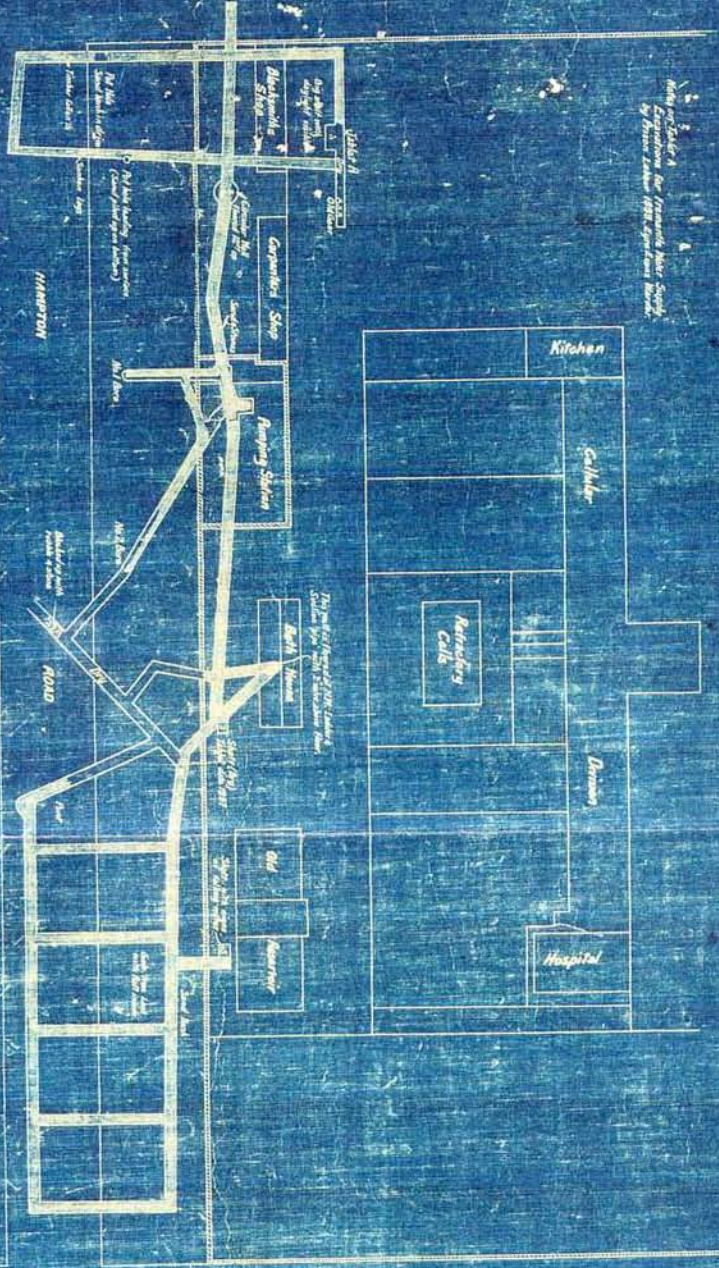
*Figure 1. 1921 Part of Plan entitled: Drives and Shafts at Pumping Station Fremantle.
5/81921.
Scale 50 ft to the inch.*

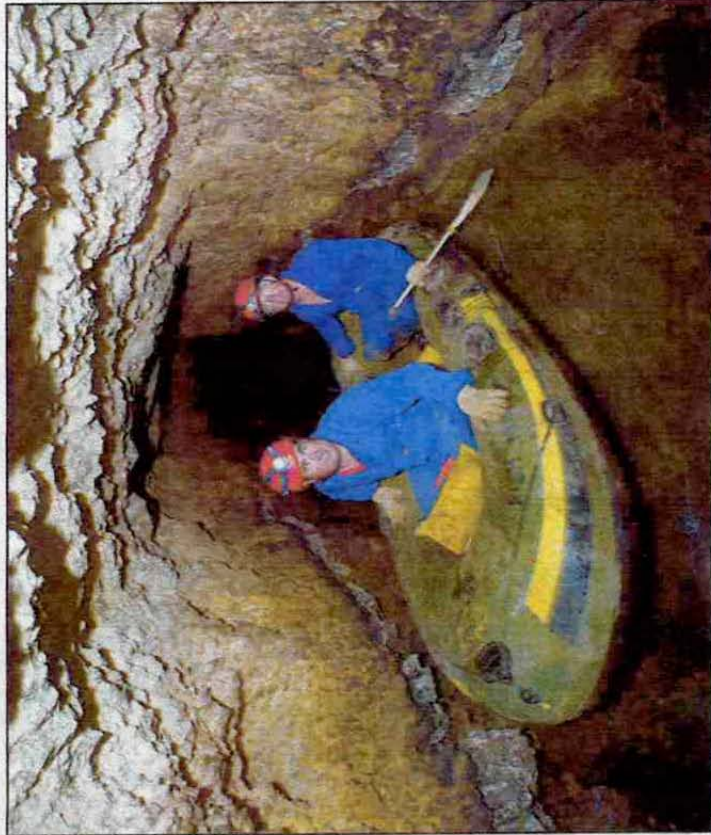
"The tunnels themselves are in terrific condition and they are very stable," Mr Gammie said during a tour of the tunnels in inflatable rafts. The air was damp and humid,

Subterranean system: Visitors will be able to tour the tunnels below Fremantle Prison, above, by climbing down a shaft, below. PICTURES: BARRY BAKER
