Fremantle Prison Bath House Excavation Report | 2014

Jayden van Beek, Stephen Wells and Ross Bertinshaw

Masters of Professional Archaeology Discipline of Archaeology

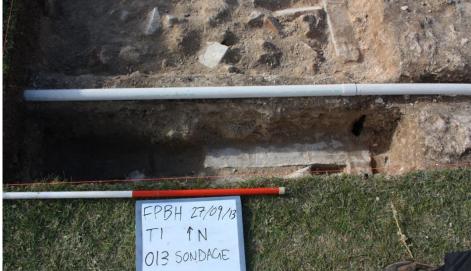
Figure 7: Trench 1 Sondage post removal of demolition layer (013).

The context immediately below (009) was found to contain high levels of structural demolition material believed to be part of the bath structure itself; as such a sondage was sunk in the south west corner of the trench in order to determine (Figure 7):

The sondage was excavated to a depth of 50 cm at which time an in-situ concreted wall feature was located. This sondage was believed to represent the composition of (013) and as such the demolition rubble layer was removed quickly using mattocks, shovels and trowels. Material from this layer consisted of large fragments of demolition material making sieving difficult, and as a result the context was not sieved for artefacts. Once (013) was completely removed the remains of

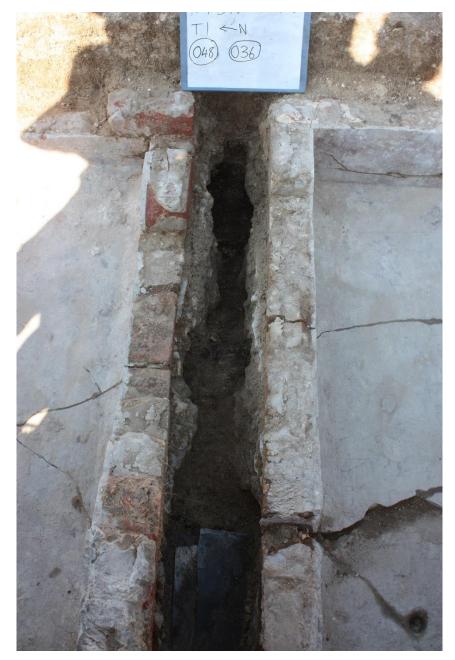
Figure 8: Excavation of fill between baths 027 and 028, with slate plate visible.

The concrete layer (035), situated between baths (027) and (028), was chosen for excavation as there were already segments of the concrete that had cracked and as such it was considered a more appropriate avenue. Removal of the concrete exposed a drainage system lined by wood and covered by slate pieces in the western end while at the eastern end of the baths a wooden feature initially considered remnants of a post were found (Figure 8). Further investigation of the 'post hole' revealed that the wooden feature extended underneath the baths in both directions. Sediment was removed across the entire length of the channel, revealing a combination of timber beams and concrete slabs running underneath the baths. These were interpreted as levelling beams perhaps used in the substantial renovation that would have occurred to replace the original baths with the 20th century baths that remain in situ.

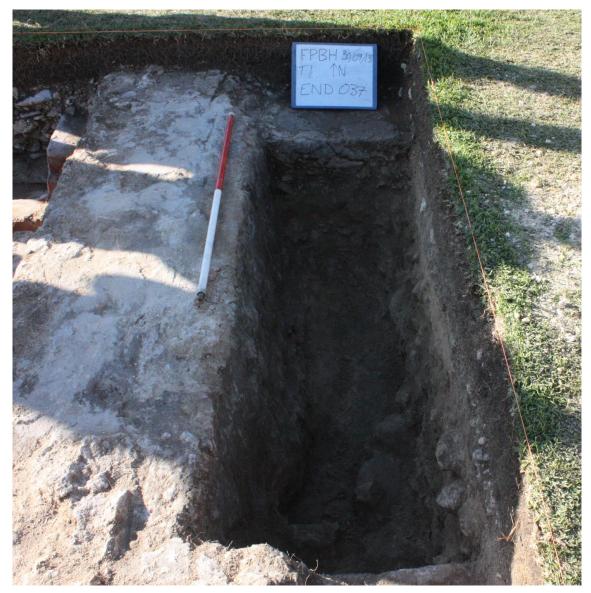
Figure 9: Post excavation of the sterile layer (037)

of the site. Beneath (010) was a layer comprised grey mixed limestone. Excavation of this layer resulted in the discovery of a stone slab believed to relate to the boiler plate (021) and a charcoal patch considered a potential post hole. Investigation of the post hole led to a feathering out of the structure, leading to the deposit being reclassified as remnants of the material used in the boiler. Beneath the grey limestone layer was a loose crushed limestone layer (022), which extended from the bottom of level of the boiler plate. Apart from some metal and brick inclusions, this layer was mostly sterile. (022) could potentially have been used as a levelling floor layer after the walls had been constructed. Excavation of (022) continued during which it transitioned into a compact limestone layer (037), with large chunks of limestone being removed in the process. This layer was completely sterile and interpreted as the eroded foundation layer relating to the wall (Figure 9).

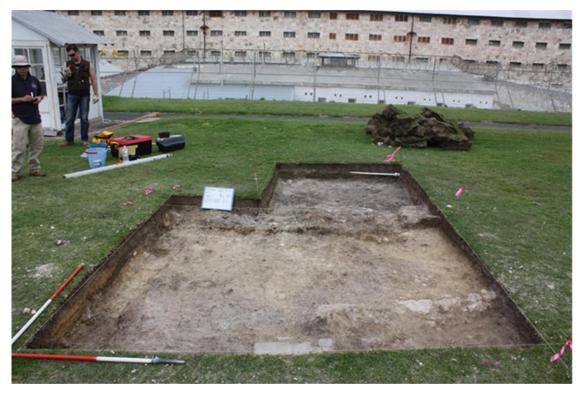
Figure 10: Trench 2 showing main trench with western extension, with both the external and internal walls beginning to show.

The sondage in the initial trench uncovered a large amount of limestone rubble, similar to what had been found in the extension, and along with the exterior wall the west also found an apparent wall near its eastern end as well, in the form of a solid section of limestone, roughly the width of a modern brick (Figure 10). This was thought to be part of an internal dividing wall (033) for the baths, running north-south near the eastern side of the trench. The sondage had shown that there was a clear change in the colour and texture of the limestone and so it was decided to leave the initial trench west of (033) at the level it had reached at the time, (024), and to focus instead on the area of the trench to the east of (033).

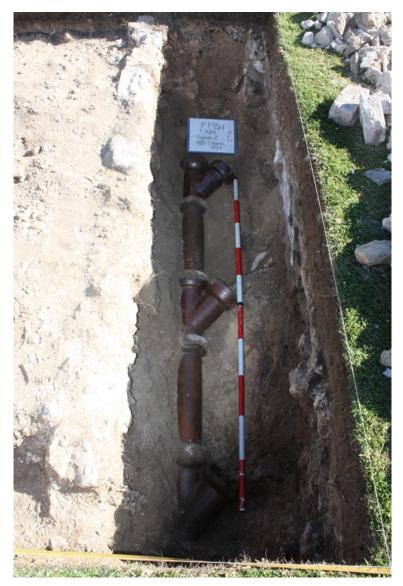
Figure 11: Trench 2 showing ceramic pipe (055) and exterior of the baths along the eastern wall

Context layer (024), followed by (025), in the eastern section were quickly removed with mattocks, removing large amounts of rubble and limestone, along with a few red bricks and some cement pieces. This revealed that the wall continued running north-south for roughly half of the trench (1.5 m), before deteriorating into more rubble. Further investigation of this section also uncovered the brick and cement rendered side of the baths along the eastern side of the trench, similar to what had been found in Trench 1. Following this a length of in situ large ceramic pipe (055) was found at the base of the internal dividing wall, featuring a series of off shooting sections running along its length (Figure 11).

This pipe runs north-south and is the drainage pipe for the baths (Figure 11 and Figure 23).

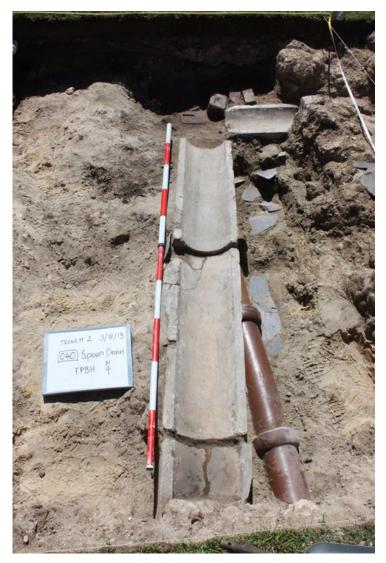
Figure 12: Trench 2 showing the concrete spoon drain overlayed over the ceramic pipe.

On the opposite side of the trench a new 2 m x 1 m extension was placed on the southern end of the initial extension, to bring Trench 2 to a total size of 5 m x 3 m. This new extension was quickly brought down to the same level as the previous extension, in the process finding the continuation of the concrete spoon drain (040) uncovered previously. Originally coming straight out from the wall, the drain then turned south and continued to the southern edge of the new extension. Further investigation of this drain revealed that it overlayed a cut (058) running along the base of the external wall), which contained a ceramic pipe (059), similar to what had been found over on the eastern edge of the main trench (Figure 12).

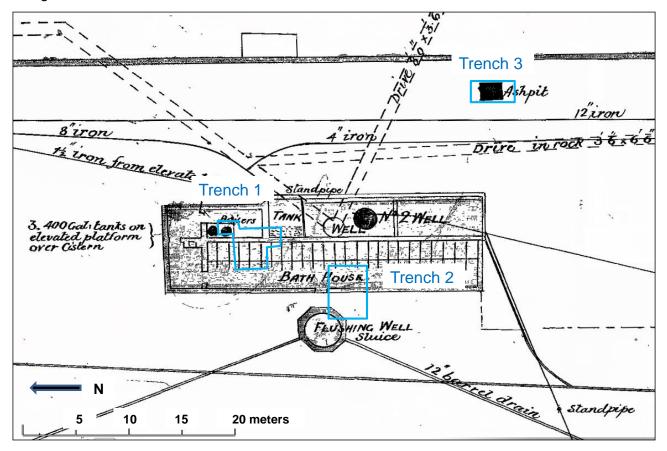
Figure 13: Trench locations compared against old bath house plan.

Figure 13 shows the locations of the trenches against an old Bath House plan. Bavin (1994:359) quoting British Parliamentary Papers gives the dimensions of the Bath House as 27.4 m x 5.2 m. Based on scaling dimensions off the plan in Figure 13 the size of the Bath House is estimated at 28.6 m x 8.4 m. The difference in lengths is reasonable within expected order of accuracy but there is obviously a substantial difference in the widths which cannot be explained by plan stretch or other likely errors. It is not clear whether this is due to a change in design or whether they were only considering the width of the bath area itself. If you only measure between the west external

wall and the internal wall separating the baths and service area, then the width is about 5m. As discussed below the excavations confirm the design in Figure 13 and basic dimensions scaled from it.

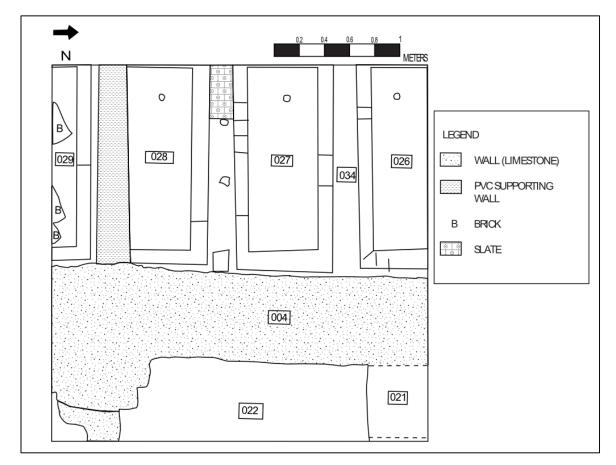
Figure 14: Trench 1 Main Structural Features.

Figure 14 shows the main structural features in Trench 1. The first context below the sand was 004 a large limestone wall running north south and the wall between the baths to the west and service area with the boilers and water tank to the east. It is about 0.7m wide and with an extension to the trench in the south, 4 m of the wall were uncovered.

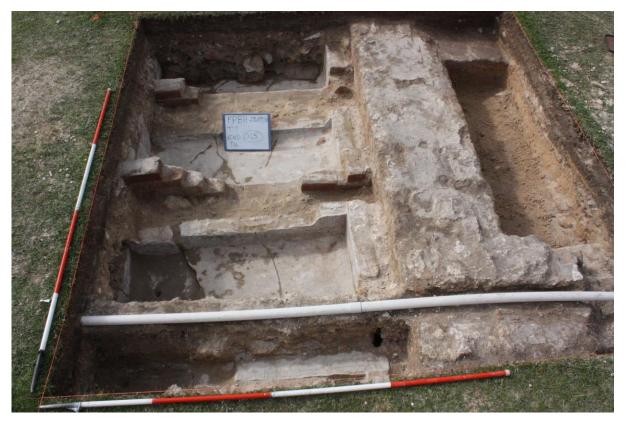
Figure 15: Trench 1 showing the baths and internal wall separating the service area.

Figure 15 is a photograph looking north showing the baths and the internal limestone wall 004. Figure 16 shows the trench and baths looking east and gives a good sense of the size and how the prisoners might have sat in them. The two figures also show a white PVC water reticulation pipe. As noted by Bavin (1994:366) this system was put into place in the late 1980's to water the lawn.

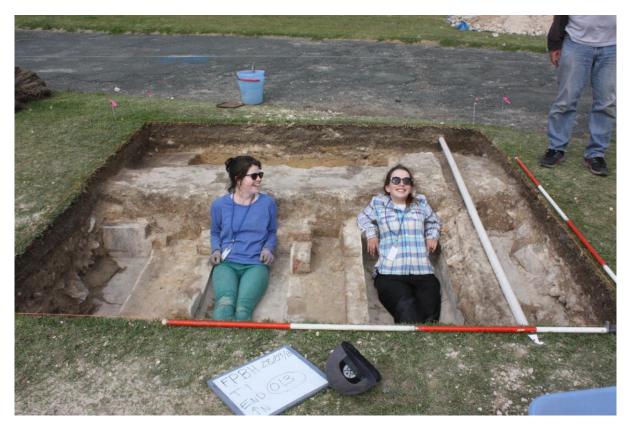
Figure 16: Trench 1 looking east giving sense of size of individual baths.

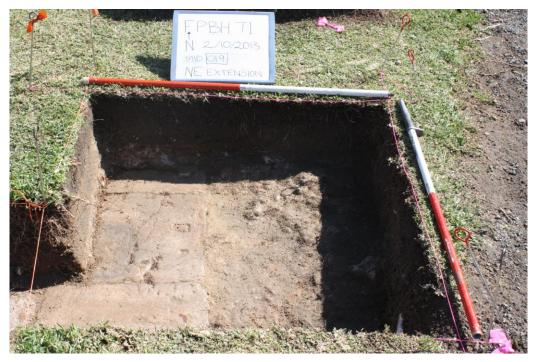
Figure 17: NE extension in Trench 1 showing the boiler floor.

To the east of the limestone wall 004, part of the service area was uncovered. Feature 021 contains limestone slabs and a circular burnt patch suggests that these were the base for the boilers. Figure 17 is a picture of the NE extension to Trench 1 showing some of the floor slabs of the boiler room. A slight darking of the floor also possibly shows where a boiler once stood.

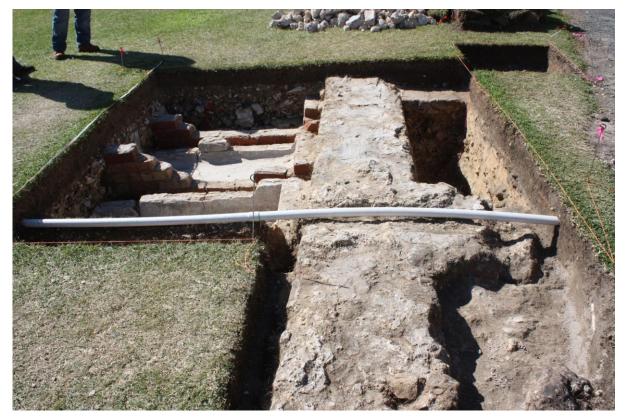
Figure 18: Trench 1 looking North showing internal north-south wall and baths.

An extension of Trench 1 to the south was made to follow the limestone wall further and show the return wall better. Figure 18 shows Trench 1 looking north. The return wall running to the east off (004) is probably the wall between the boilers and water tank which can be also clearly seen in Figure 19, confirming that basic design shown in that plan.

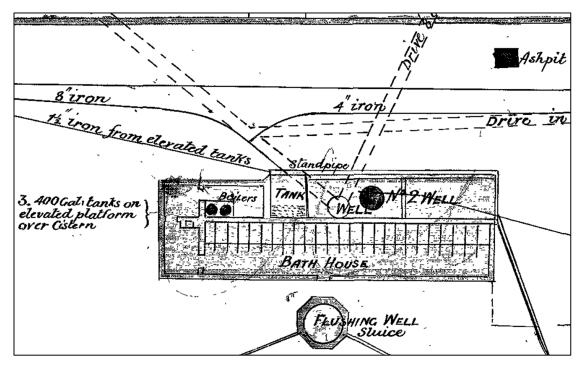
Figure 19: Old plan showing boilers and return wall.

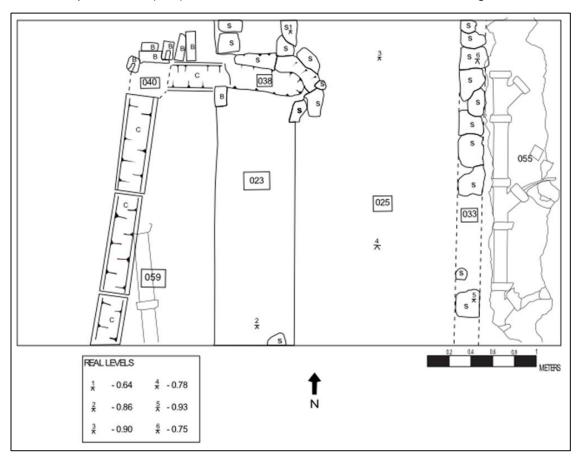
Figure 20: Main structural features in Trench 2.

Figure 20 shows a plan of the main structural features in Trench 2. Feature 023 is the external western limestone wall of the Bath House. The break through the walls northern end was interpreted as being a means of draining water from the interior surface of the bathhouse. The concrete spoon drain (040) is seen as the continuation of the drain through the wall.

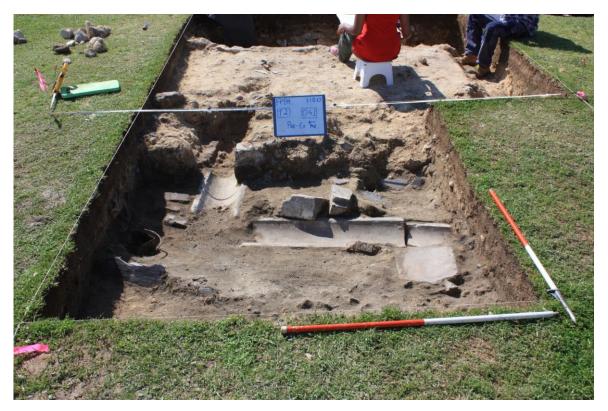
Figure 21: Trench 2 looking east showing concrete drain and external wall.

The drain runs to the west away from the break for 0.5 m before turning to the south, as seen in Figure 21. Under the drain is feature (059), a ceramic pipe that runs north-south (Figure 22). This appears to be the 6" drainage pipe, shown in the post 1900 Fremantle Prison Sewage Plan, which takes the waste water from the bath house and then east towards the main cell block (Figure 23). It must have been at this time that the drainage system of the Bath House was upgraded with the water no longer going to the Flushing Well.

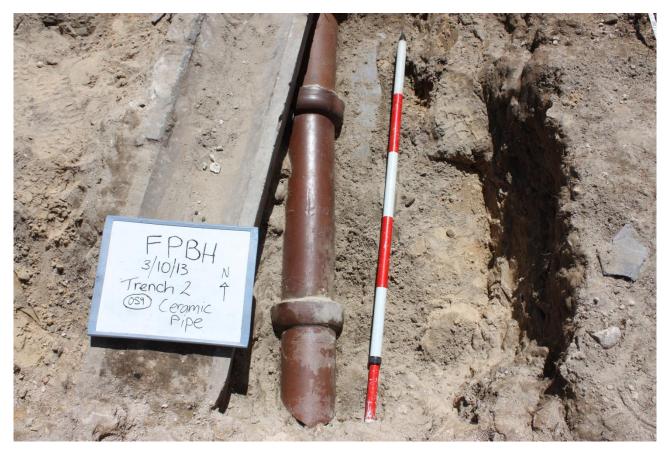
Figure 22: Trench 2 showing the ceramic pipe beneath the spoon drain.

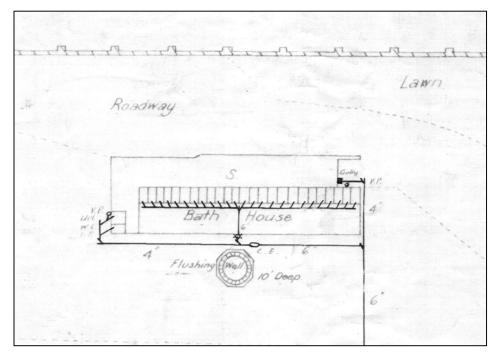
Figure 23: Bath House drainage from post 1900 sewage plan.

The Ash Pit shows up on the a number of the 19th century maps including the 1899 Penal Commission Plans however by the early 20th century, a post 1900 plan of the Fremantle Prison sewage system (Figure 23) shows a roadway and lawn in the area so by this time the Ash Pit is likely to have been closed off. The depth of the pit is only about 0.85 m to the limestone bedrock so the capacity to take actual ash from the boilers in the area would not have been large. As it is, only small amounts of charcoal were found and there appeared to be no continuous layer of ash/charcoal in the pit. It is possible it was only used as an interim holding location with the ash being used on the gardens around the prison as required. When the pit was finally grassed the opportunity may have been made to get rid of other waste. An analysis of the artefact dating range may shed more light on this.

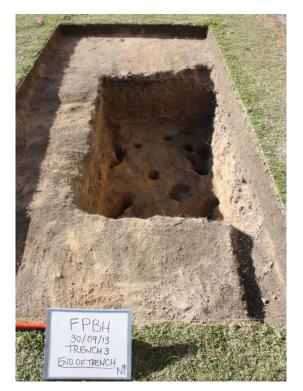
Trench 3 aimed to uncover the Ash Pit and Figure 24 is a photo showing the final excavation. Figure 25 is a plan of the contexts after removal of the initial layer 001.

Figure 24: End of excavation in the Ash Pit (Trench 3).

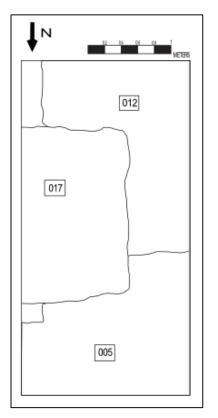
Figure 25: Plan of Trench 3 showing contexts.

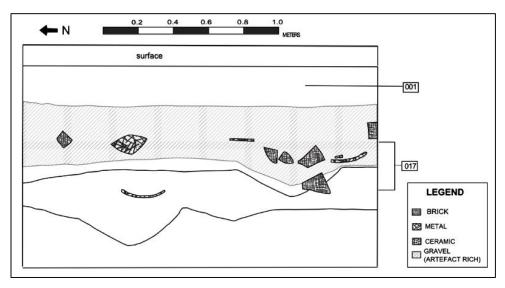
Context 017 is the fill material within the Ash Pit. It is a loose fill with a mixture of sand, limestone rubble, brick and artefacts. The top half of the fill is artefact rich with the density of artefacts decreasing as the limestone bedrock is reached. The total depth of the pit is about 0.85 m. The material above the pit is sandy yellow fill in the north with a dark grey fill mixed with gravel and charcoal towards the south.

Figure 26: Section on east side of Trench 3 and context 017.

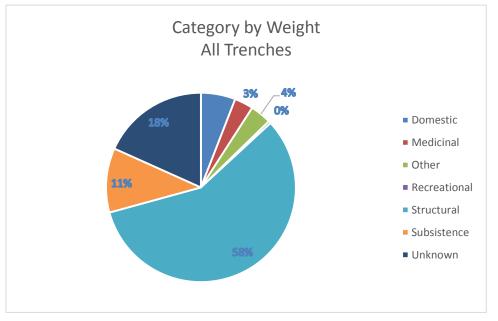
Table 1 and Figure 27 summarise the weight of artefacts collected by function and trench. A more detailed table including material type and context is included as an Excel file in the digital data and

Figure 27: Artefact Function by Weight

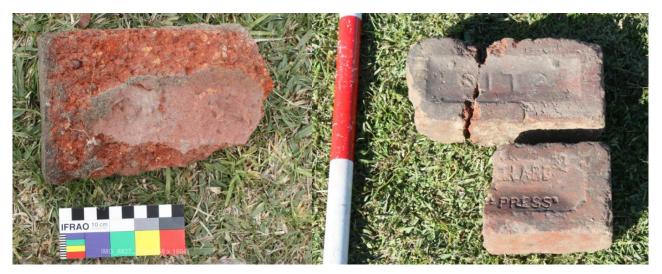
Figure 28 shows on the left a handmade brick with finger imprint and to the right a machine made brick. The handmade brick would have been convict made and was probably part of the initial bath house constructed around 1858. The machine made brick would have been used as part of the upgrade or maintenance of the Bath House after about 1880. Bavin (1994:364) has also noted these two brick types demonstrating a number of phases in the Bath House development. This was also shown by the later ceramic piping used to upgrade the drainage from the Bath House.

Figure 28: Left - Handmade brick – Right- machine made brick.

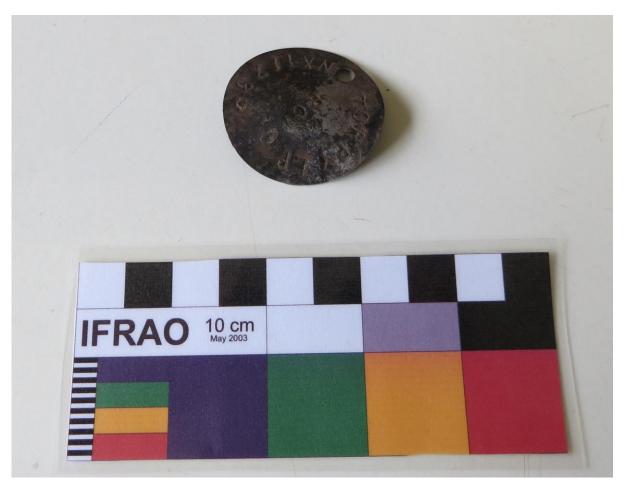
The disk shown in Figure 29 has inscriptions on both sides and a hole for a cord so that it can be worn around the neck. The inscriptions on the front are "TORPY LP" "RC" "NX1173" and on the reverse "O4". This is respectively the surname and initials, religious affiliation (Roman Catholic) and army service number. It is not known what the inscription on the reverse represents though it could be blood type.

Figure 29: Military Identity Disk

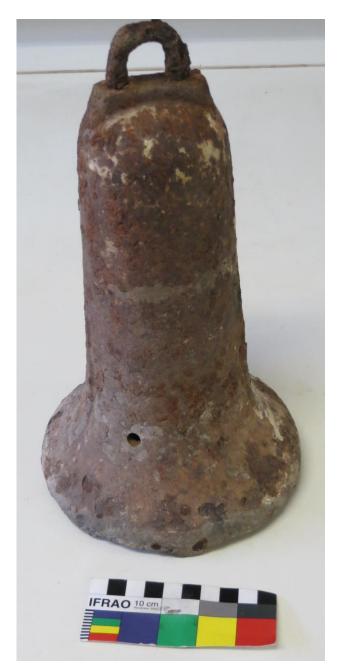
This bell like artefact was found in Trench 2 context 018 so was probably part of the Bath House demolition. It looks like a bell but has no clapper internally or even a loop for a clapper to be attached to. It is made of cast iron and is 27.5 cm high and 15 cm wide at the flange. It is thick and very heavy. A small hole is located near the bottom flange of the artefact (Figure 30). A metal bolt was also found nearby and may have been used as a striker. When struck it does make a ringing sound but not particularly loudly.

It would appear that this artefact has been adapted as a bell, maybe to ring when it was time to get out of the baths or sound when they were ready. However what it was initially is still a mystery. Suggestions have been as a counter weight for a door or as a part of a pressure relief valve on a boiler such as were in the Bath House.

Figure 30: Bell

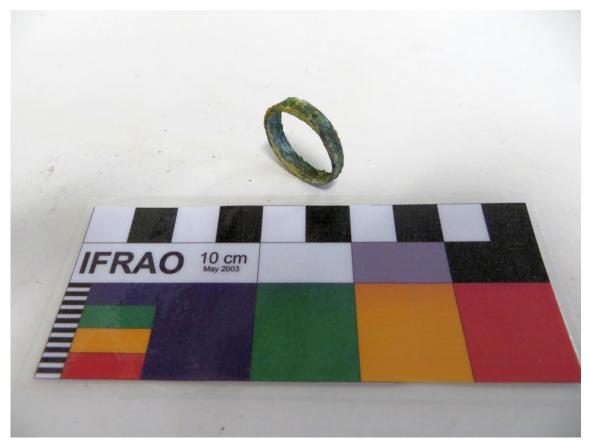
A small corroded copper ring 20 mm in diameter and about 4mm wide was found in Trench 1 context 042 (Figure 31). This is the fill of the drainage structure under the baths. So it could have been lost during construction by a worker.

Figure 31: Wedding Ring

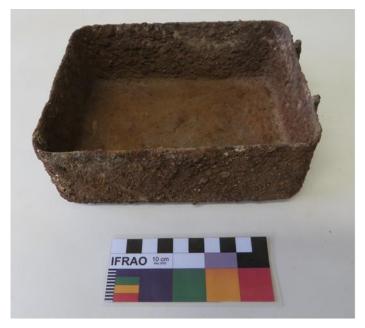
A metal food container was found in Trench 2 context 041 which was mixed fill located under the surface contexts west of the external wall. It is possible it was lost during the installation of the new drain system.

It appears to be a standard military/prison food container (Figure 32).

Figure 32: Food Container
