FREMANTLE PRISON ARCHAEOLOGY

HISTORICAL ARCHAEOLOGICAL ASSESSMENT OF  
HAMPTON ROAD RESERVE AND THE REAR OF  
HENDERSON STREET COTTAGES

JACK McILROY  
DEC. 1989

Report Prepared for the  
Building Management Authority of Western Australia,  
Fremantle Prison Project

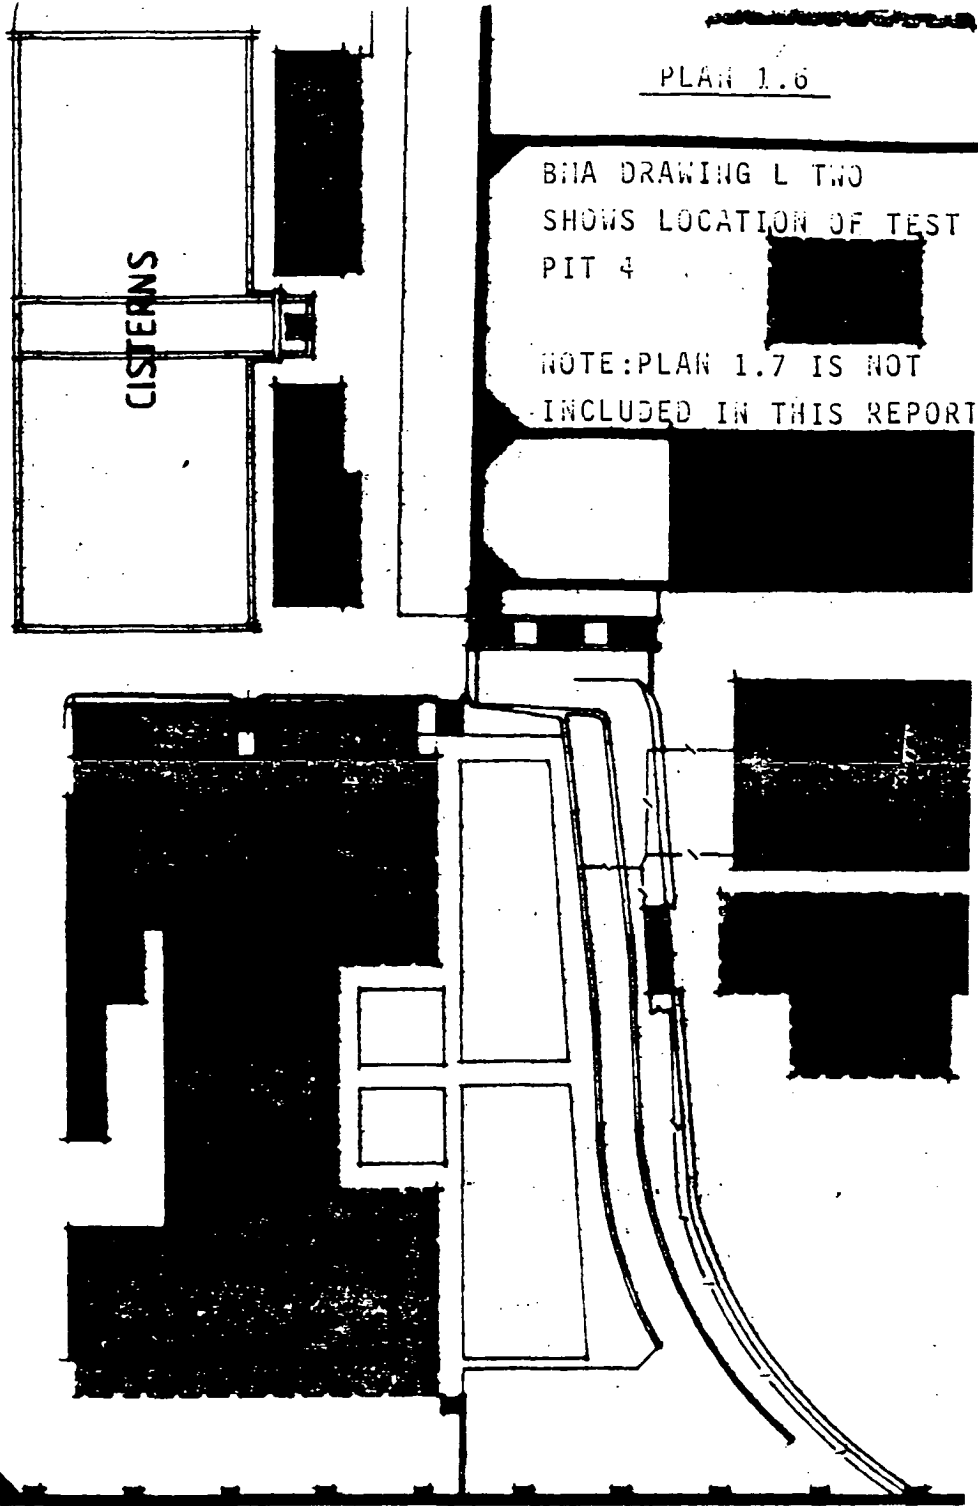
BIA DRAWING L TWO  
SHOWS LOCATION OF TEST  
PIT 4

TP4

APPROXIMATE LOCATION  
OF FUEL LINE

HISTORIC SITES  
APPROXIMATE  
EXTENT OF  
NEW EARTH MOUND

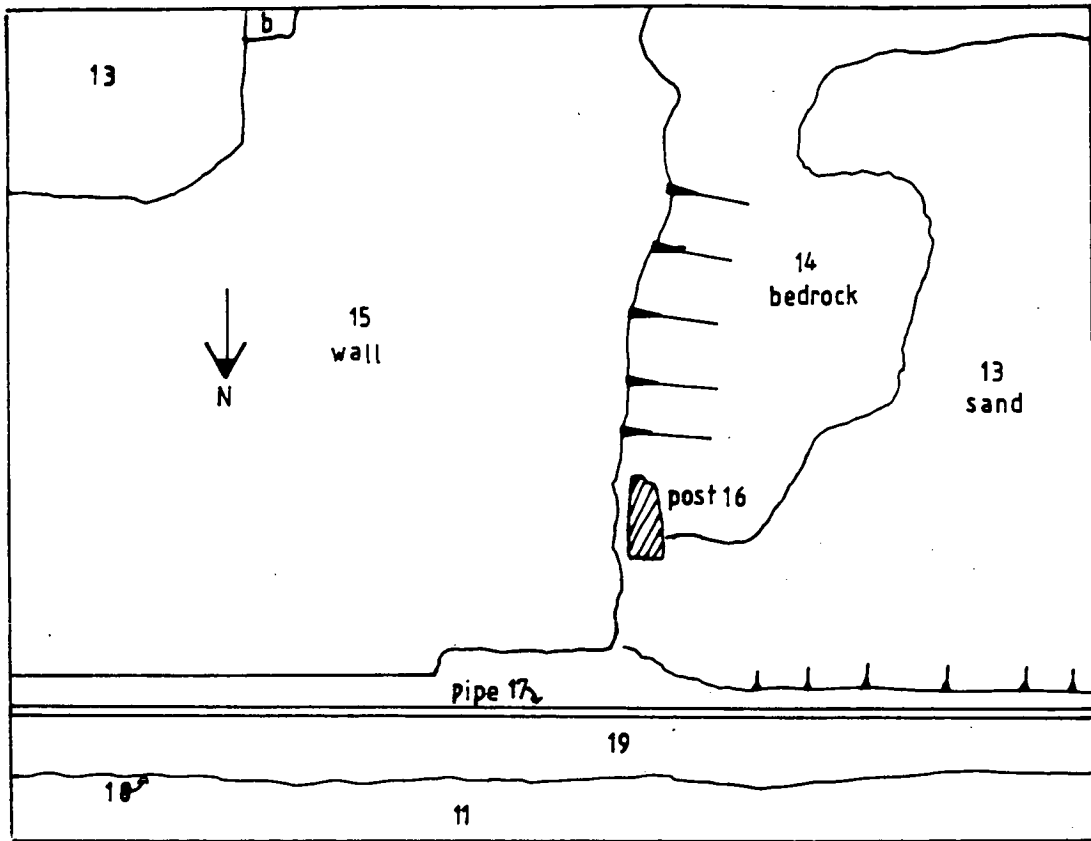
89 HMP  
TEST PIT 1

Plan

sections

- 3.3.4** At the bottom of the test pit lay bedrock 14 containing pockets of natural yellow sand 13. The bedrock has been cut to form wall foundations 15 rather than the foundations having been set separately on the bedrock. The foundation corner is visible rising no more than 12 cm high and varying from a maximum of c. 95 cm wide on the northern foundation to c. 77 cm wide on the western.

- 3.3.5** The internal foundation corner shown by excavation is c. 50cm further south than indicated on PWD 17271. However the PWD plan presumably shows standing walls rather than foundations which could help account for the difference.

- 3.3.6** Remains of a verandah post 16 lie along the west face of wall 15 as indicated on the PWD plan. The somewhat decayed post is 13cm long by 7 cm wide and at least 18 cm high disappearing into sand 13. The post and foundations represent all the structural remains of the warder's quarters.

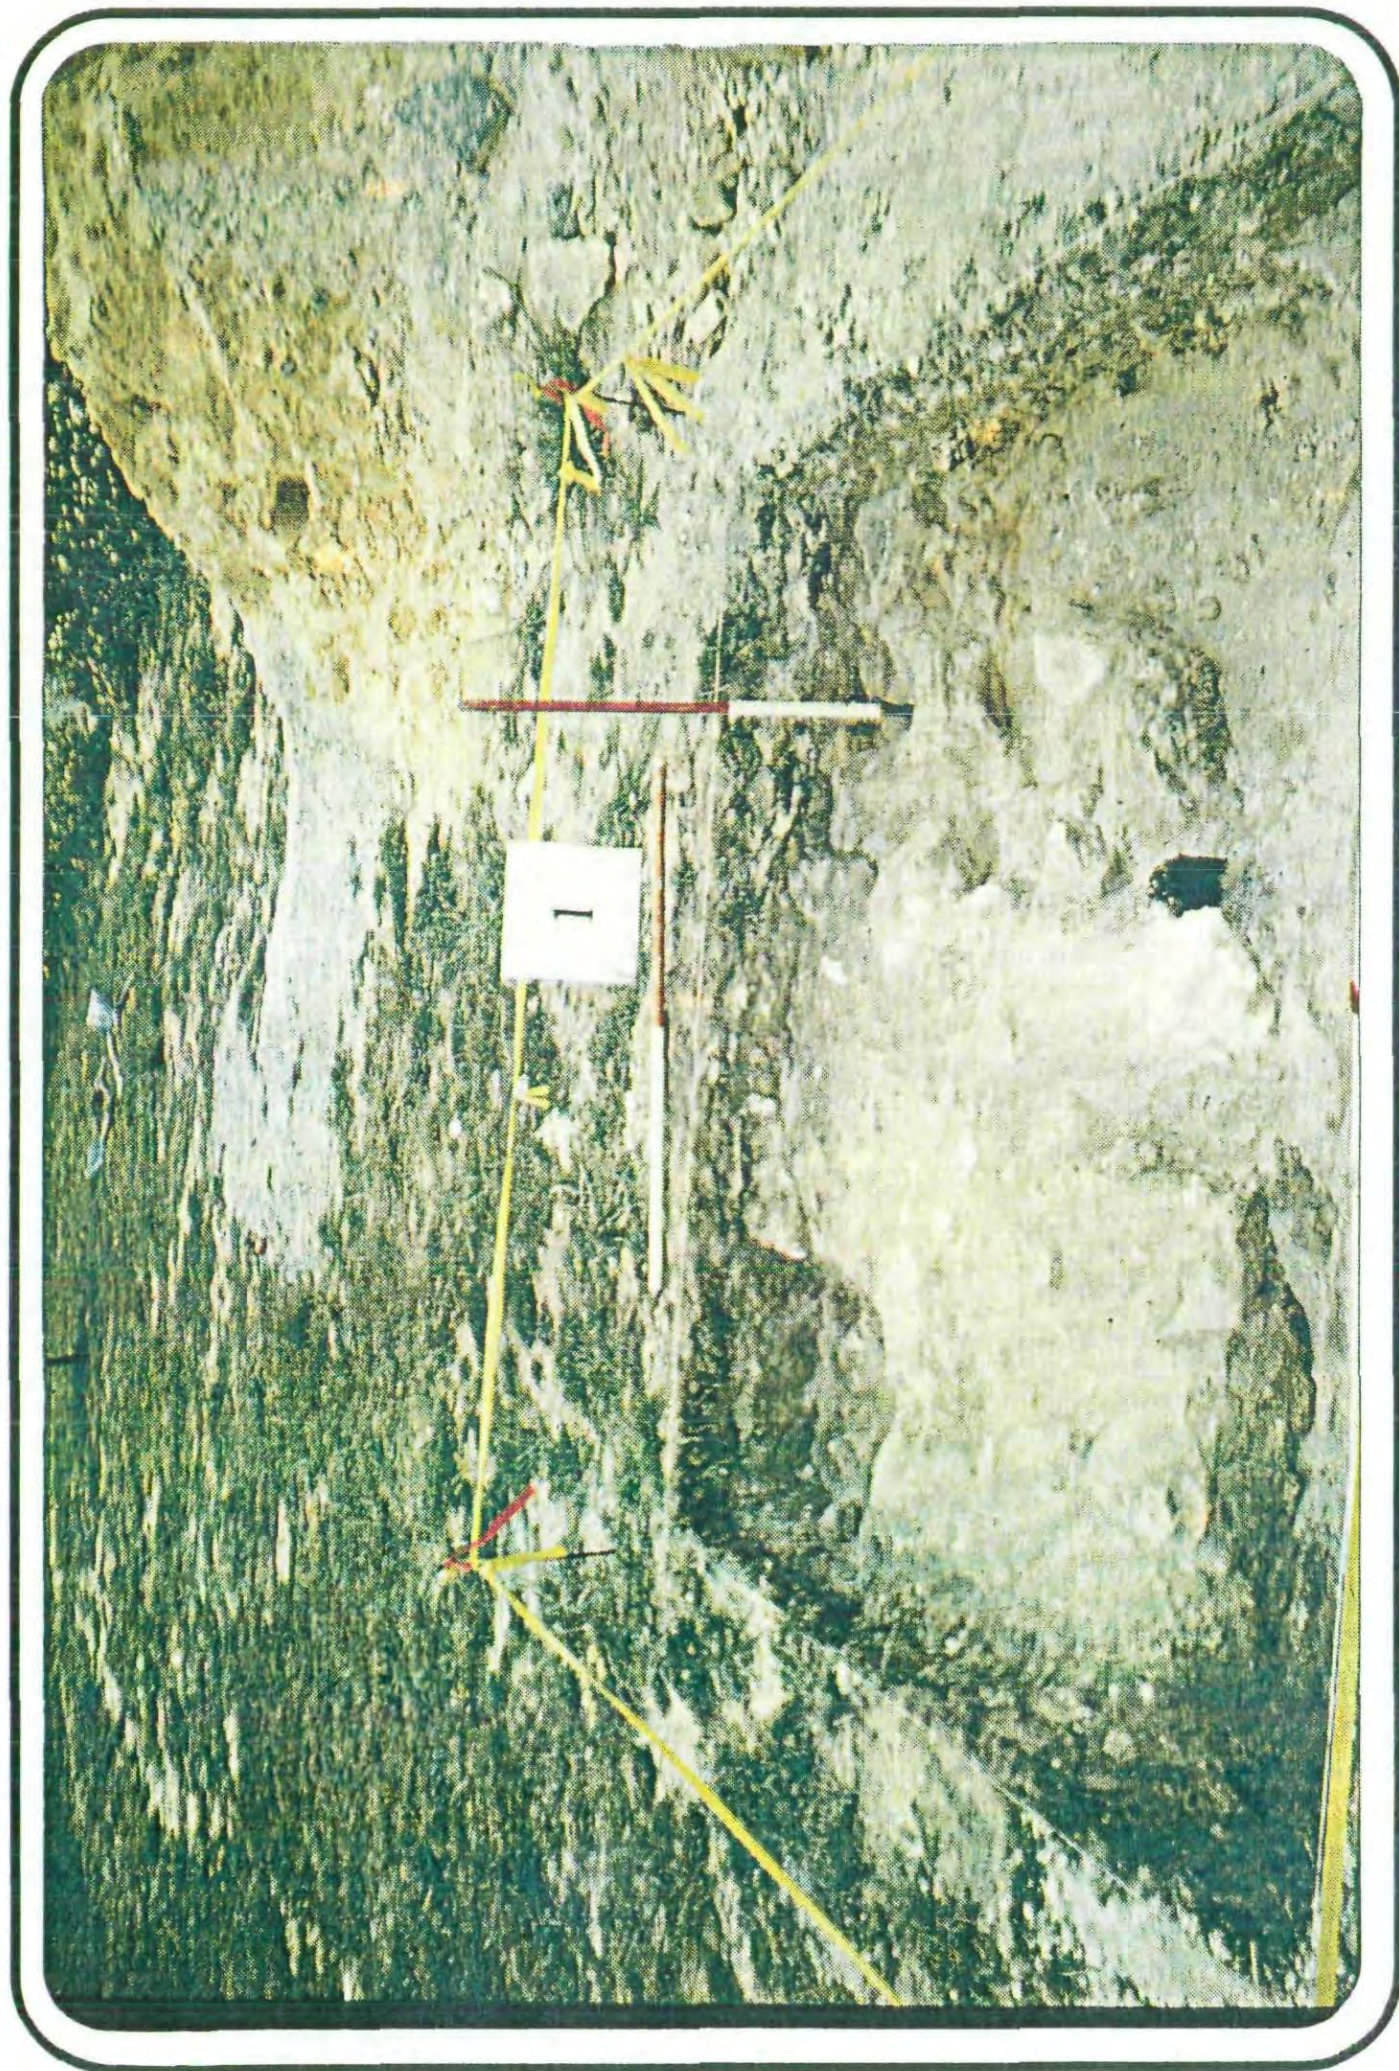
FEST PIT 1, BUILDING CORNER AND VERANDAH POST, VIEW S

- 4.1.7.** The wall foundations have been formed from cut and worked bedrock as seen in test pit 1.
- 4.1.8.** Corrugated or galvanised iron or tin sheeting as found in test pit 2 has been used probably for roofing material and possibly for some rear walls.

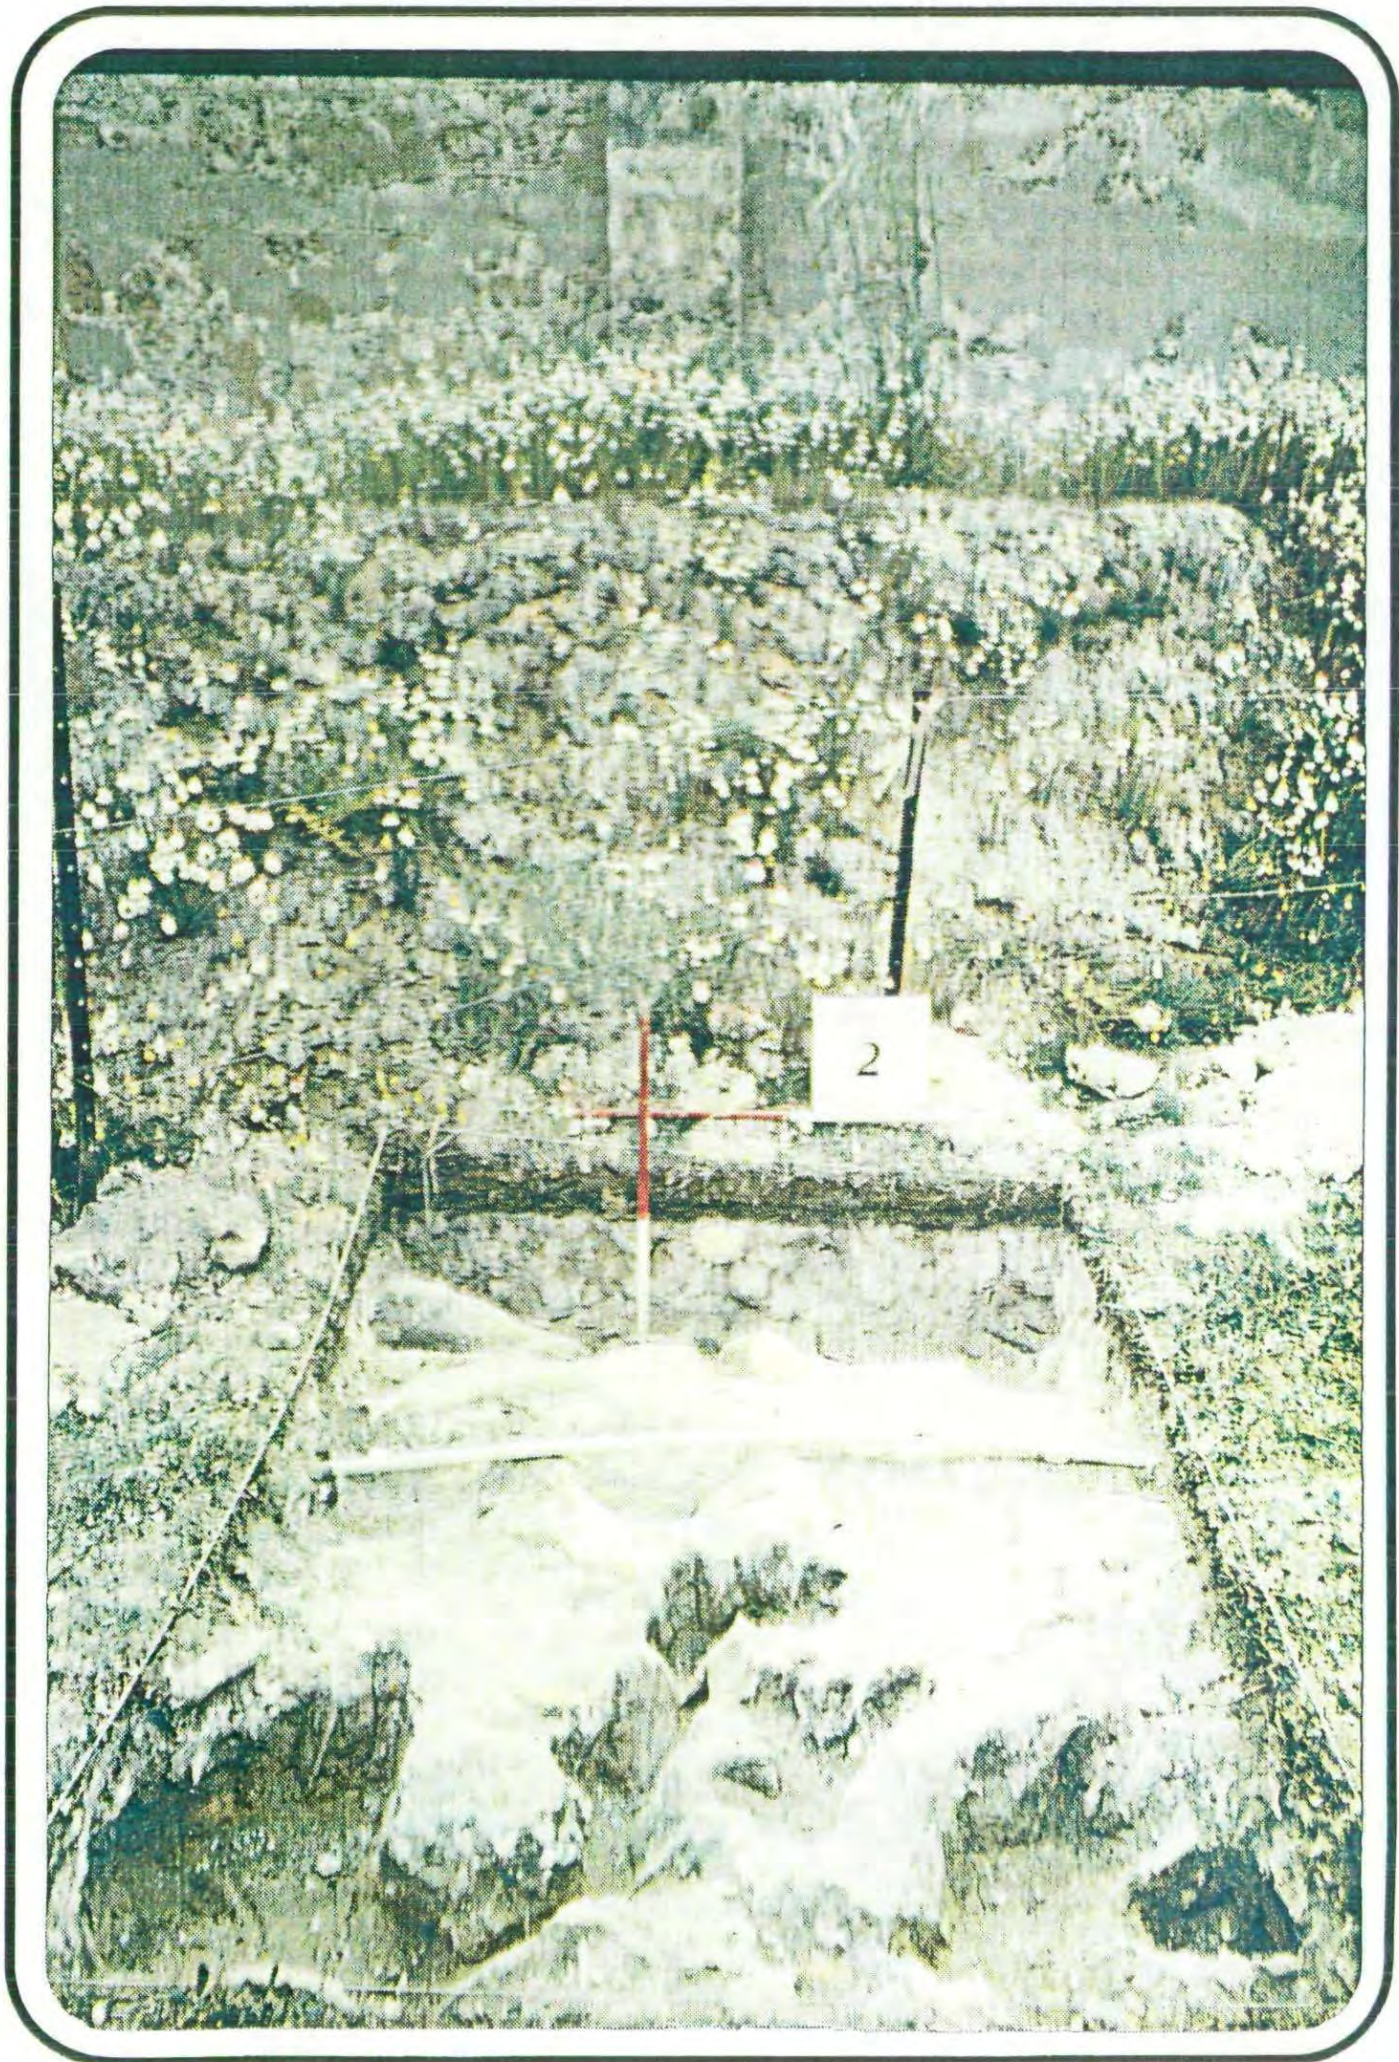
TEST PIT 2, BEDROCK, VIEW W

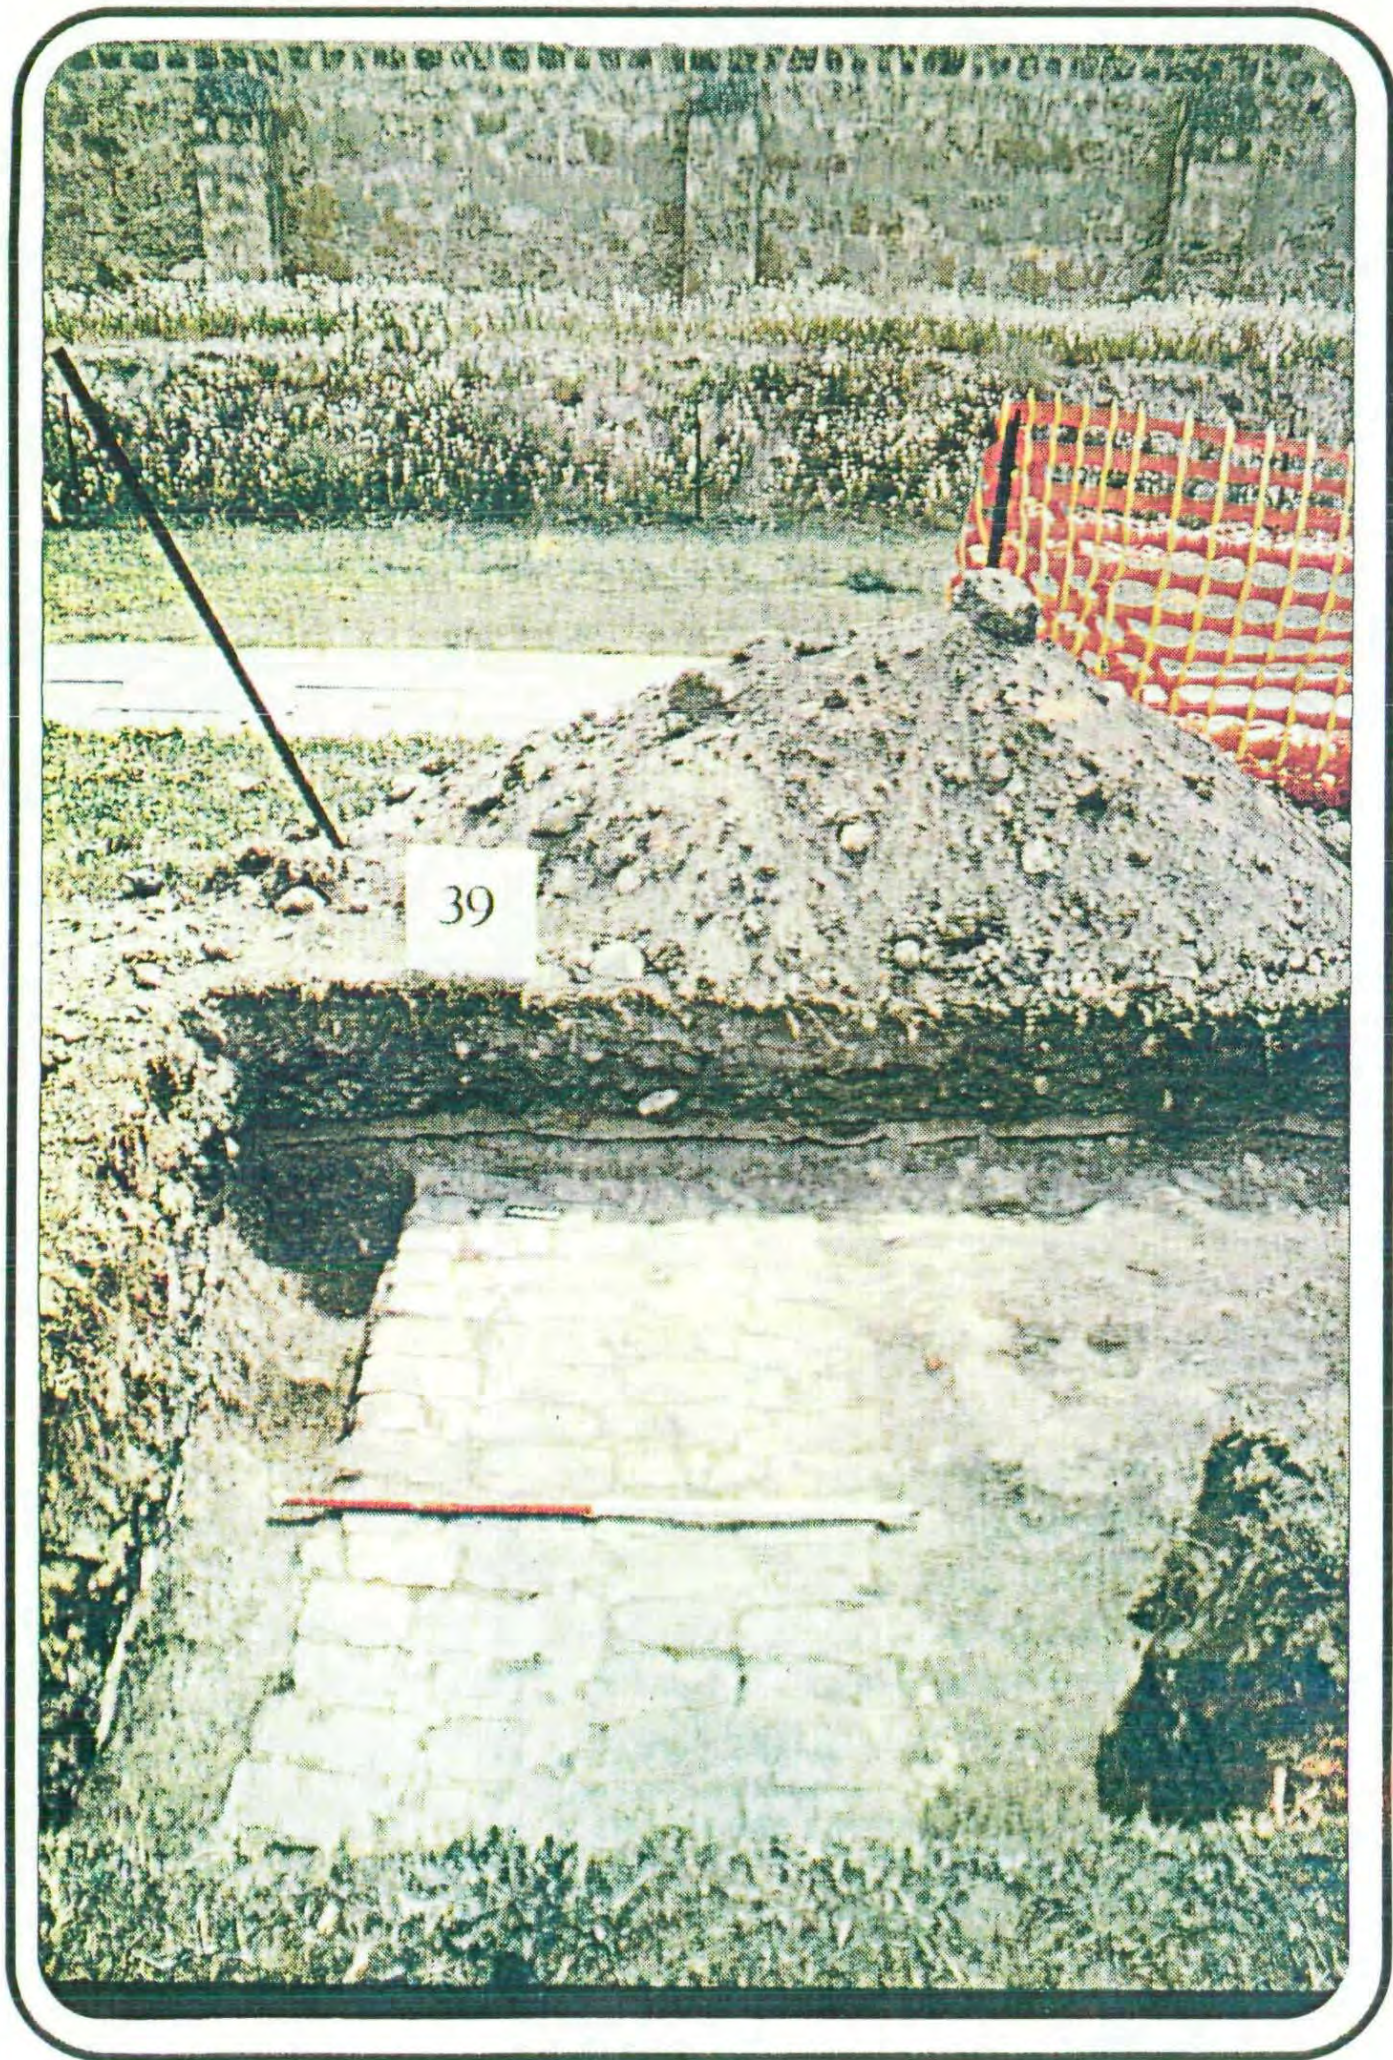
TEST PIT 3, BRICK PATH, VIEW W

- 4.1.13.** It is possible that this footpath would rapidly deteriorate if exposed to the elements.
- 4.1.14.** The brick footpath would be an isolated interpretive element located outside the prison walls in an area which would presumably have low visitor impact.

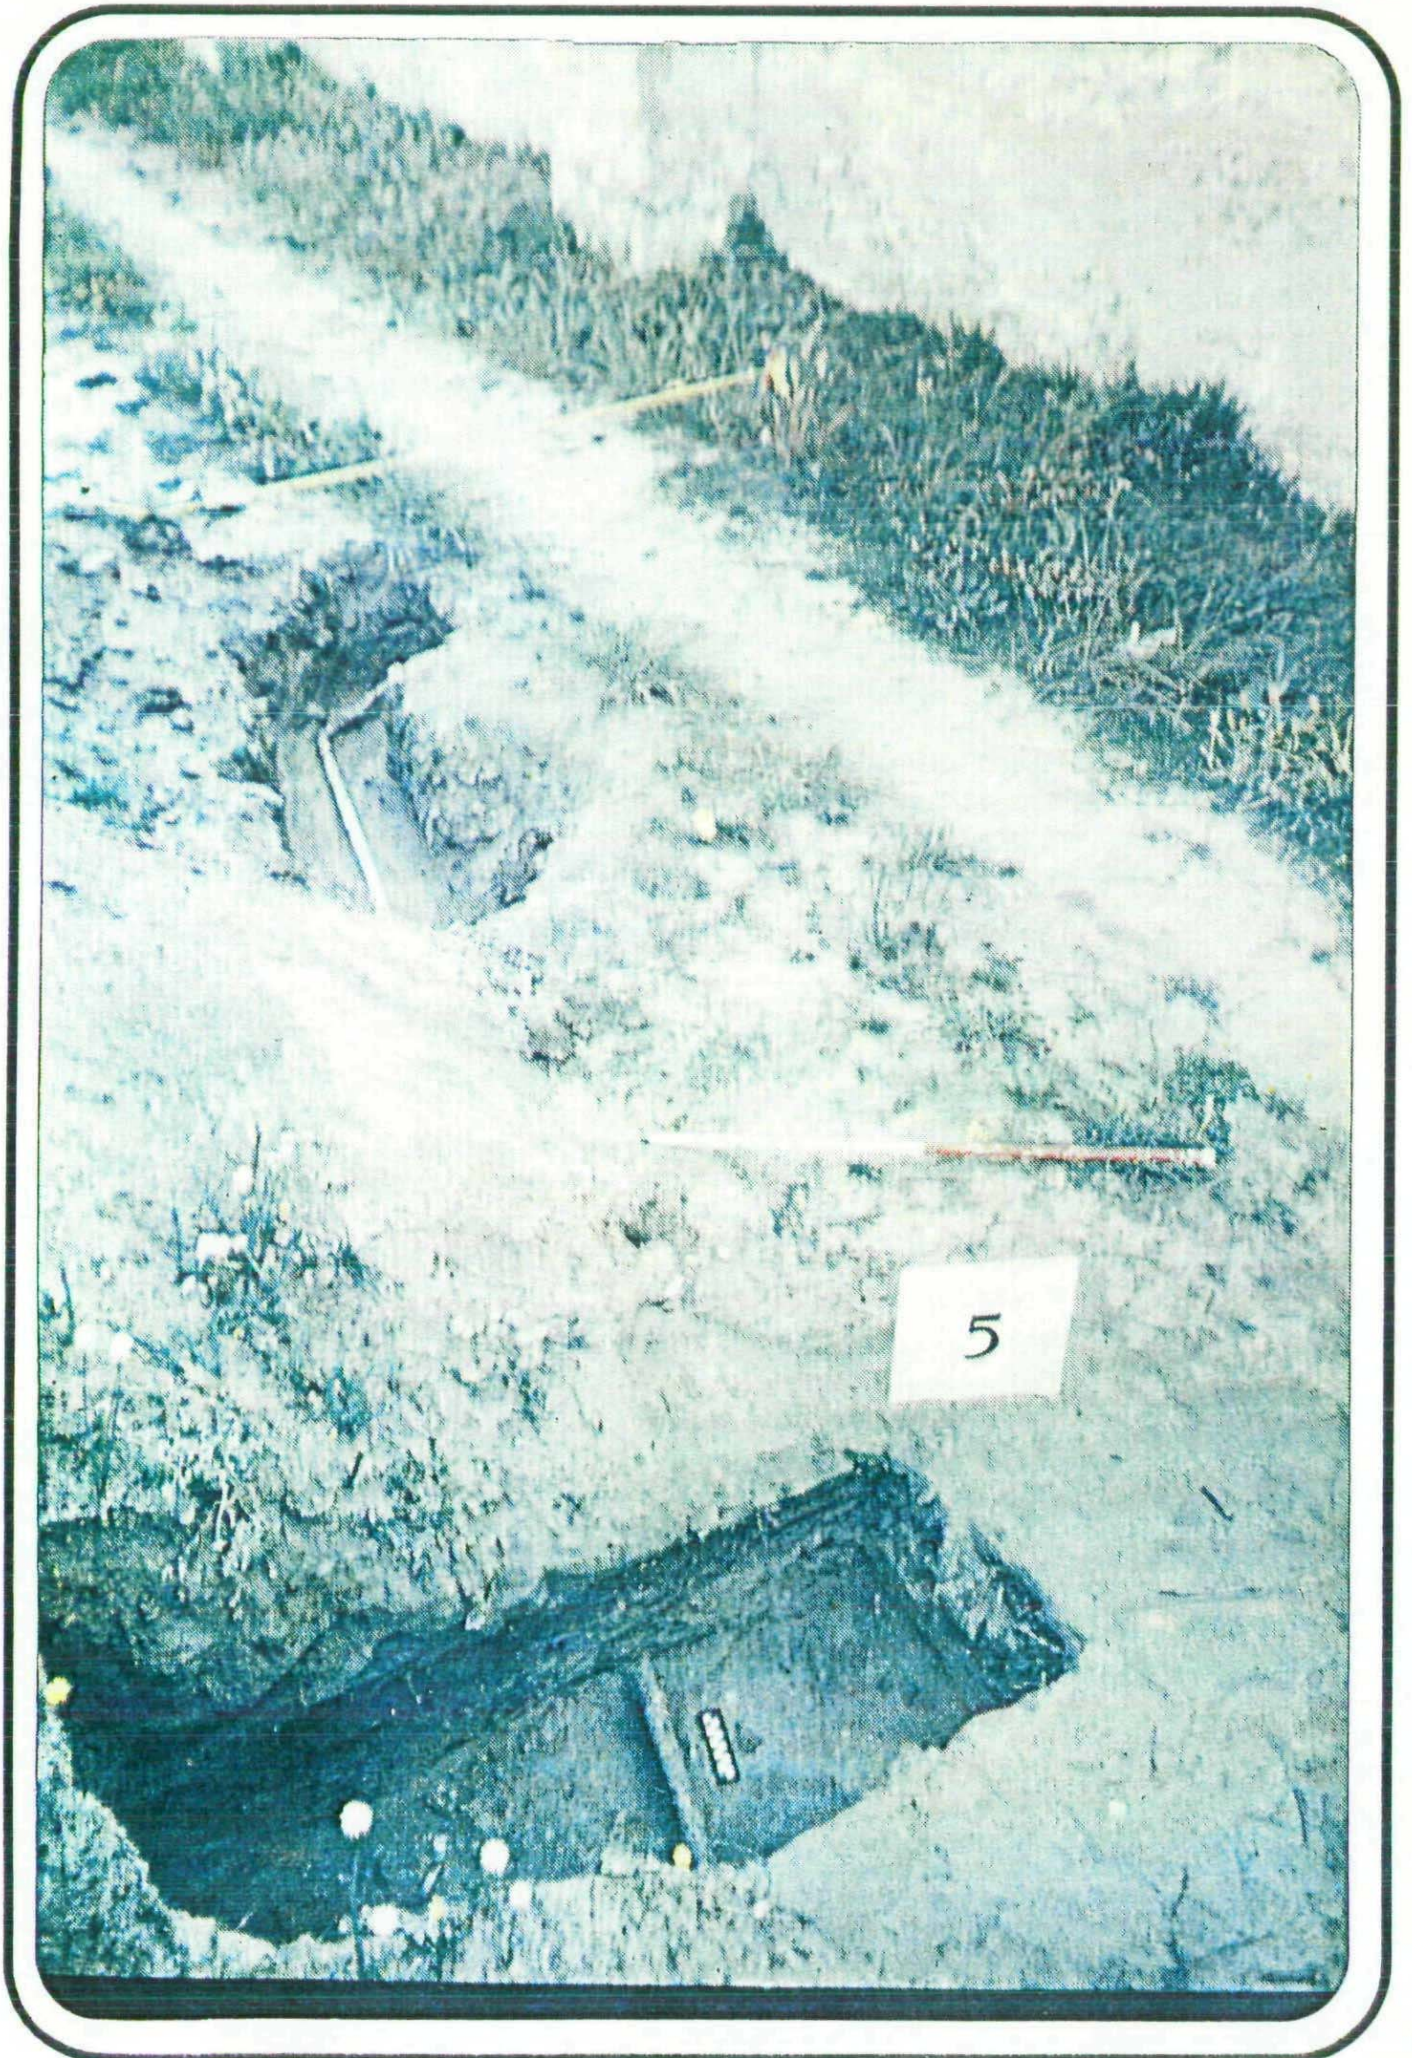
TEST PITS 5 AND 6, PIPES, VIEW SW

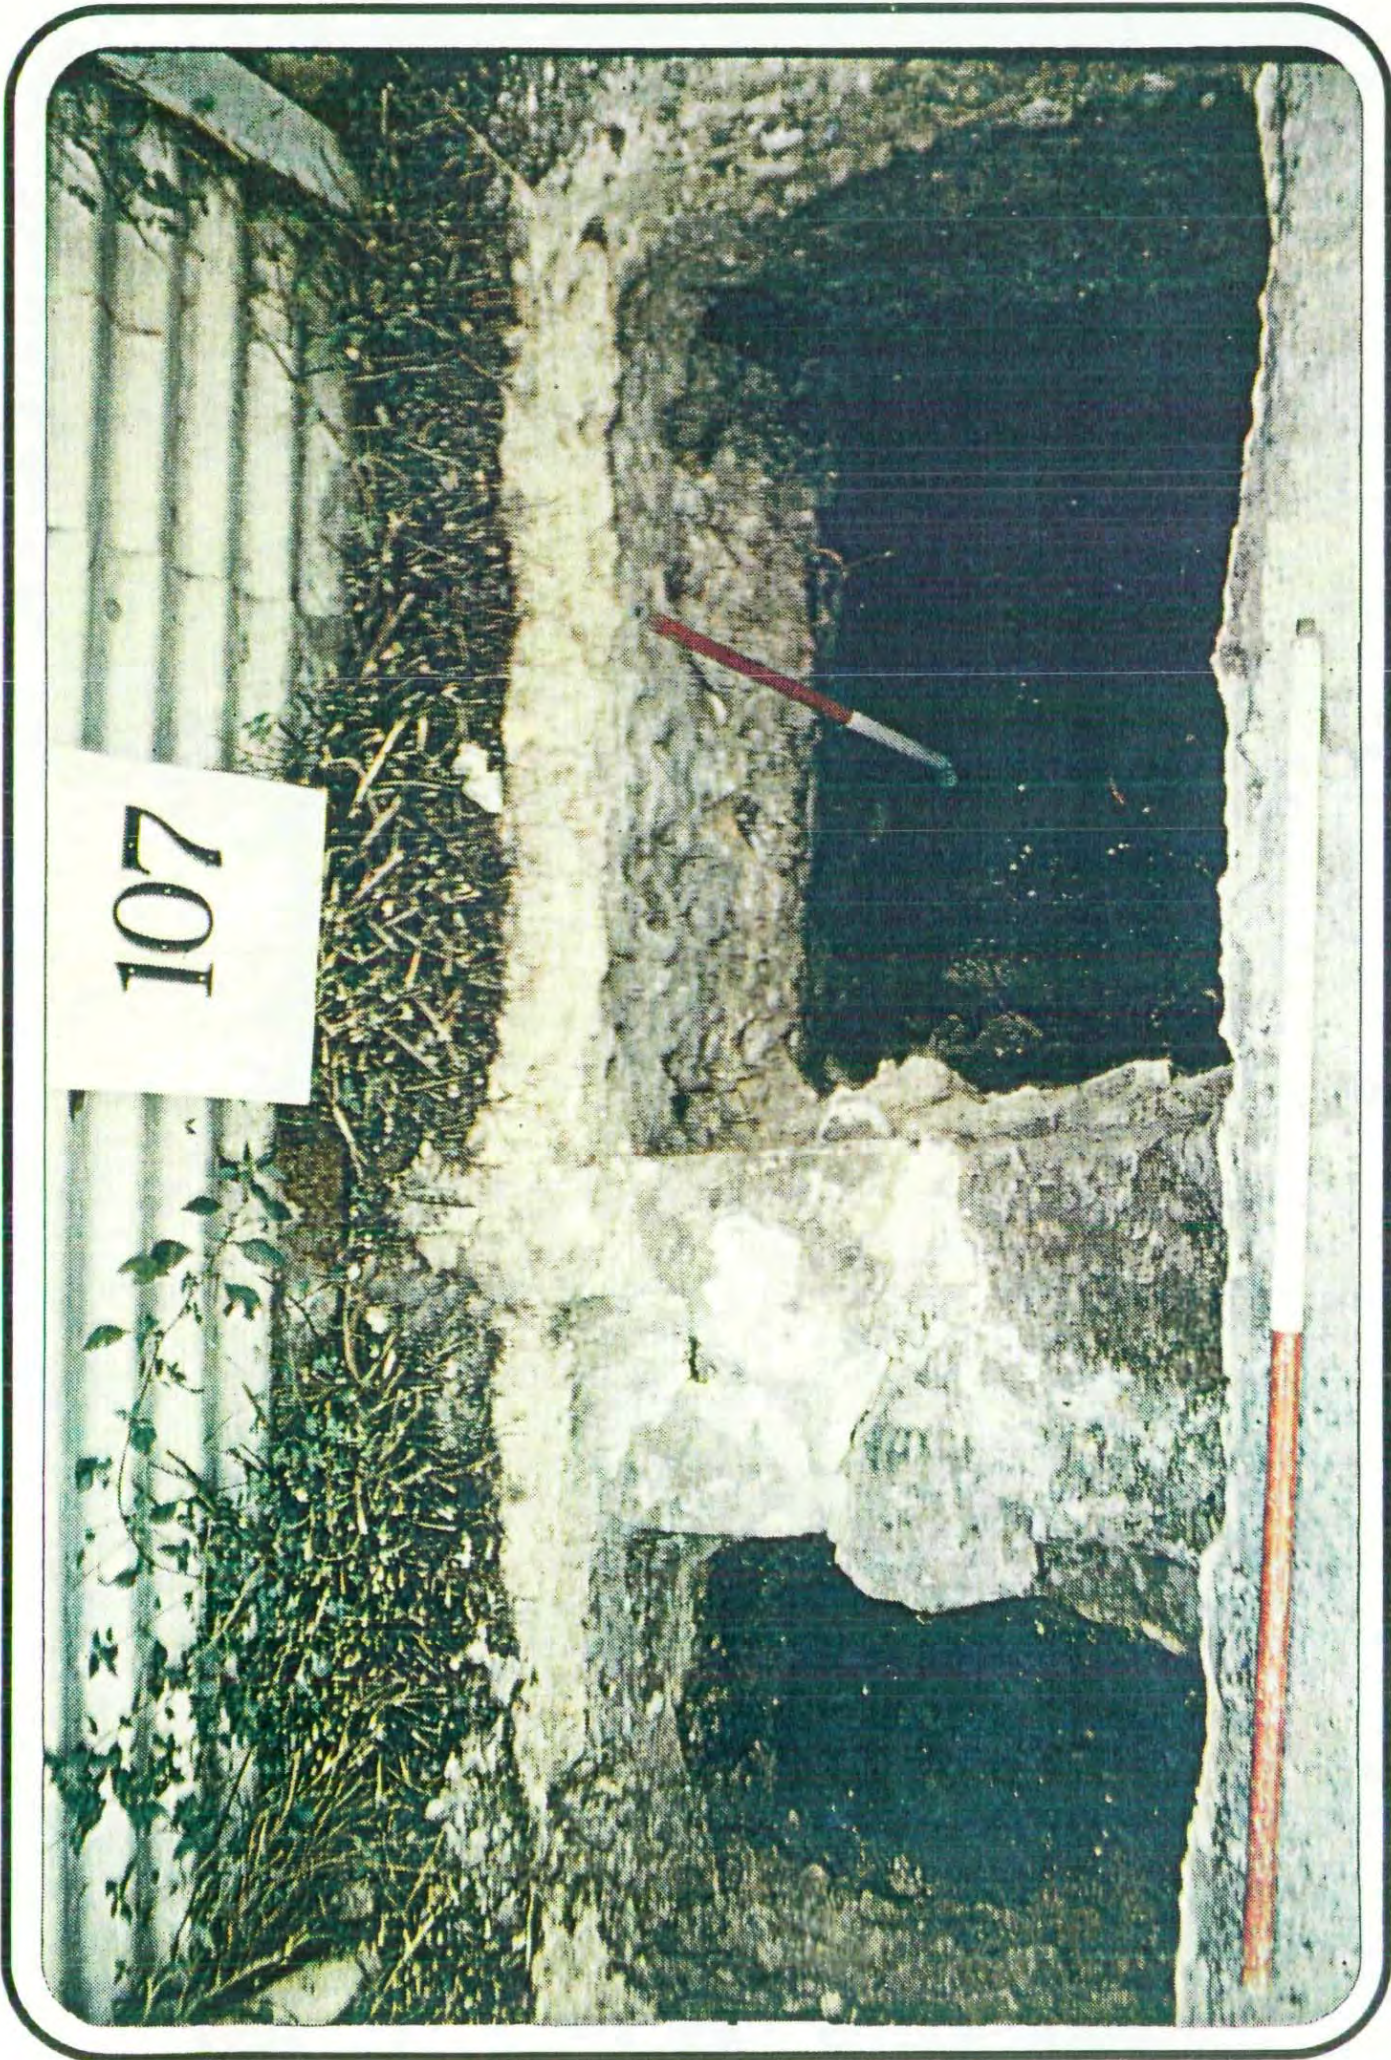
TEST PIT 100, CLOSET WALL 104, CONTEXT 107

- 4.2.1** The external wall foundations of the closets have survived demolition within the laneway and probably have been preserved also within the rear gardens of the warders' cottages.

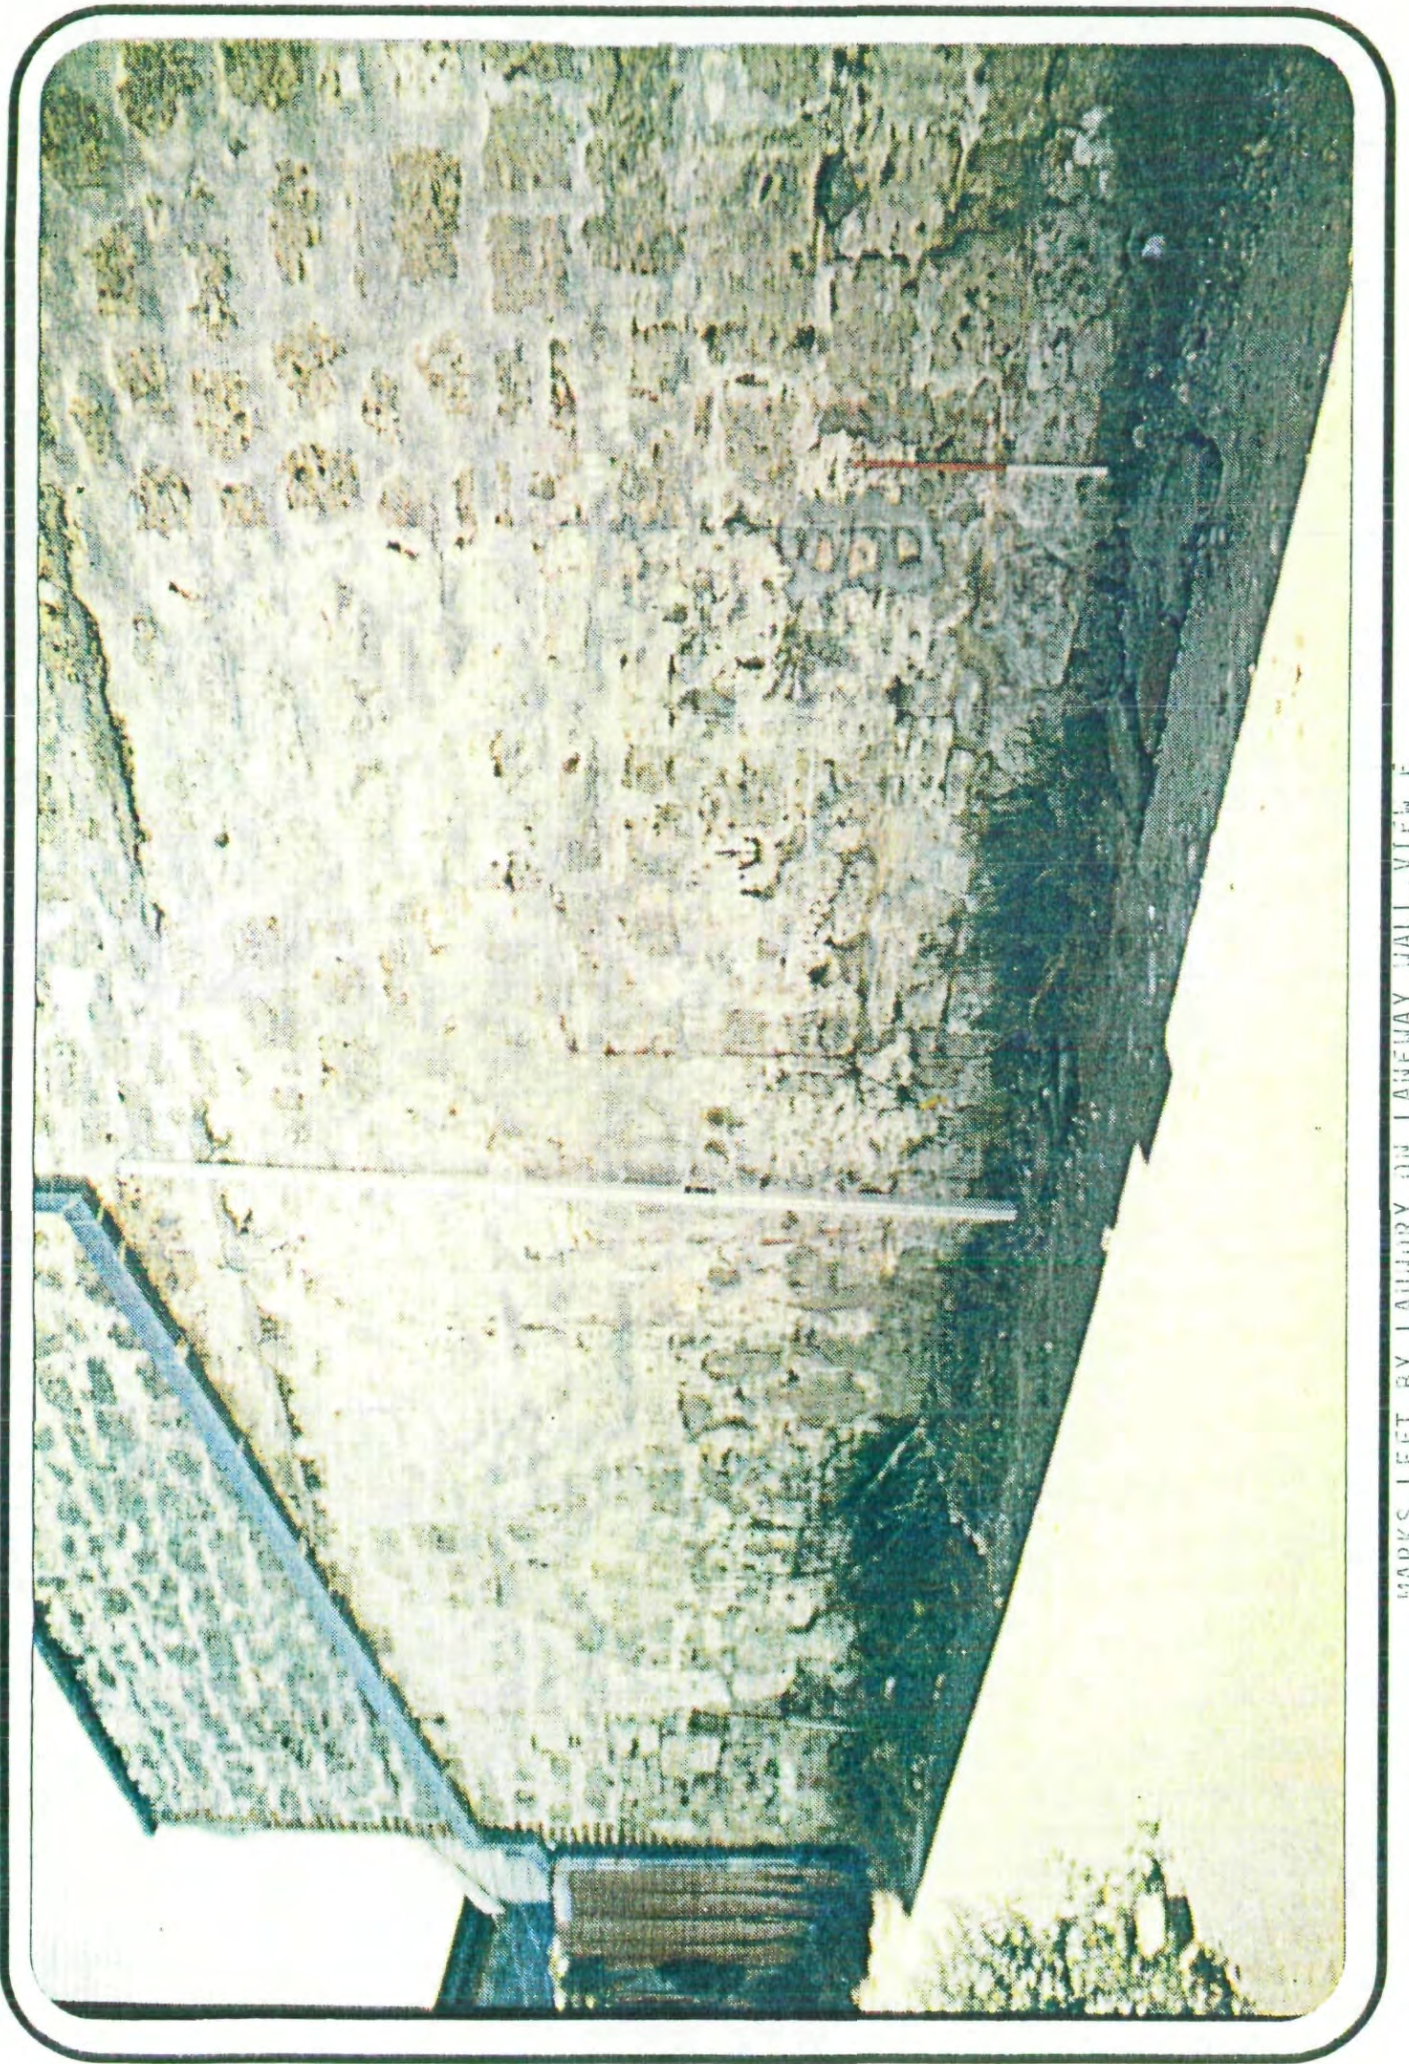
MARKS LEFT BY LAUNDRY ON LANEMAY WALL, VIEW E
