FREMANTLE PRISON ARCHAEOLOGY

HISTORICAL ARCHAEOLOGICAL ASSESSMENT OF  
HAMPTON ROAD RESERVE AND THE REAR OF  
HENDERSON STREET COTTAGES

JACK McILROY  
DEC. 1989

Report Prepared for the  
Building Management Authority of Western Australia,  
Fremantle Prison Project

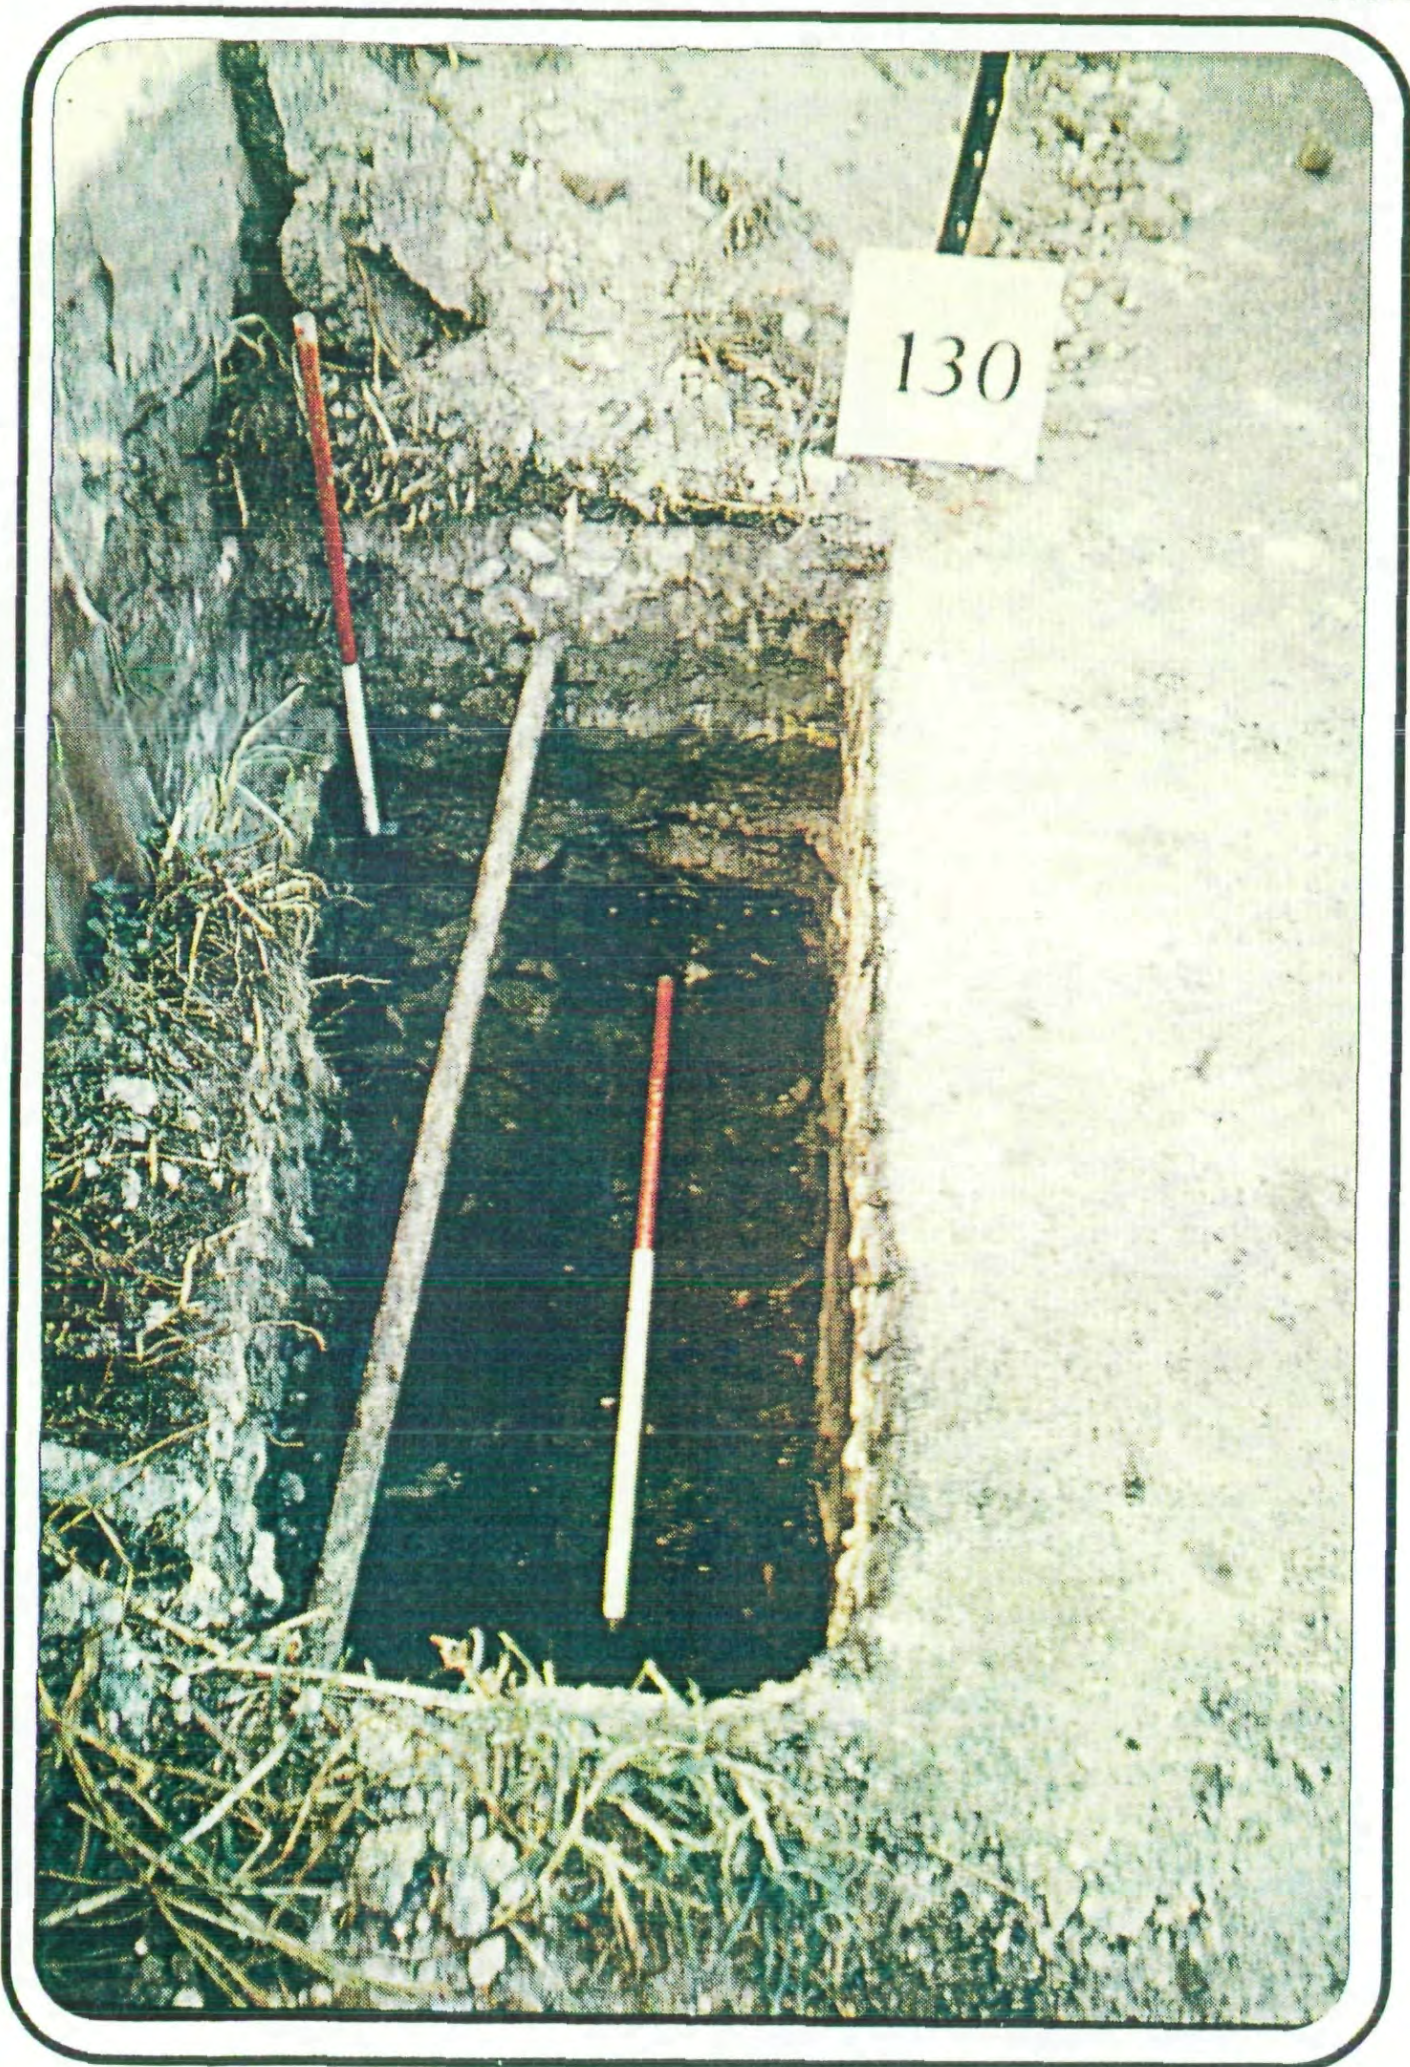
TEST PIT 120, NATURAL SAND 130, VIEW SW

- 4.2.18** It is almost certain that the foundations continue under the garden shed in No. 17.
- 4.2.19** Three one inch iron water pipes have been found during excavations, one in test pit 120 running along the laneway and the remaining two in the rear garden of No. 17.

- 4.2.29** The dark grey natural sand uncovered in most test pits in the laneways is similar to base deposits found at Pioneer Park, Fremantle, in excavations earlier in the year.

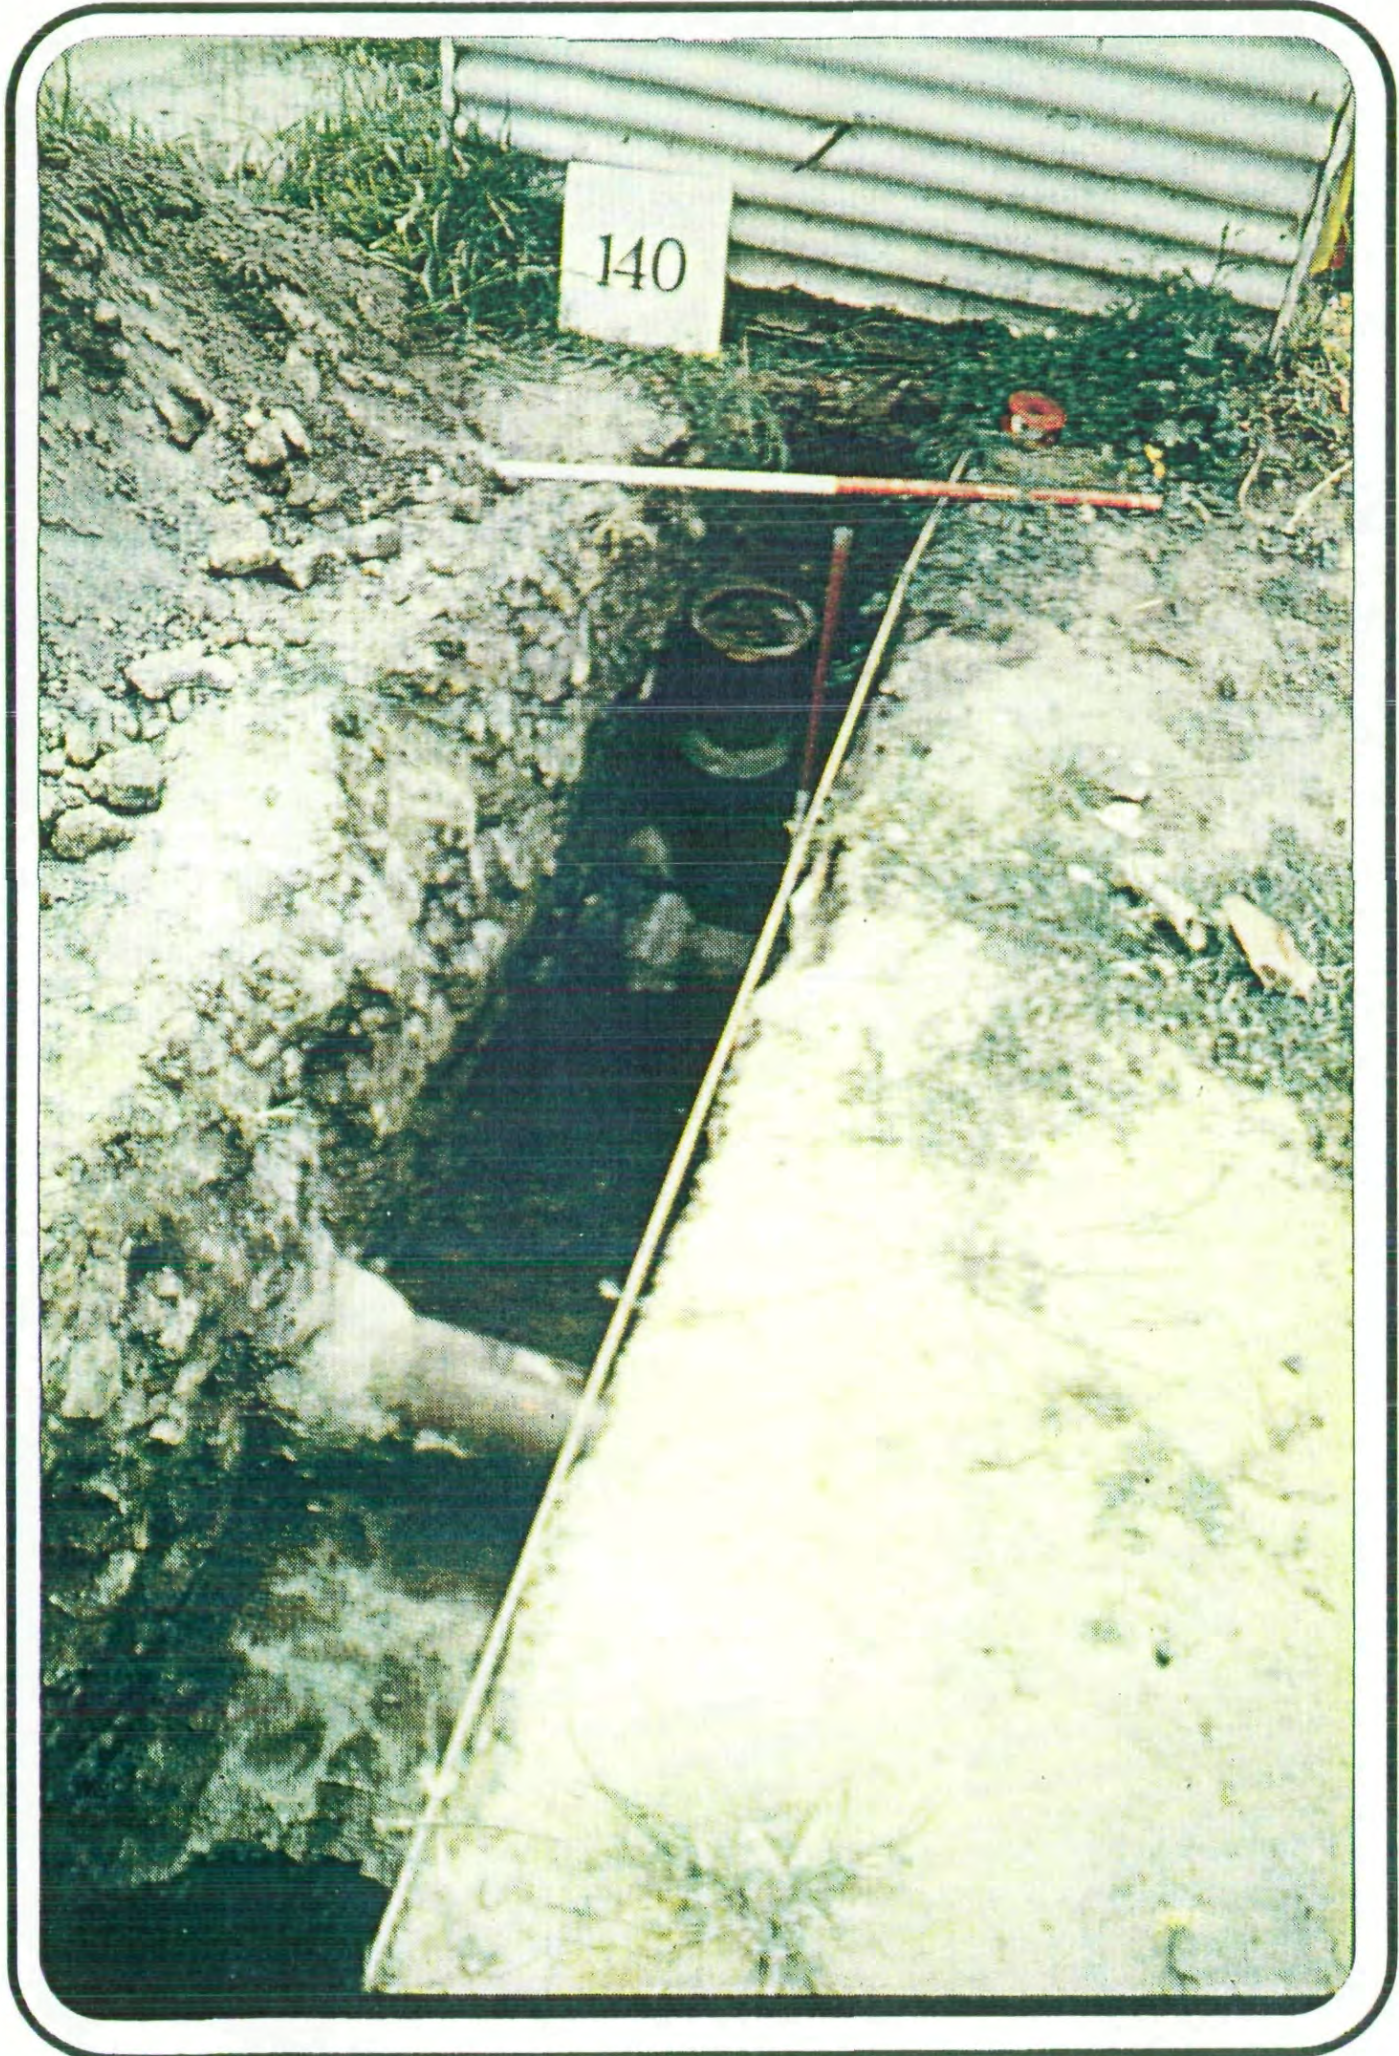
TEST PIT 140, SEWER PIPES, VIEW W

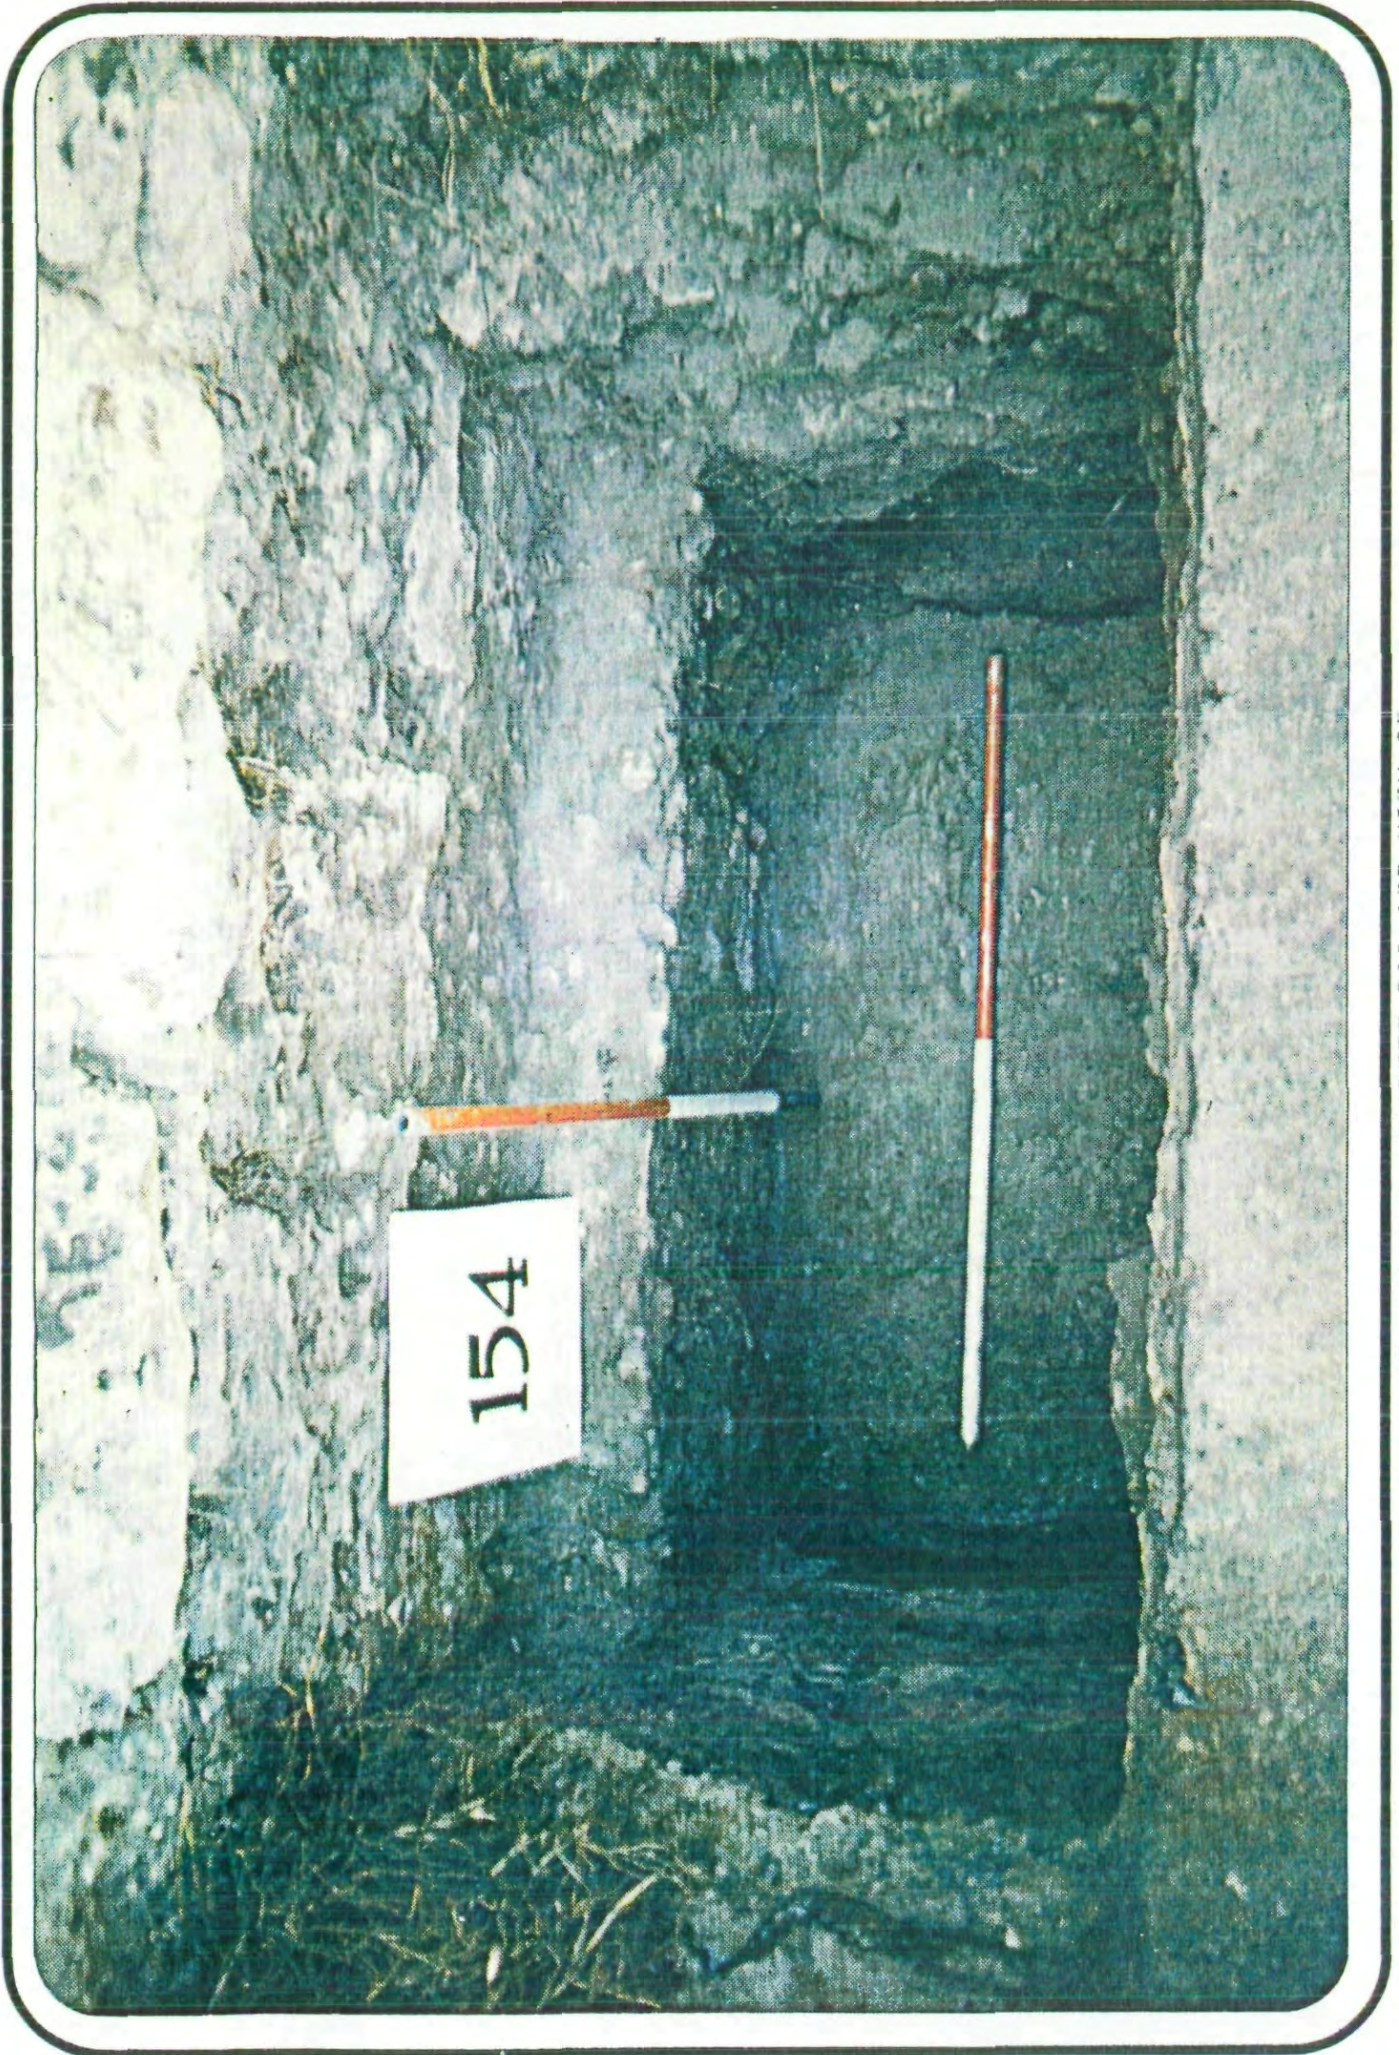
TEST PIT 150, SAND 154 AND CONCRETE PAD 157, VIEW SE

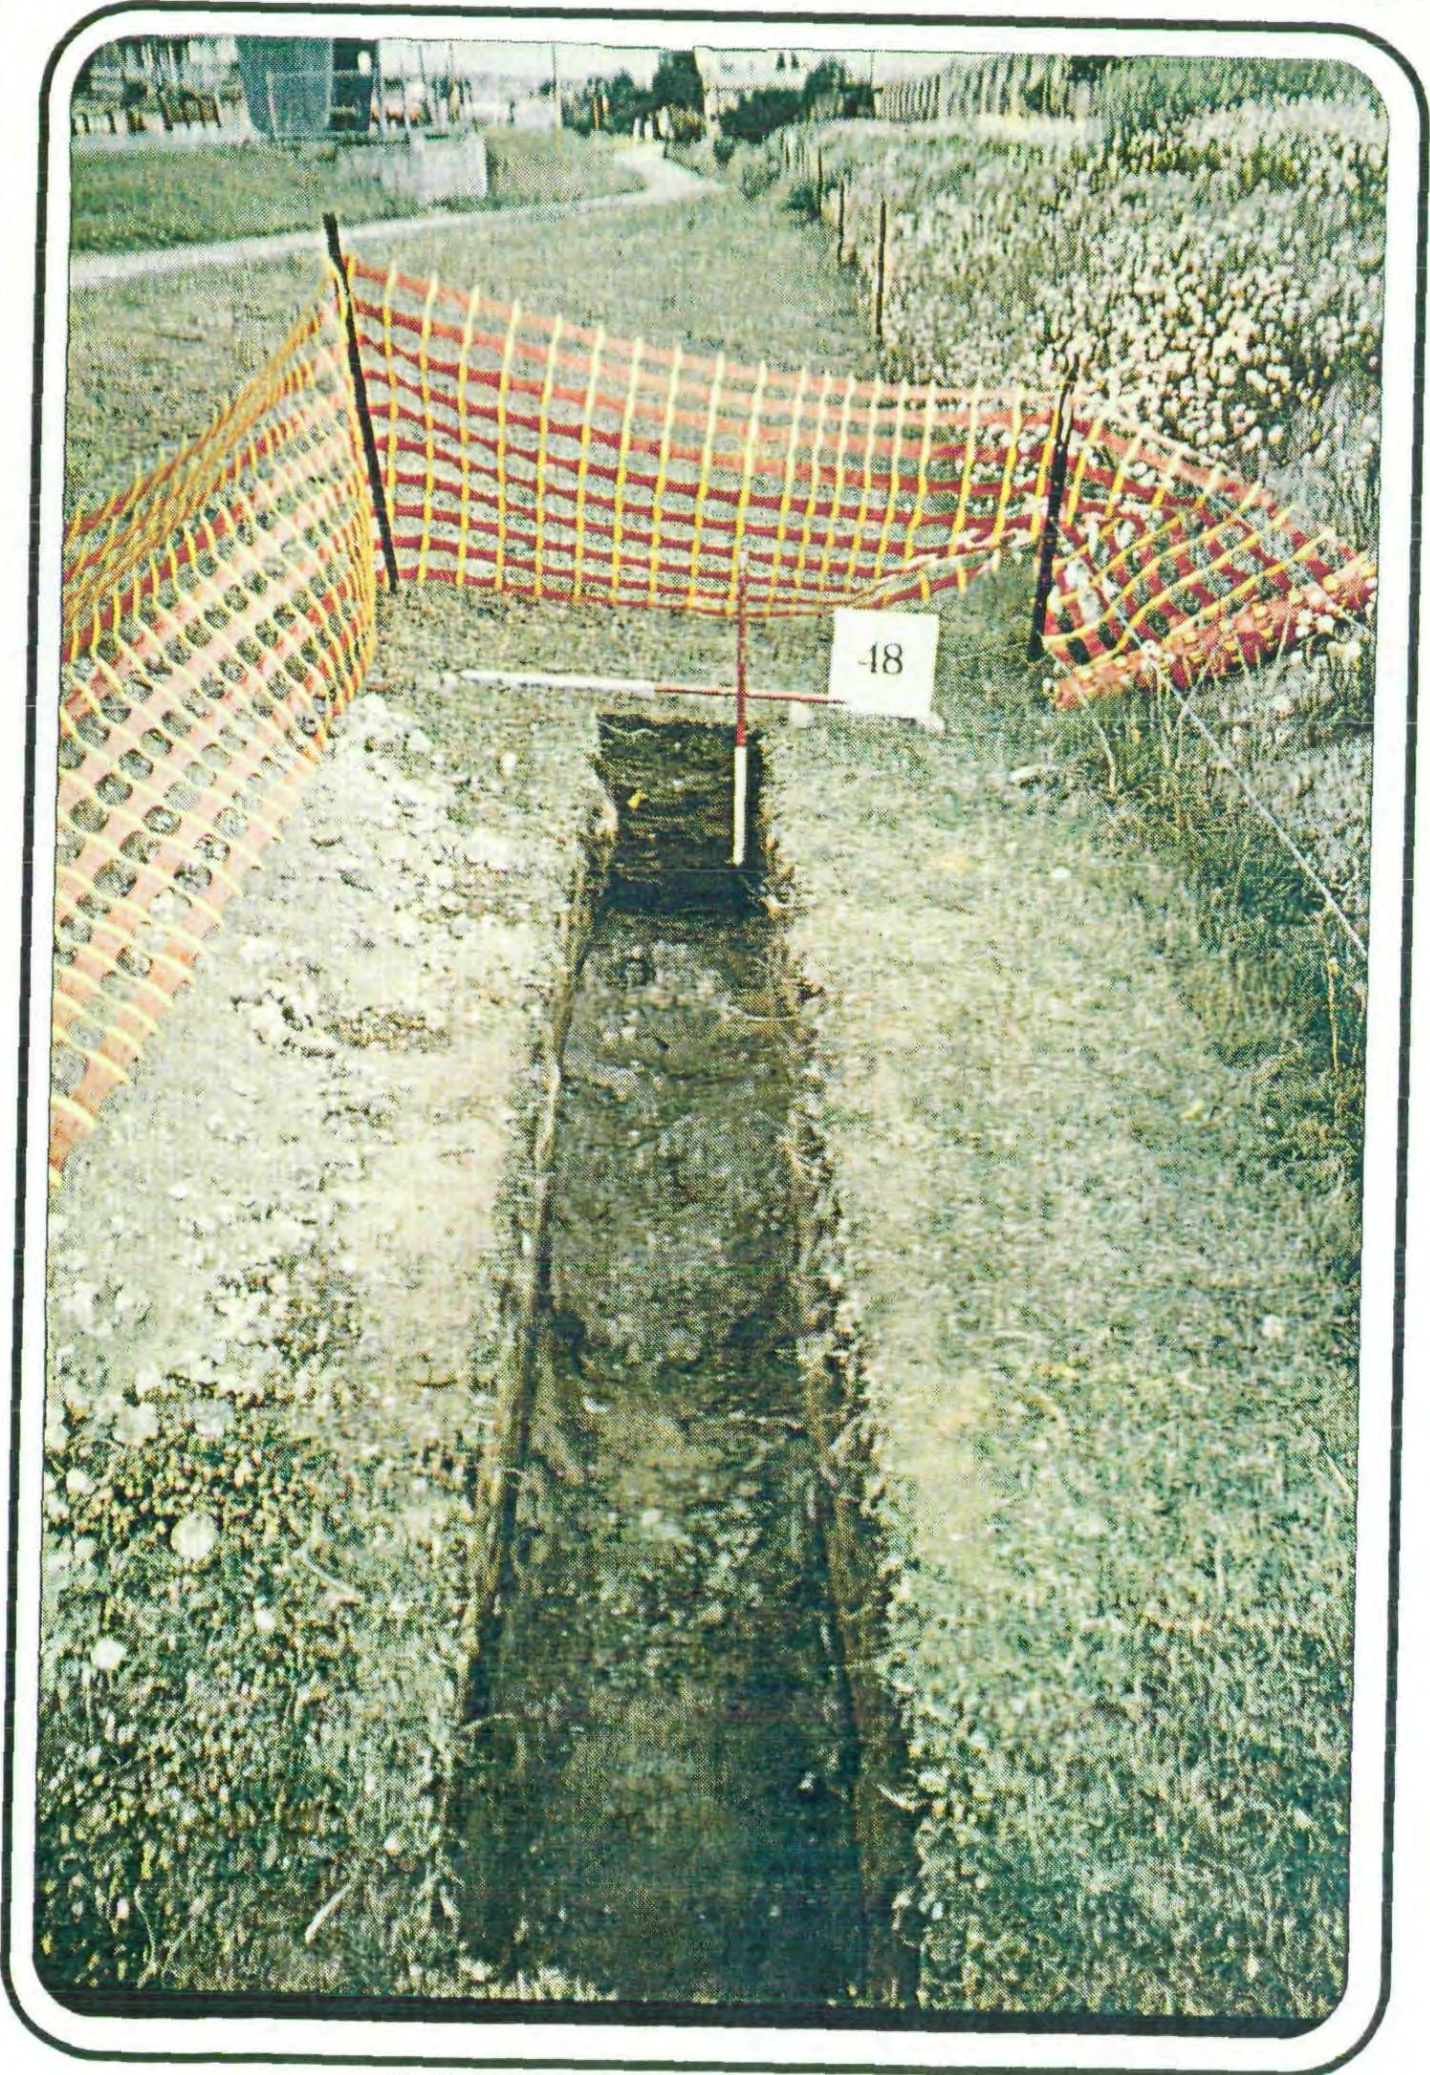
TEST PIT 4, BEDROCK, VIEW S

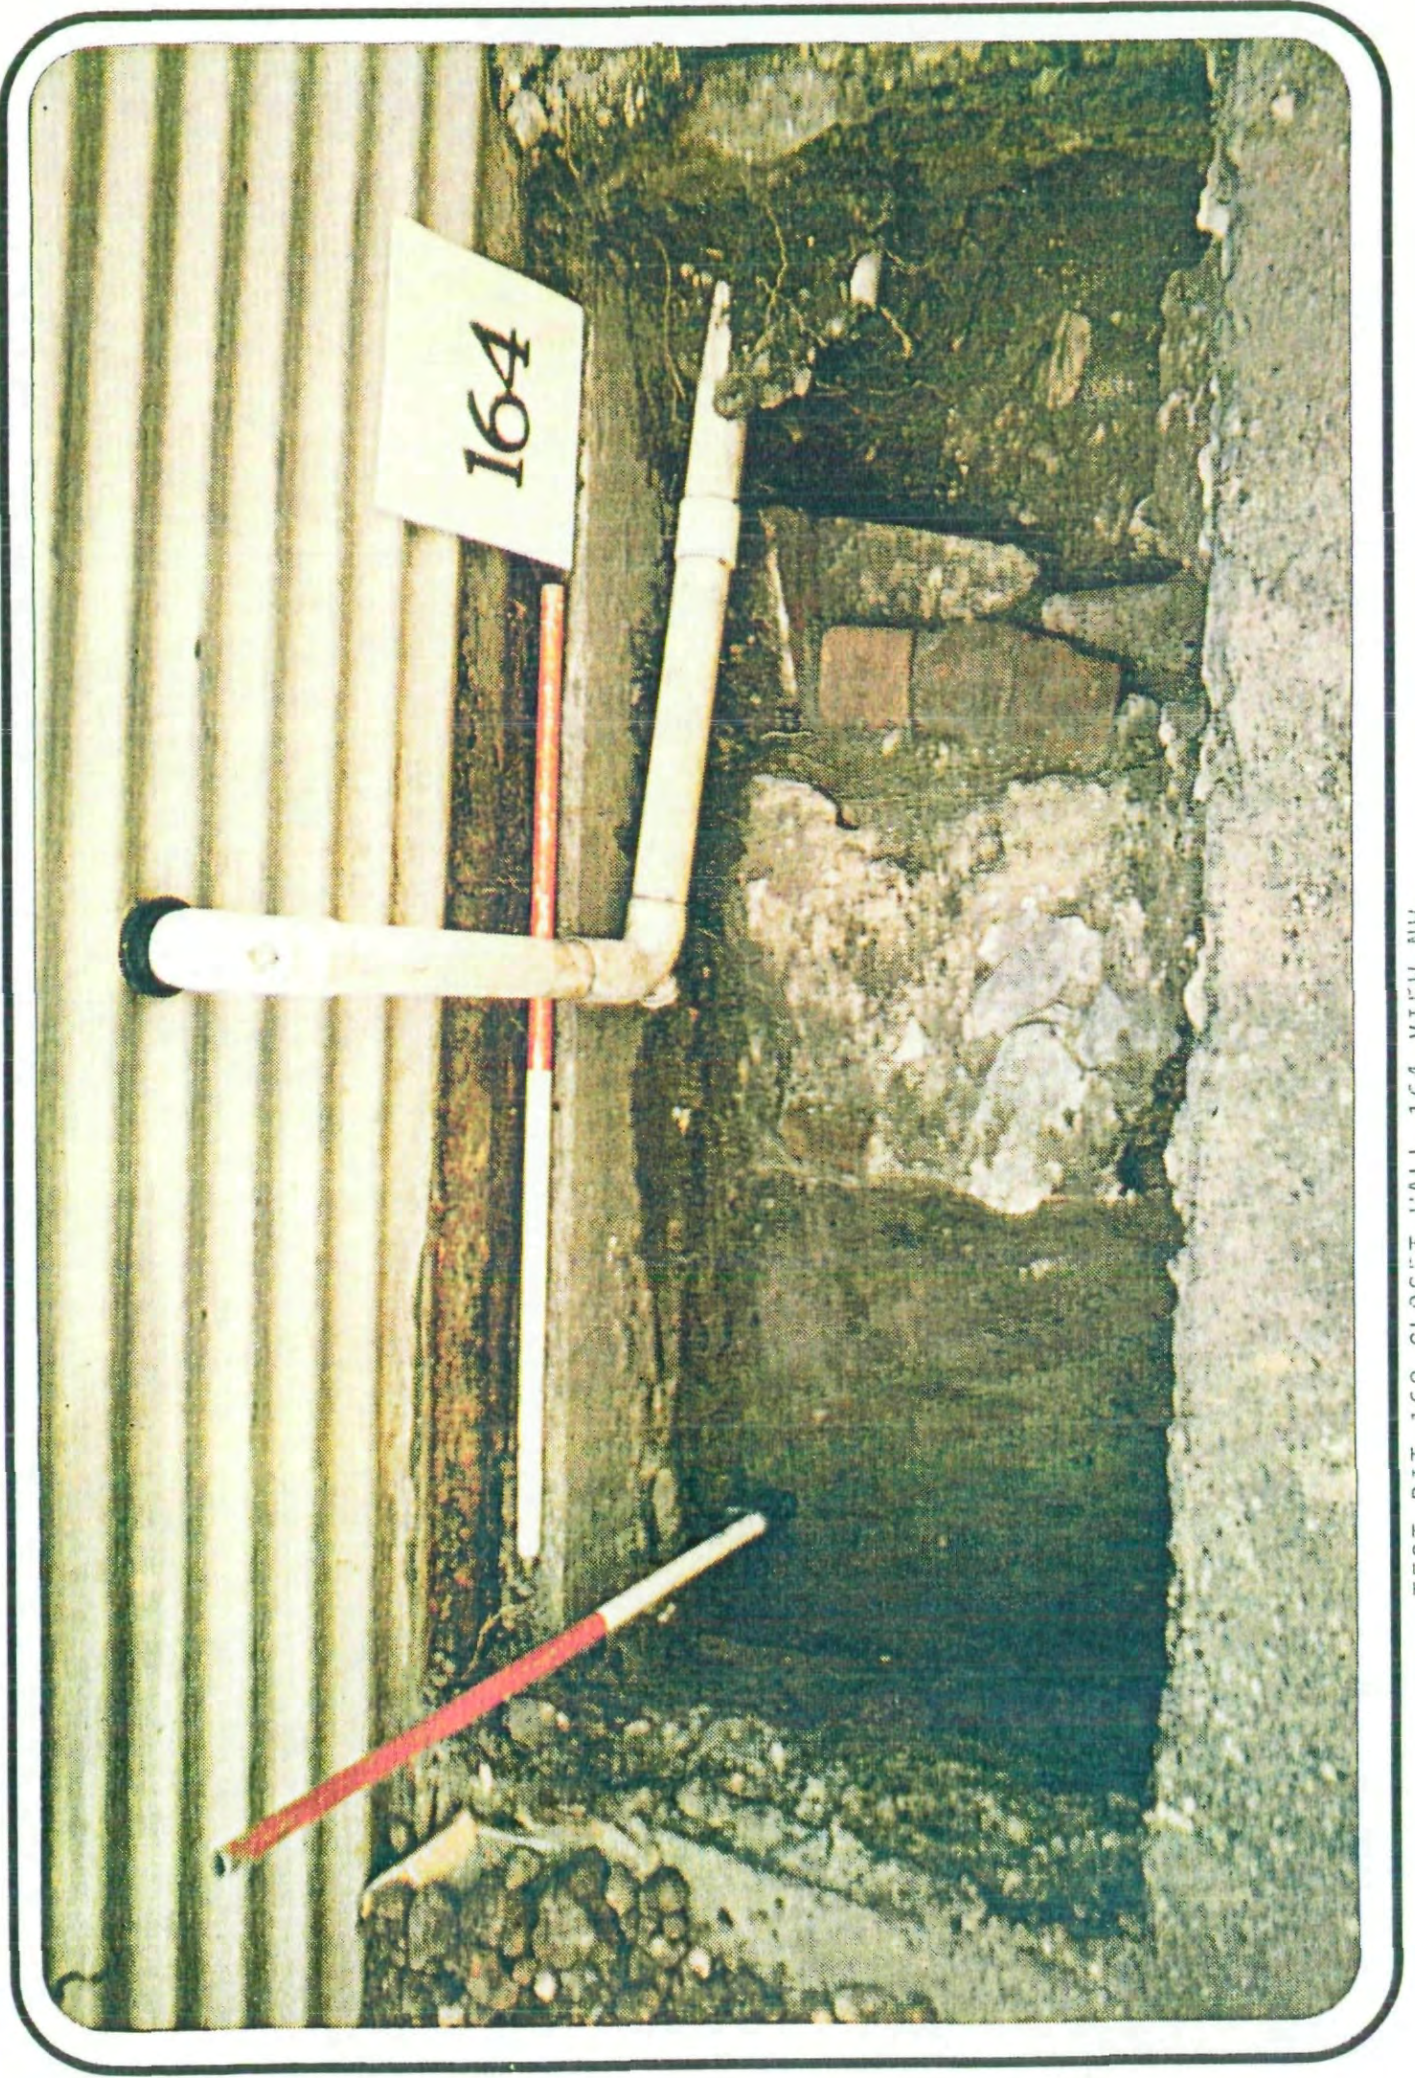
TEST PIT 160, CLOSET WALL 164, VIEW NW

- 4.2.2** There is evidence from test pit 160 that the internal faces of the closet walls were brick lined.
- 4.2.3** Slate embedded in the top of the wall foundations as seen in test pit 160 may indicate an early form of damp proofing.

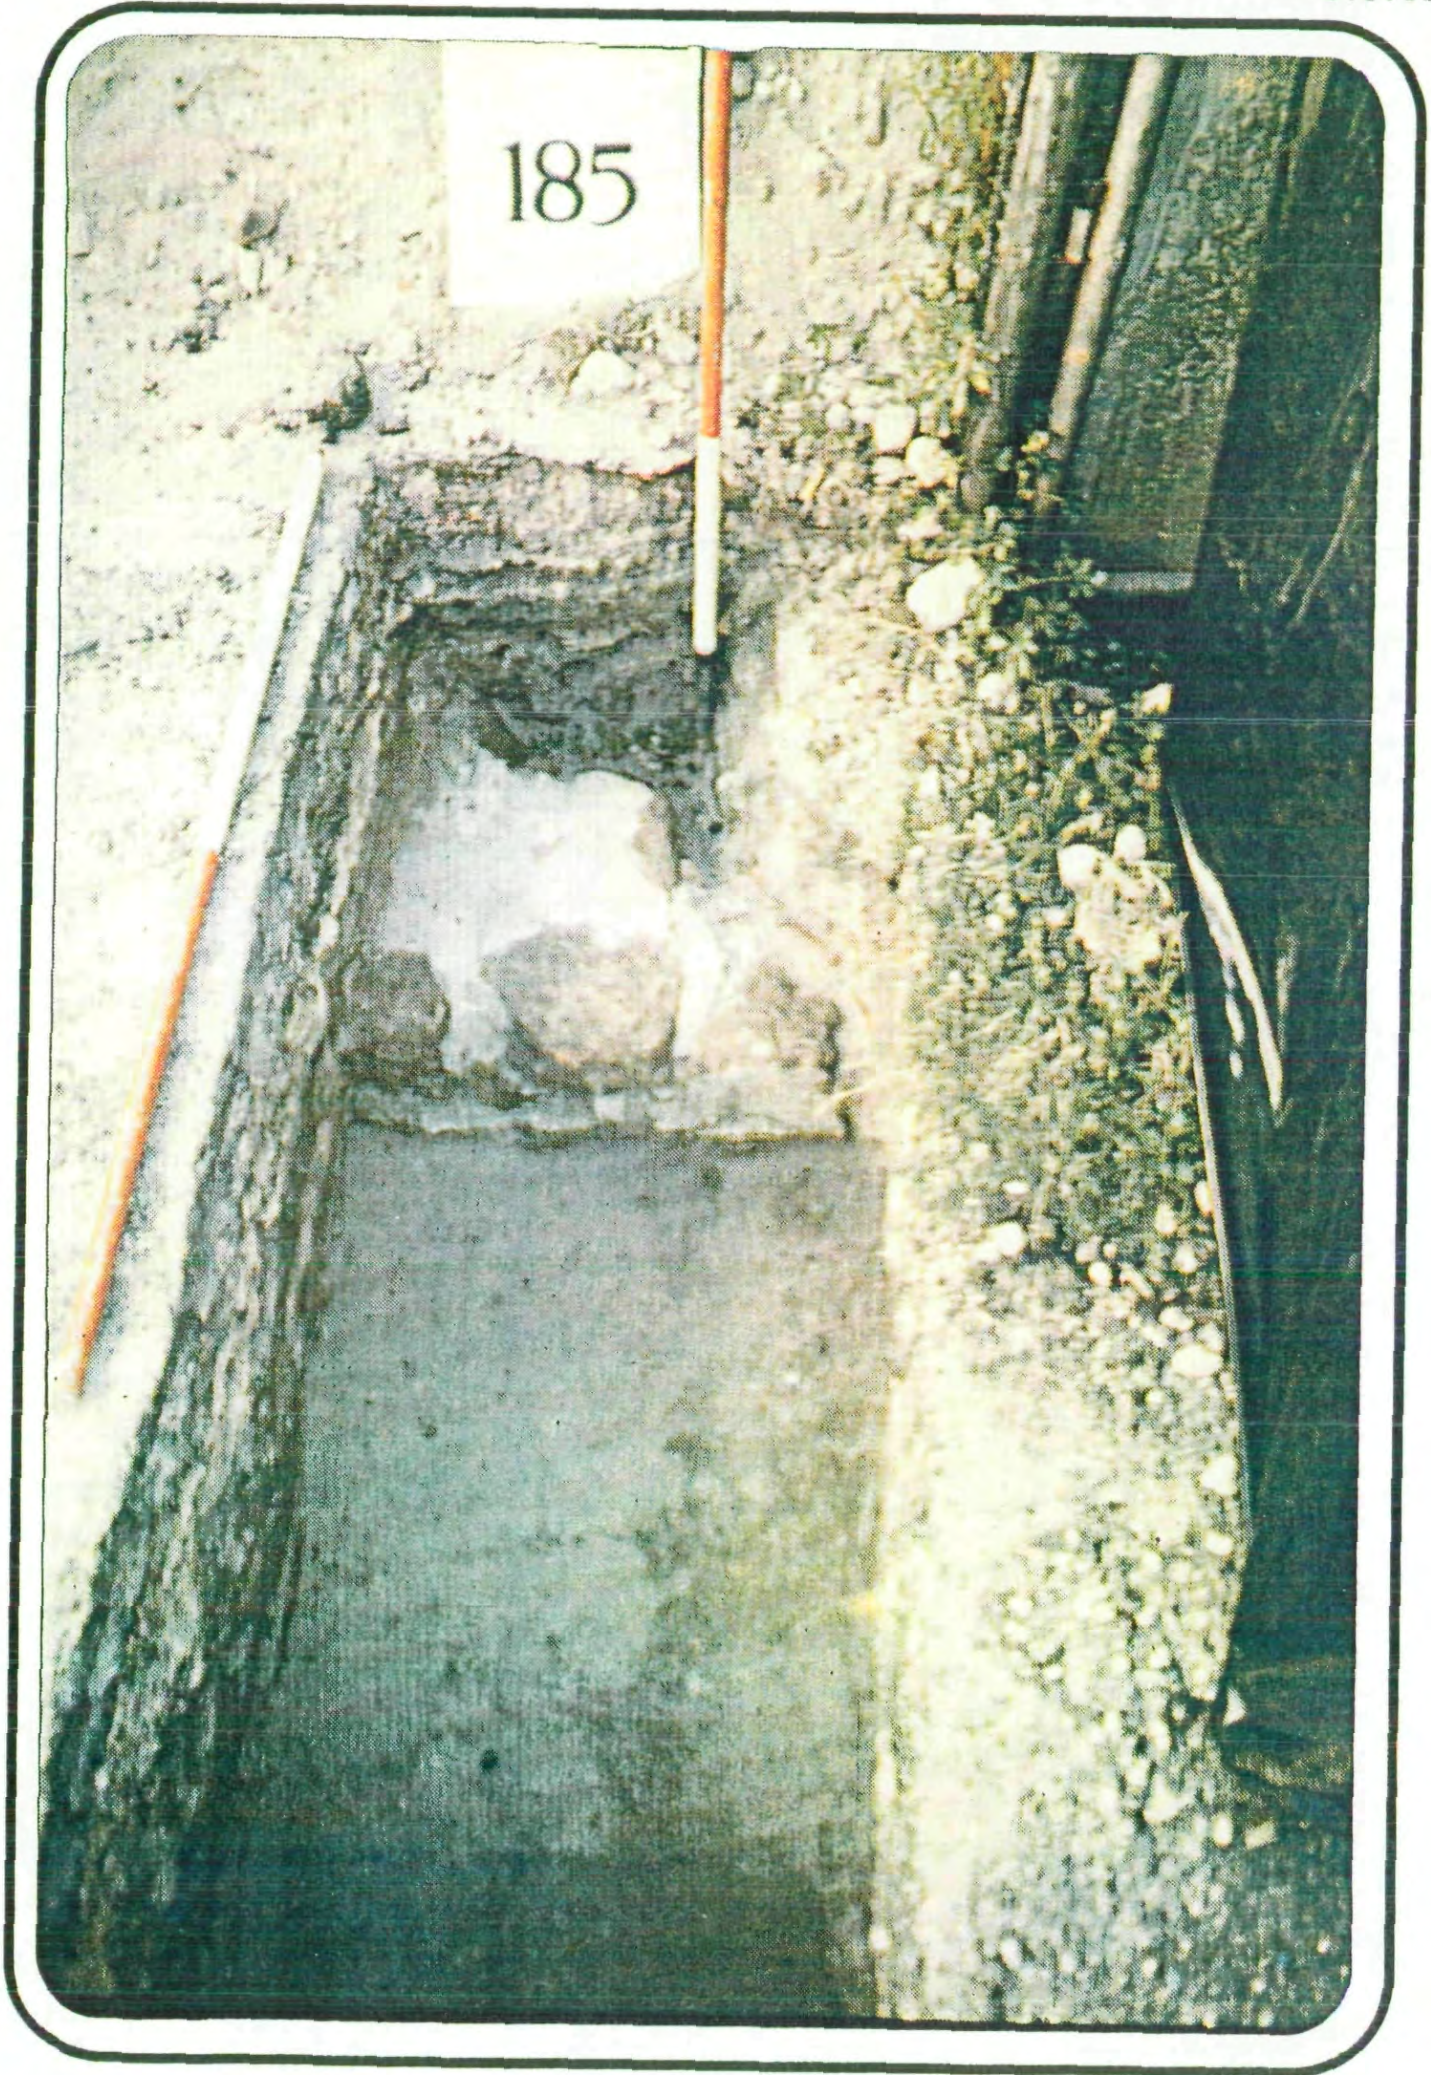
TEST PIT 180, CLOSET WALL 185, VIEW SW

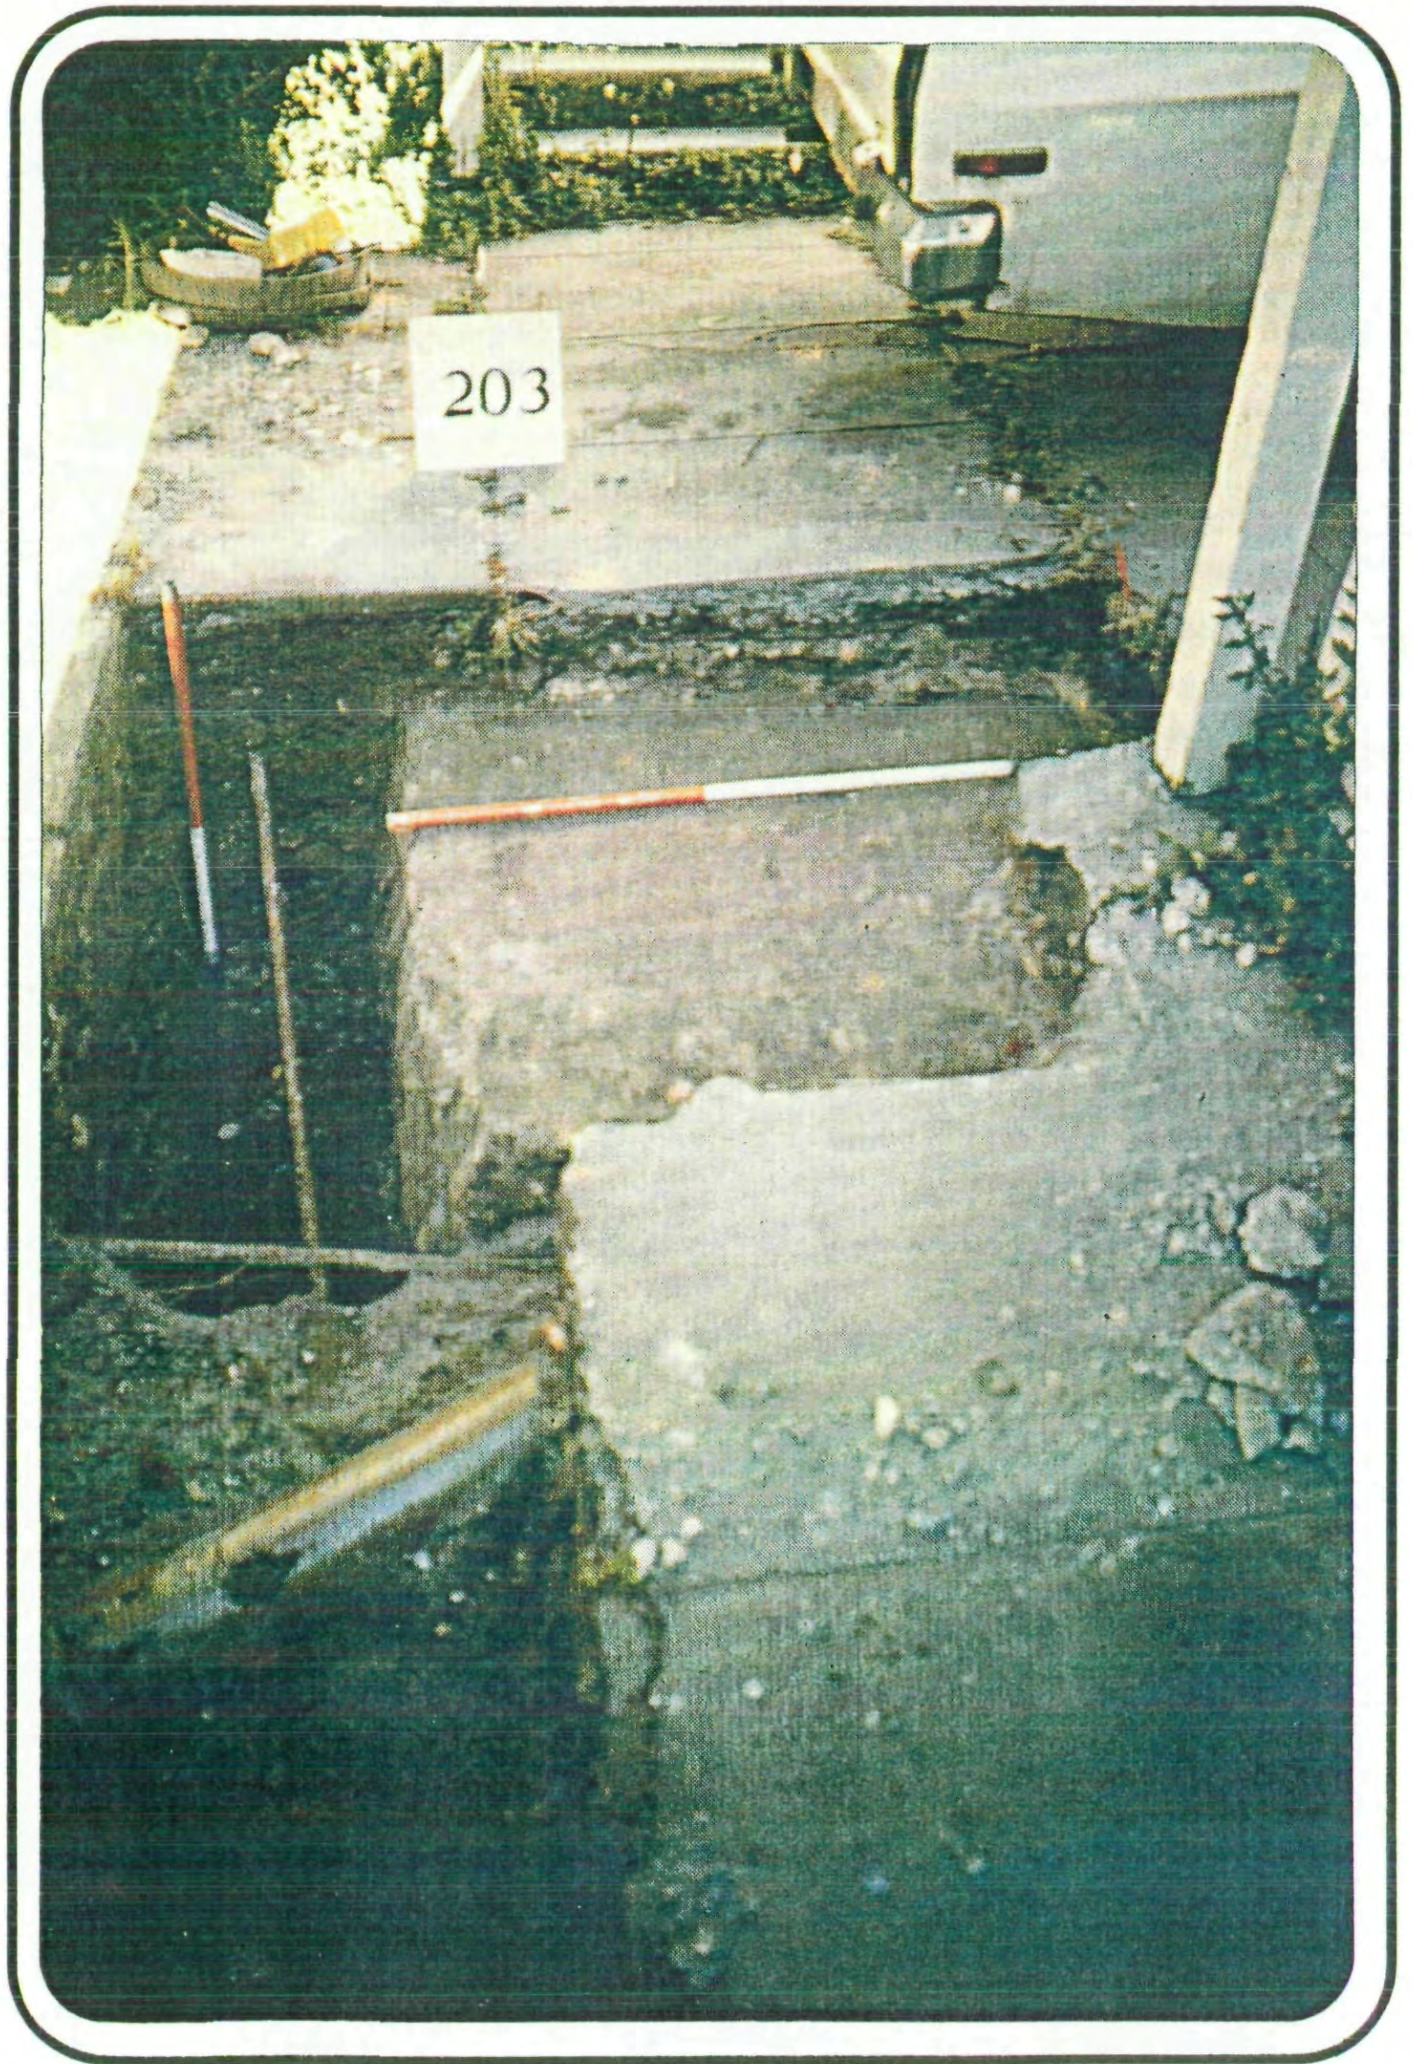
TEST PIT 200, FOUNDATIONS 203, VIEW NW
