FREMANTLE PRISON ARCHAEOLOGY

HISTORICAL ARCHAEOLOGICAL ASSESSMENT OF  
HAMPTON ROAD RESERVE AND THE REAR OF  
HENDERSON STREET COTTAGES

JACK McILROY  
DEC. 1989

Report Prepared for the  
Building Management Authority of Western Australia,  
Fremantle Prison Project

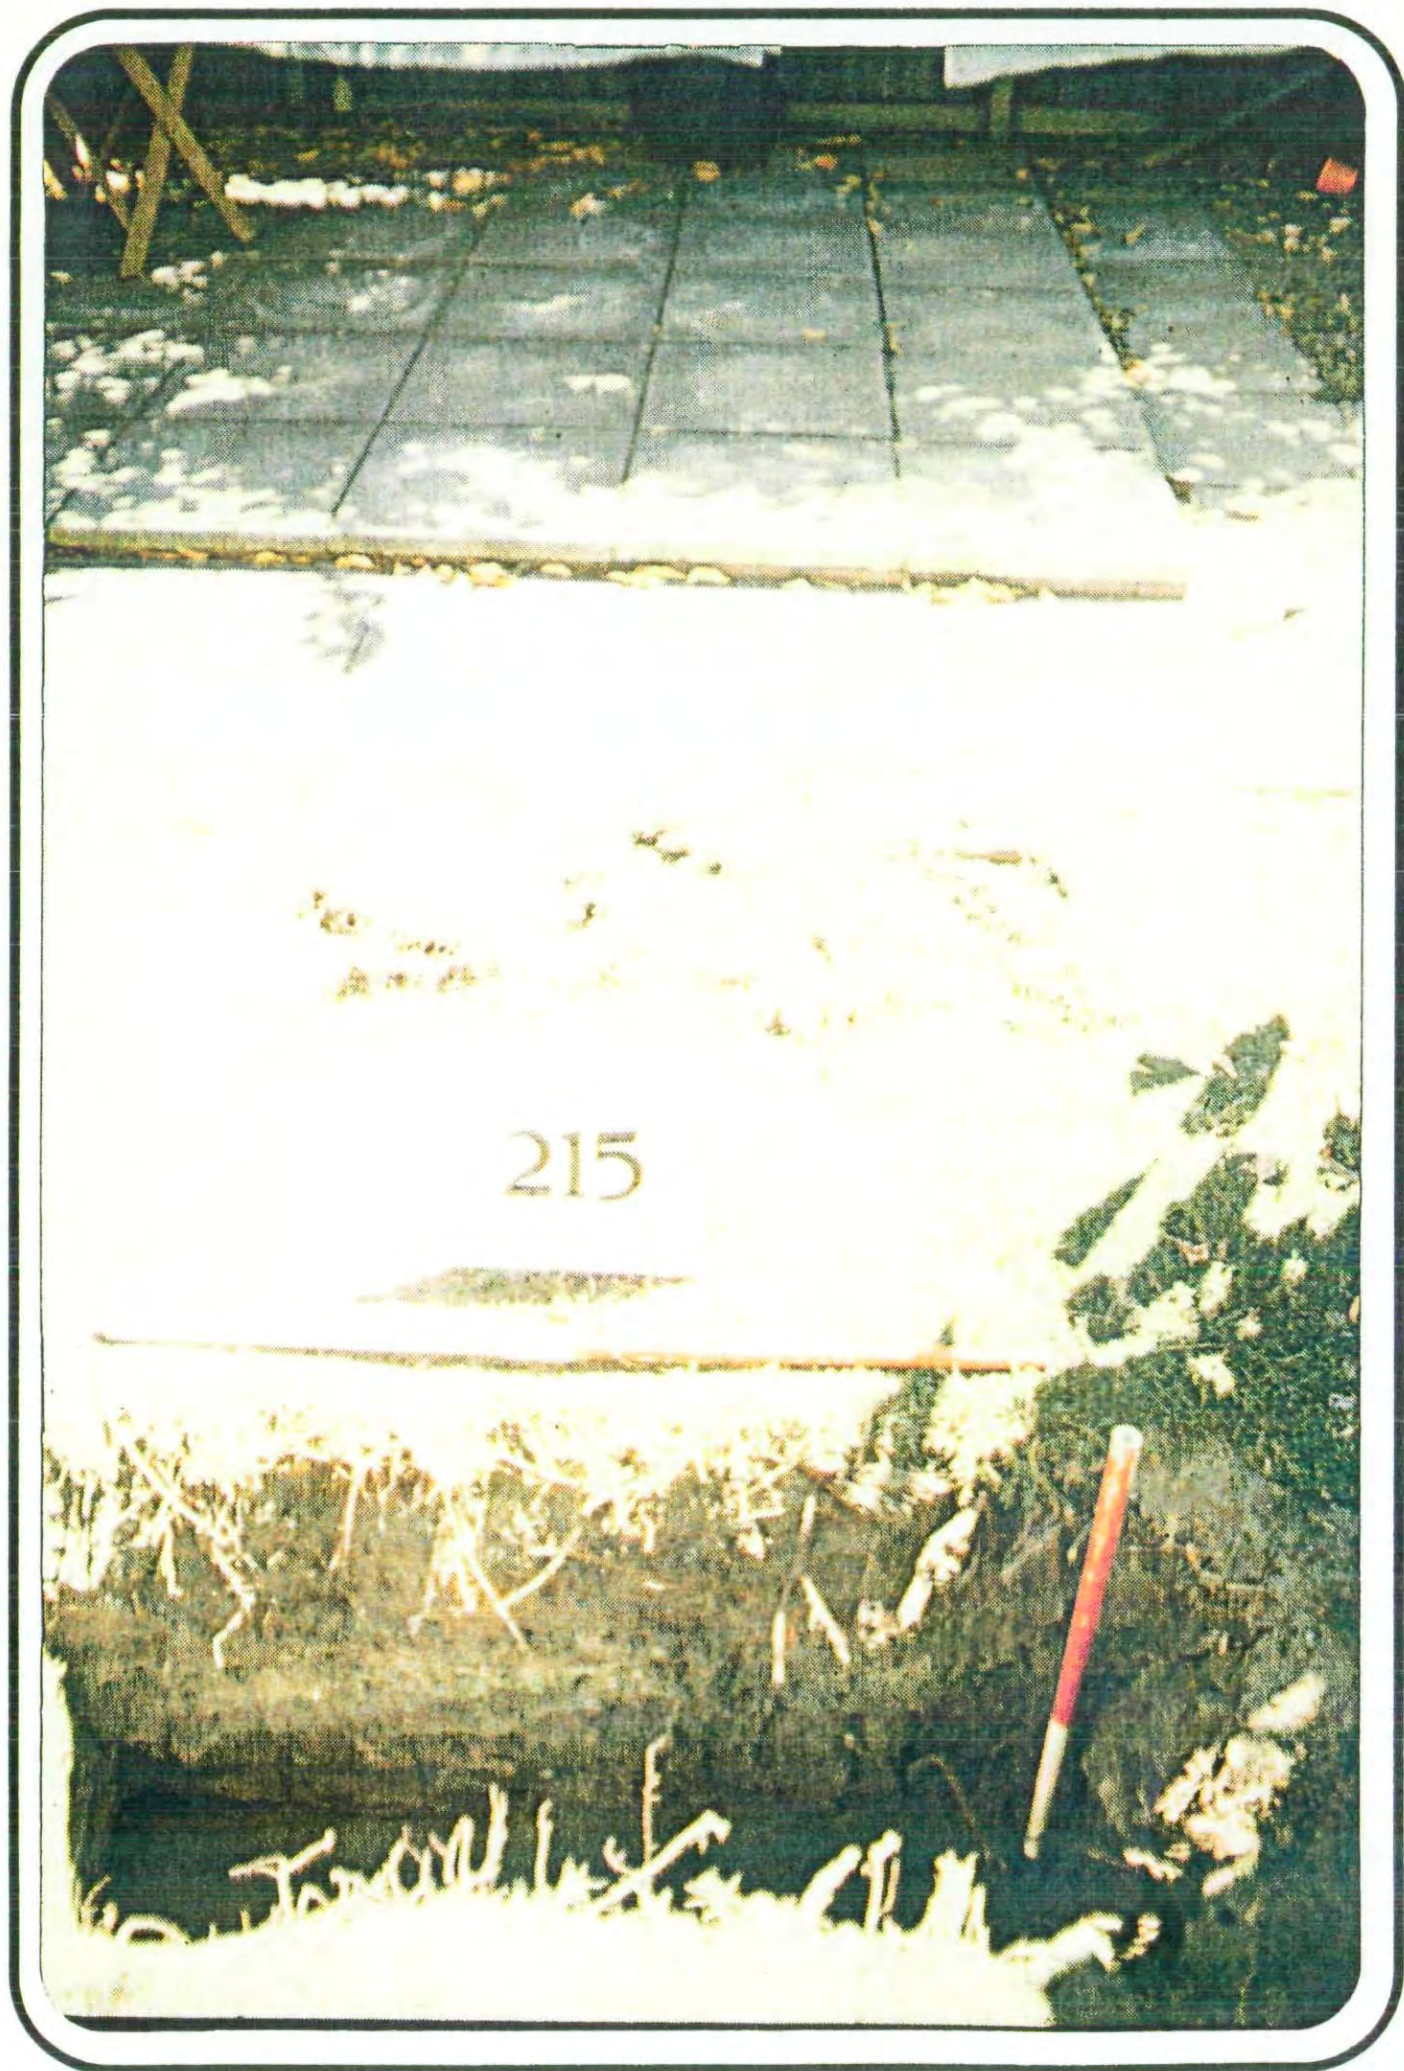
TEST PIT 215, SECTION, VIEW NE
