FREMANTLE PRISON, WESTERN AUSTRALIA ARCHAEOLOGICAL TEST EXCAVATIONS OF THE STABLES BUILDING

(Stage 2)

Philip Griffiths Architects and Building Management and Works

June 2010

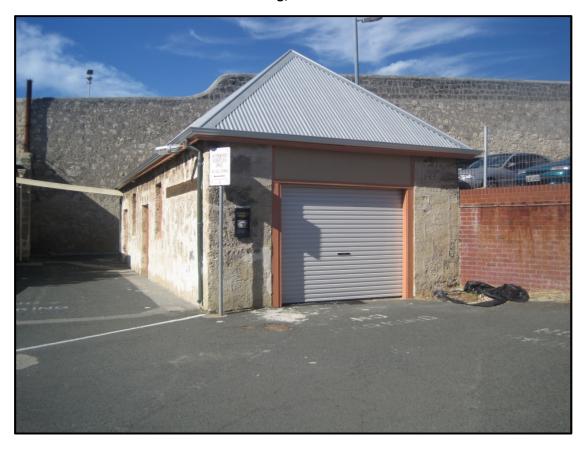
Plate 1: Fremantle Prison Stables building, view south-east

Fremantle Prison Stables building (Plate 1) is located to the south of No.18 The Terrace, adjacent to the Parry Street car park (Figure 1). Research undertaken by Palassis Architects (1999) indicates that the Stables, in its present location, was given approval for construction on 10th November 1874, at the request of the then Surgeon G.C. Attfield. The next record of the Stables is a photograph taken in 1878, showing the building in its current location and indicating that it was constructed between 1874 and 1877.

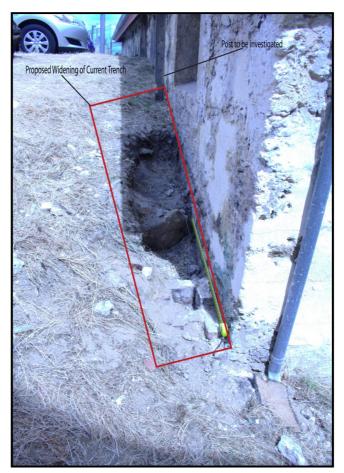
Plate 2: Southern exterior wall of Stables showing trench dug by BMW and extent of proposed archaeological investigation (Trench 1)

In 2009 mitigation work was undertaken by BMW to conserve the Fremantle Prison Stables building. Deposit had been heaped against the southern wall to a height of approximately 2m during levelling for the car park. Moisture seepage from this deposit was degrading the limestone wall. A trench was dug along the southern exterior wall of the Stables to remove the deposit and allow inspection of surviving timber joists. Eureka was requested to investigate the archaeological potential of this area following the recovery of historic artefacts during the initial phase of digging the trench (Plate 2). The artefacts uncovered by BMW workmen carrying out the work include a number of old bottles (pre 1920) and a hollow, cast iron ball initially thought to be a ball from a convict era ball and chain (Plate 3).

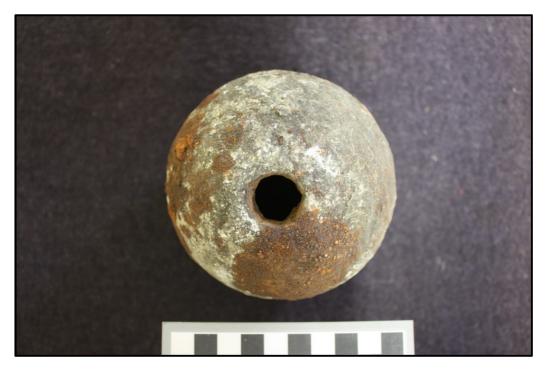
Plate 3: Hollow, cast iron ball found by workmen adjacent to Stables southern exterior wall (Scale = 10cm)

Eureka has been asked to report on four hollow, cast iron balls recovered from Trench 1. The first of these, found by workmen in the deposit at the south of the Stables, was originally thought to be from a convict era ball and chain. All four of the balls have diameters of 110 mm, weigh 3.3 kg and have a 17mm diameter circular hole and a 25 mm circular mark (Plate 9). Analysis indicates that they are in fact "spherical case shot" or "shrapnel shot", invented in 1748 by Lt. Henry Shrapnel of the British Royal Artillery (Dupuy 1990:219). The hollow ball was filled with lead shot, an explosive charge and then filled with sulphur that hardened to hold the shot in place. The hole would have accommodated a fuse (Lissak 1915:439).

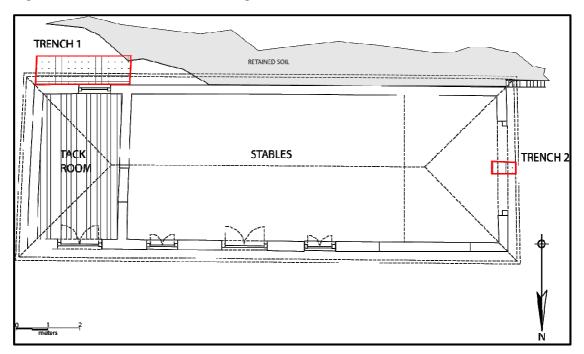
Figure 2: Plan of the Stables building with the locations of Trenches 1 and 2

The location of Trench 1 is marked on Figure 2 on Page 8.

The location of Trench 2 is marked on Figure 2 below.

A single trench (Trench 1), measuring 1 m wide (N-S) by 3 m long (E-W), was excavated along the southern exterior wall of the Stables building (Figure 2). The excavation was conducted by hand using trowel and hand shovel. Trench 1 was excavated into a slope that descended from a height of approximately 2 m at the west end of the trench, to just 50 cm above ground level at the east end of the trench. The west end of Trench 1 was excavated to a depth of approximately 60 cm. Further excavation at the west end of the trench would have required additional time and safety precautions beyond the scope of this work. The east end of the trench was excavated to the existing floor level of the Stables. A series of steps were excavated within the trench to maintain a relative level of approximately 60 cm below ground surface level. While this meant that the base of the southern Stables wall was only reached at the east end of Trench 1, it was considered appropriate to meet the aims of the excavation (Plate 4).

Trench 2, a shallow trench measuring approximately 70 cm (E-W) x 30 cm (N-S) was opened across the threshold of the Stables doorway (Figure 2). The trench was positioned centrally, equidistant from the two door jambs (Plate 5). The excavation was conducted by hand using trowel and hand shovel.

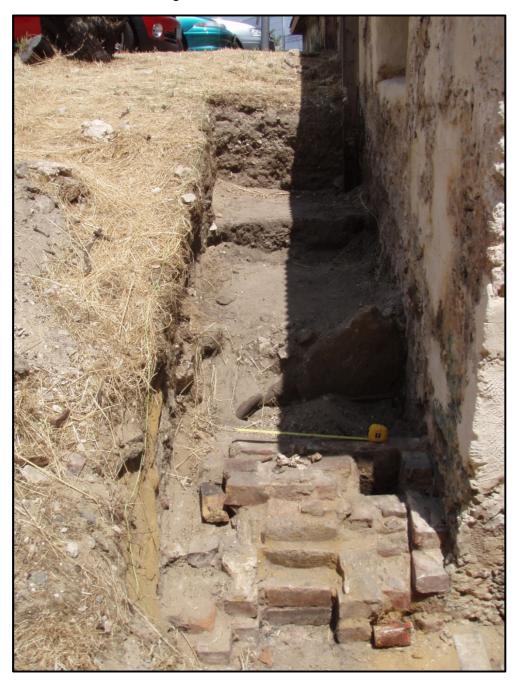
Plate 4: Trench 1 showing structural elements and southern exterior Stables wall

Structural timber [003] / [004] at the southern exterior wall of the Stables may be the remains of a trellis or similar structure designed to support grape vines. The structure appears to have been supported by the extant upright timber joists that are set against the southern exterior wall. Excavation revealed a number of other timber joists and planks that run horizontal to these uprights, both along the wall and at right angles away from the wall. These timbers were variably preserved; some were in very good condition, while others were in a poor state of preservation. It was not possible to determine the exact form of the structure, however the timbers had been nailed and there was no evidence of carpentry joints. The various joists are not uniform and it appears that pieces of miscellaneous timber were utilised in the construction of this structure.

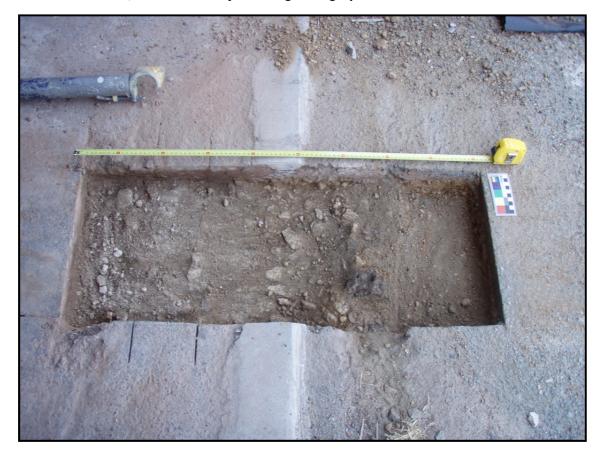
Plate 5: Trench 2, Stable doorway showing stratigraphic units 102 and 104

The structural elements of Trench 2 consist of a posthole [106] filled with deposit (108) and the remains of a post [103], two identical small metal cylinders [104] which are inserted into Unit (102), and a degraded piece of timber [107] which runs horizontally along the line of the door threshold (externally) and is set into Unit (102). This timber is very degraded and set into the limestone levelling layer (102). The posthole is also cut into this unit.

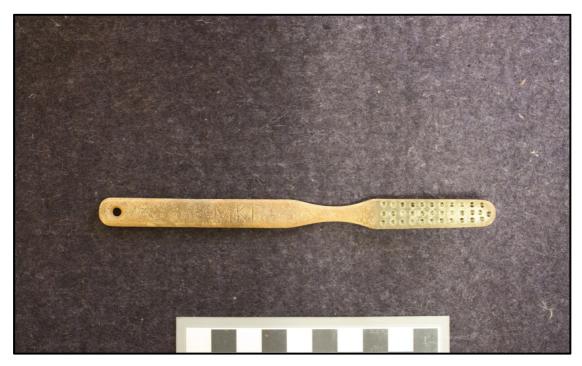
Plate 6: Toothbrush handle with scratched initials (Scale = 10cm)

A large artefact assemblage was recovered from the deposit at the external southern wall of the Stables (Plate 6, Plate 7 & Plate 8). All artefacts have been cleaned and a preliminary analysis conducted. Artefacts were identified and categorised by form and function and, where diagnostic features were preserved, for probable date of manufacture. A catalogue of artefacts is provided in Appendix 1. No additional analysis of artefacts has been undertaken although there is clearly potential to work further on this collection of archaeological material.

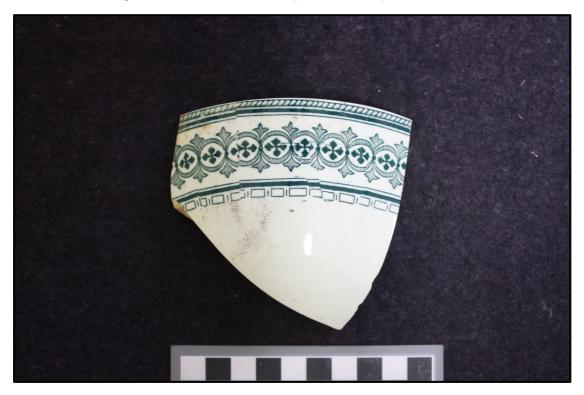
Plate 7: Transfer printed ceramic rim sherd (Scale = 10cm)

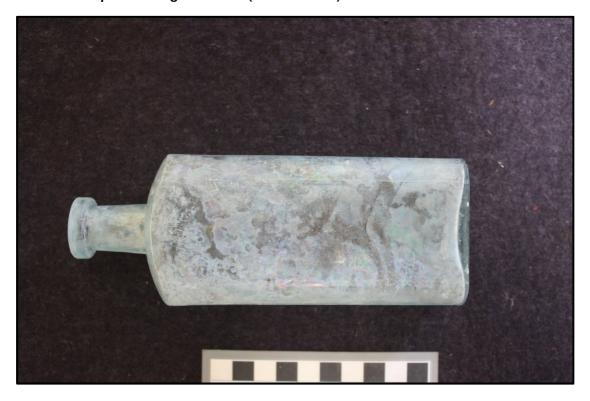
Plate 8: Complete clear glass bottle (Scale = 10cm)

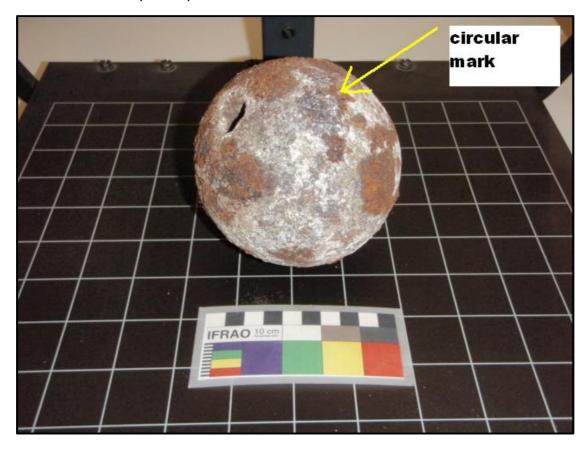
Plate 9: Case shot (c. 1825) recovered from Trench 1
